**BEFORE THE
SURFACE TRANSPORTATION BOARD**

EX PARTE No. 772

OVERSIGHT HEARING PERTAINING TO
UNION PACIFIC RAILROAD COMPANY'S EMBARGOES

**UNIONS' SUPPLEMENTAL FILING REGARDING
UNION PACIFIC SERVICE PROBLEMS**

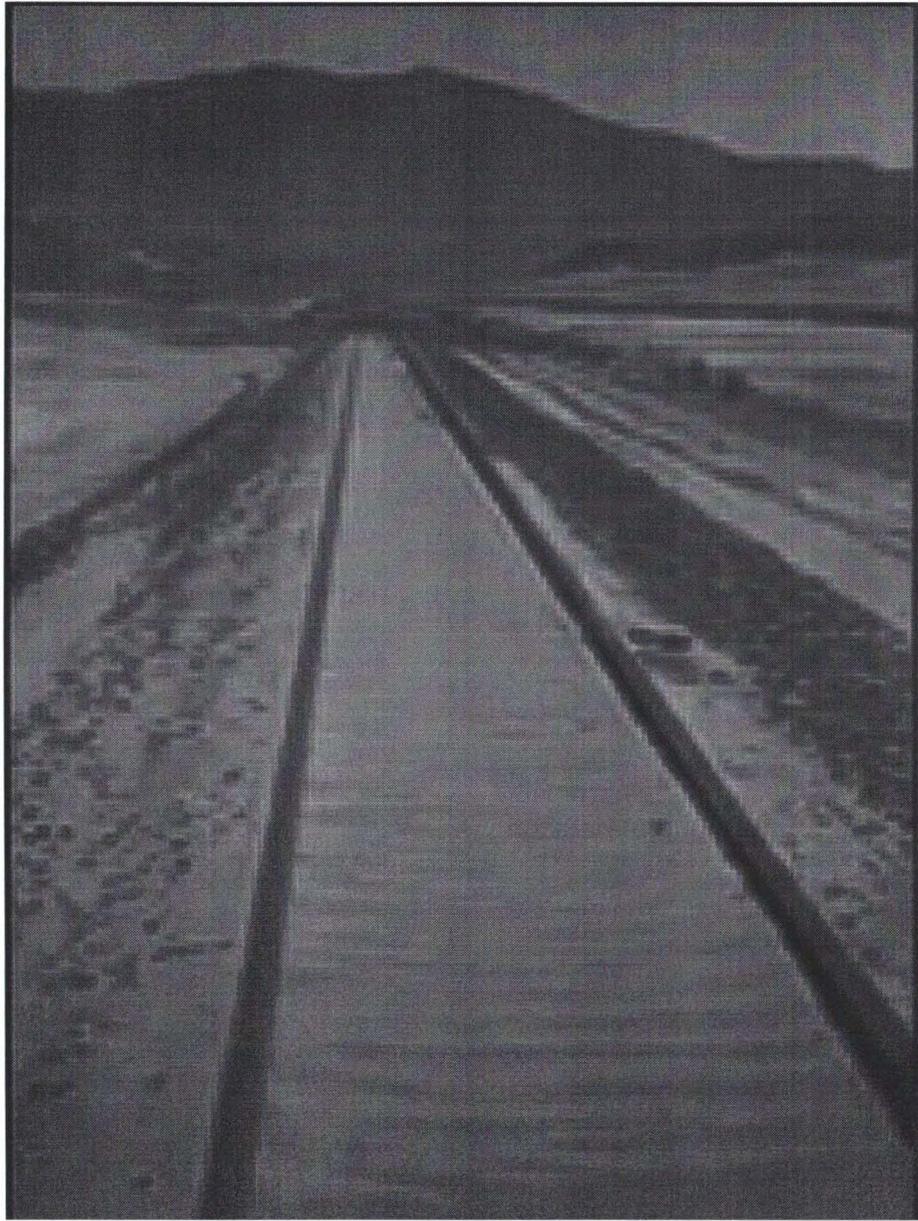
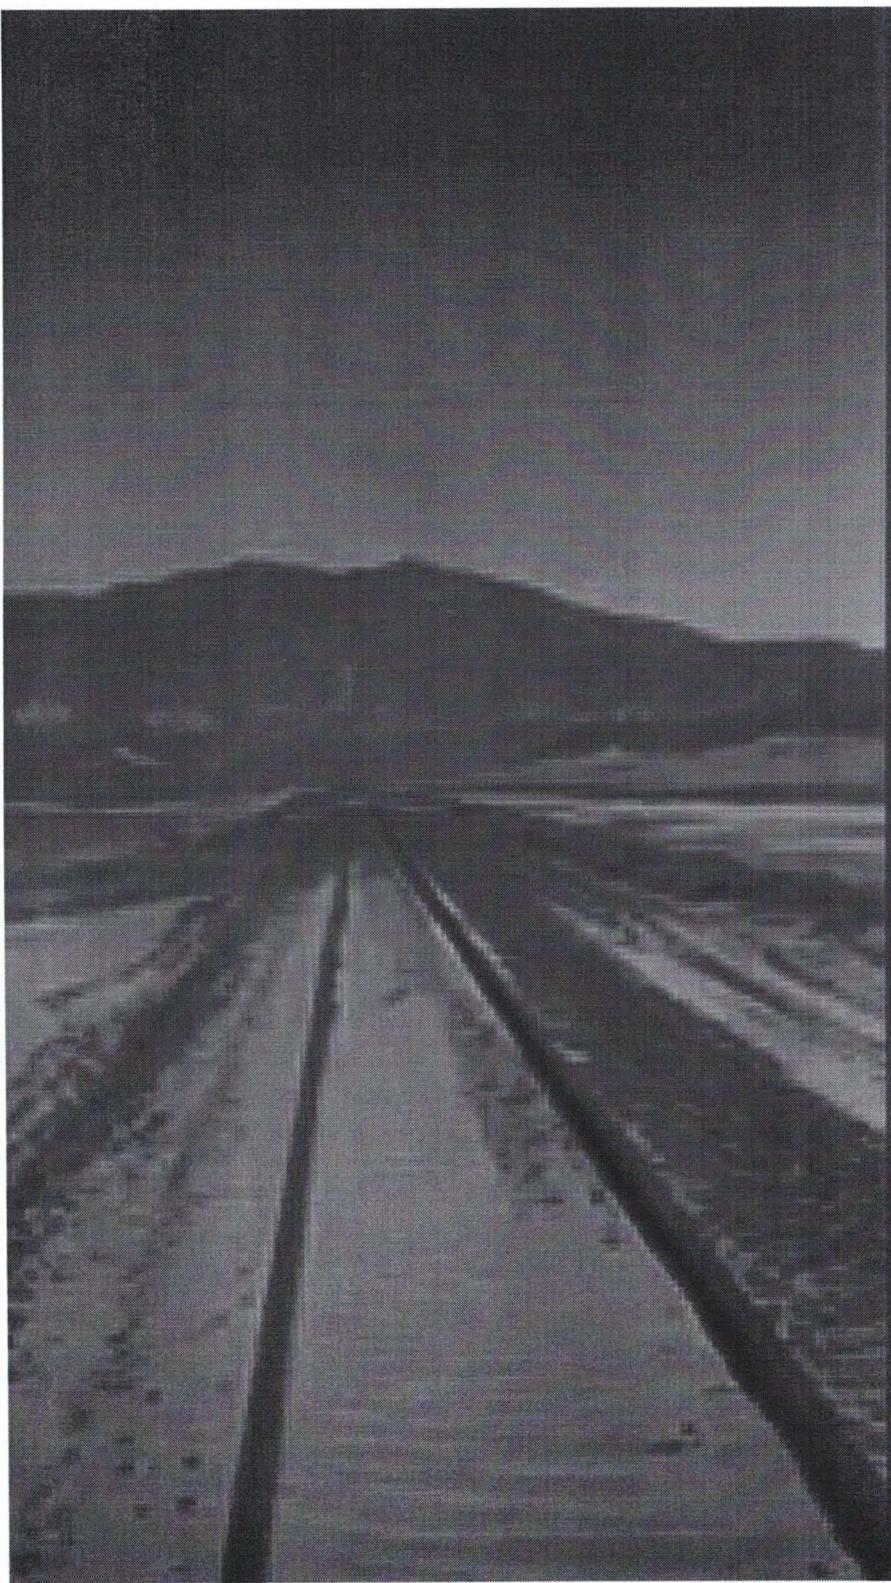
NORMAN EXHIBIT B

trains and congestion on the line. *Id.* Additionally, sand fences and berms have not been maintained, so the track is full of sand, which also causes degradation of the track and right of way, and slower train movements. *Id.* ¶4. Attached to the Norman declaration are pictures of track that is part of the line that is covered with sand. Norman Declaration ¶7. With the current deteriorated track conditions, the CTC system is not functioning. As a result, UP must do multiple re-crews for trains running on the line. Using track warrants will lessen the need for re-crewing, which will allow for faster movements over the line. *Id.* ¶6. But, as Mr. Norman has noted, if the track infrastructure had been properly maintained, UP would not have had a need for multiple re-crews; and UP would not have had to request to suspend use of the CTC system, which will render operations over the line less safe and less efficient. *Id.* ¶6. By underinvesting and cutting Signal and Maintenance of Way staffing, UP has created a choice between two bad options, rather than running like a modern railroad.

Current condition: Abnormal amounts of high alkaline soil and sand has blown into the track that was just raised six inches in August. That sand and soil then received a seasonally high amount of rain and moisture that then quickly froze before it dried or evaporated. To compound the problem, it then snowed encasing the ties and rail creating a shut.
