Re: Docket No. FD 36500, CPKC Quarterly Environmental Mitigation  
Measures Report for March 15 to June 14, 2024

# CPKC Quarterly Environmental Mitigation Measure Compliance Report Number 5

This report includes compliance activities completed between March 15 and June 14, 2024 (Quarter 1, Year 2 of the STBs oversight period following the acquisition of KCS by CP, STB Docket FD 36500)

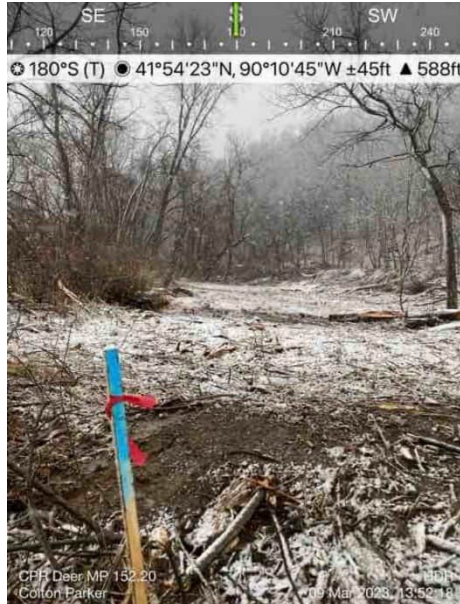
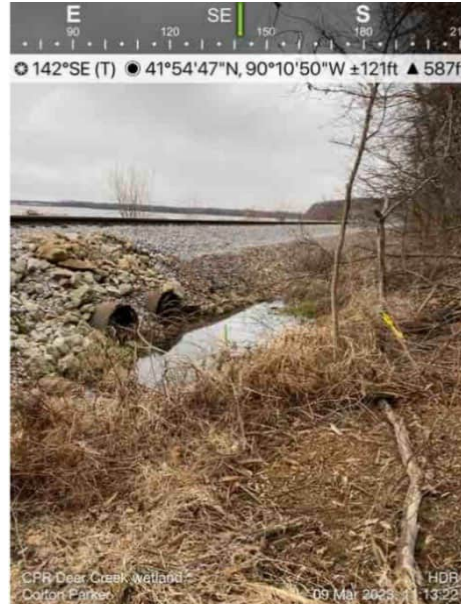
ROW boundary/limits are marked by blue survey stakes with pink ribbon. All wetlands are marked with green lath with yellow ribbon. All work was performed within the ROW limits.

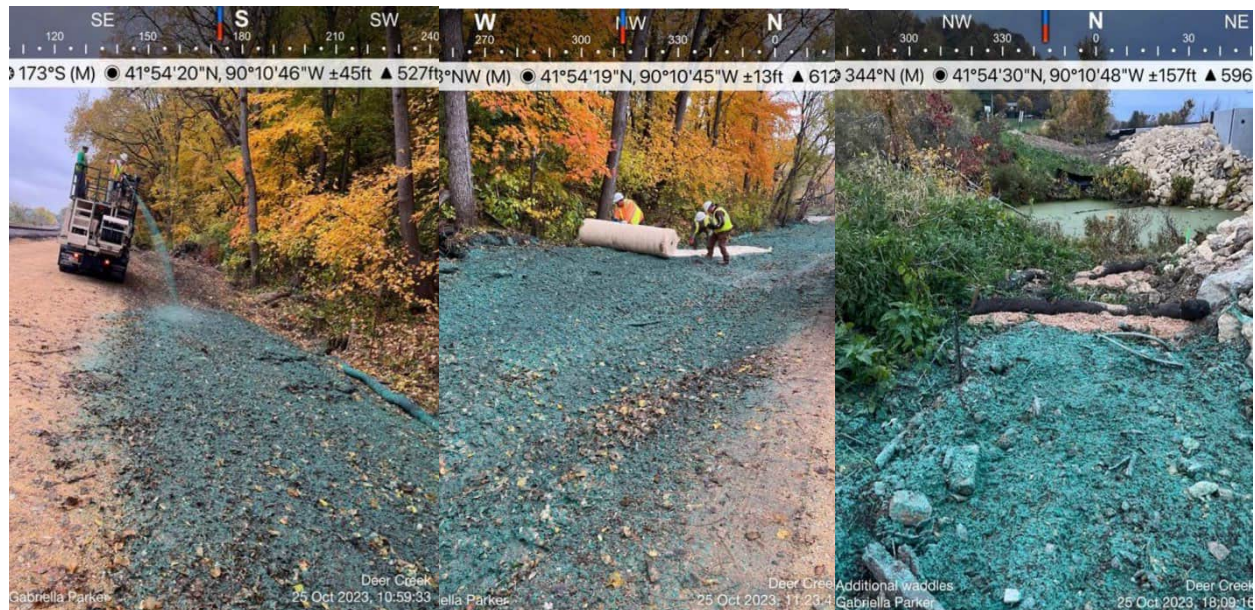
Contractors ensured stabilization with hydro mulch, seed, and erosion matting measures on areas where vegetation clearing took place and re-worked areas within the 7-day period. Post construction inspections have ensured re-stabilization measures have taken place on the entire ROW.

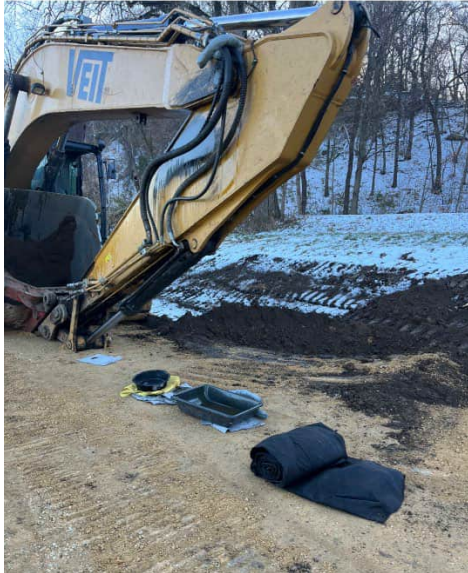
All contractor equipment was equipped with spill kits. Extra spill kit materials were available at the main entrance by the contractor's trailer. One spill caused by a hydraulic leak in the excavator was observed on 11/29/2023. That spill was below the applicable reportable quantity, and the liquid was contained with absorbent pads and a drip bucket until it was repaired.

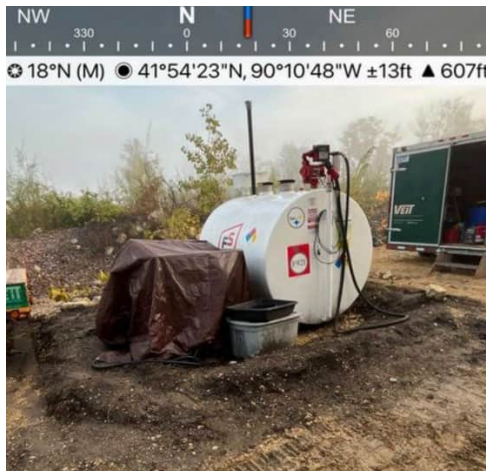
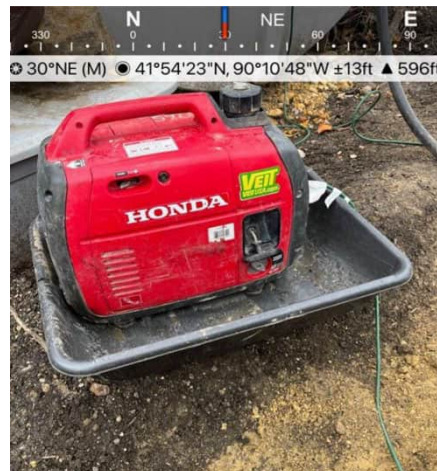
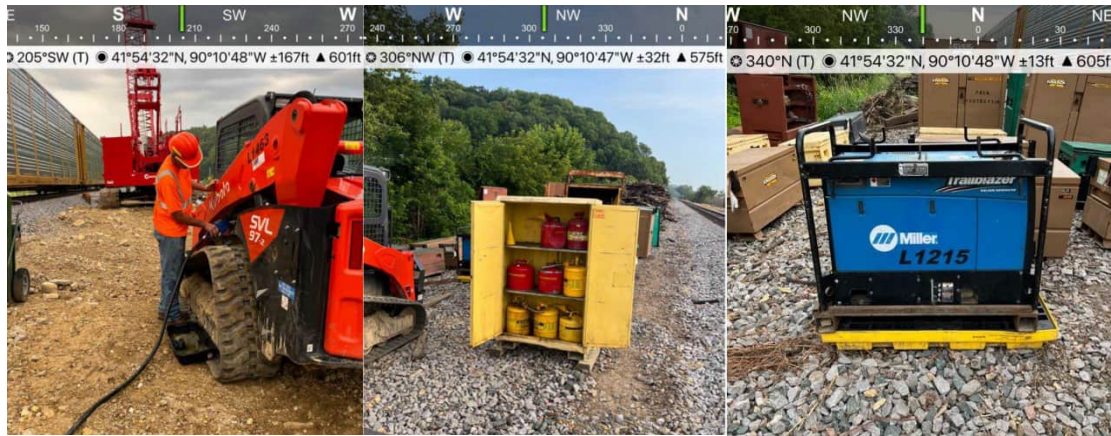
Any extensive maintenance or large quantity fluid change was performed off site to minimize risk of a spill or impact to surrounding environment. Contractors utilized secondary containment when refueling equipment at the main entrance. Each piece of equipment contained spill kit materials in preparation of a spill or leak.

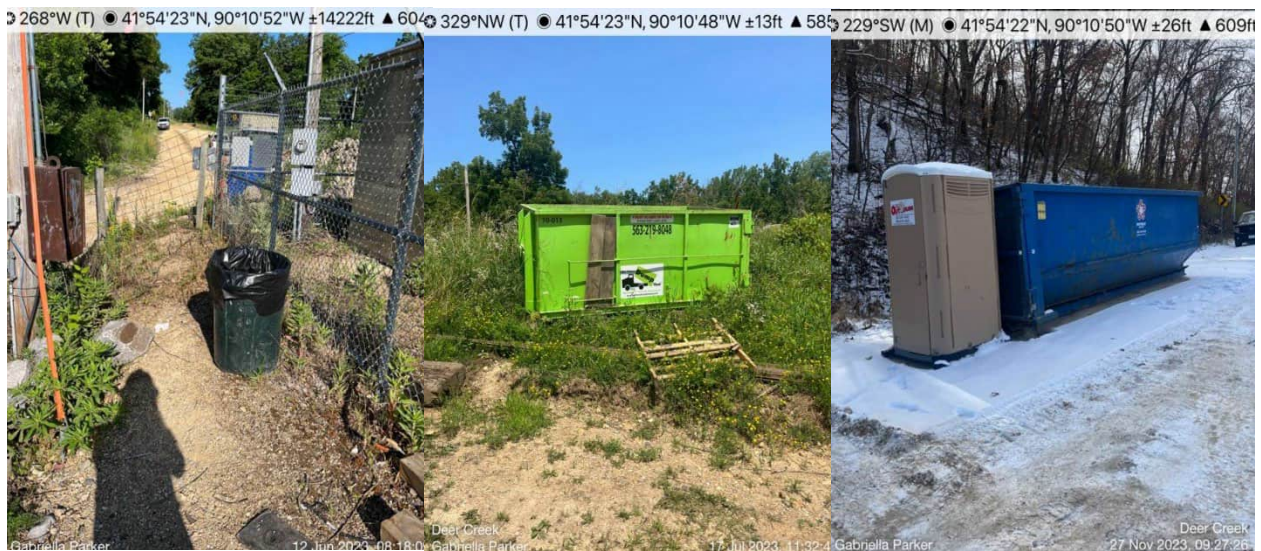
All waste generated on the Deer Creek site was disposed of in accordance with all applicable federal, state, and local regulations. A dumpster and several garbage cans with lids were located along the ROW.

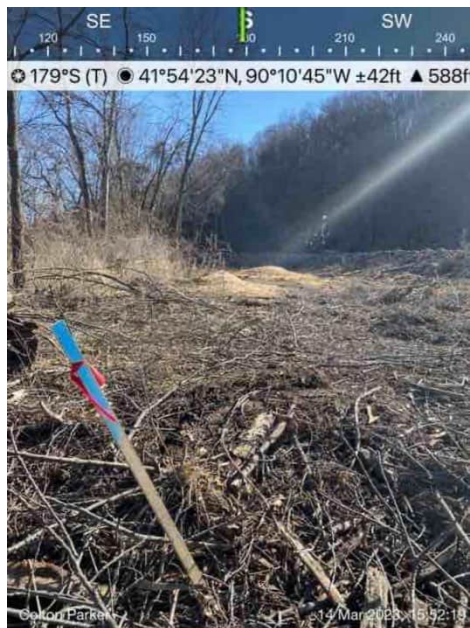
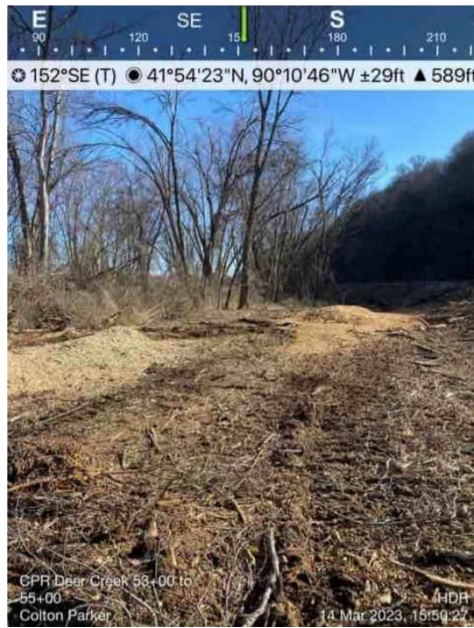
All tree clearing at Deer Creek site was completed prior to April 1, 2023. No active bird nests were observed on site during clearing operations or construction.

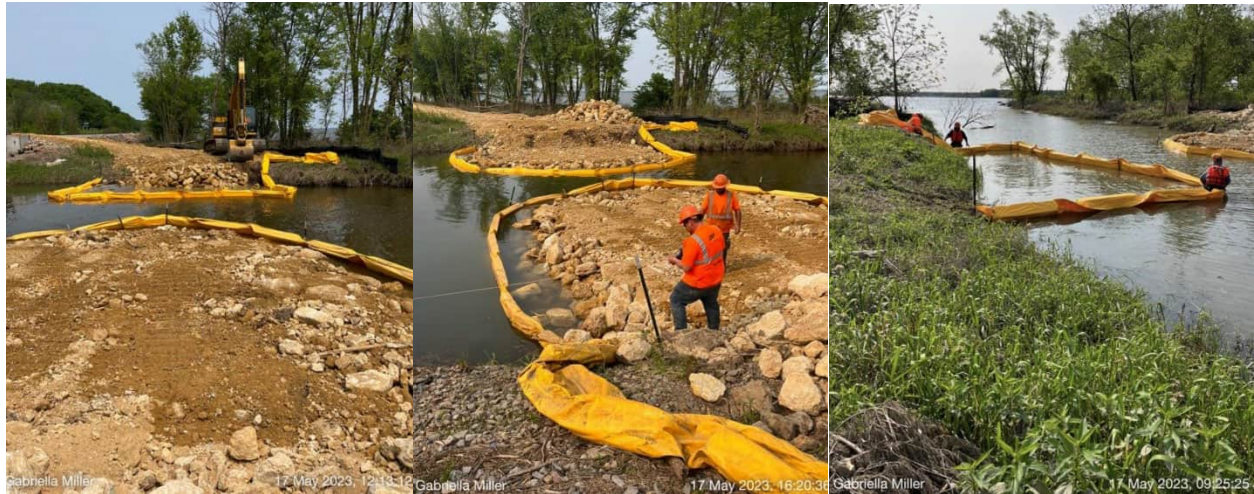
Environmental monitors worked together with contractors on protecting the stream while construction was occurring. A temporary crane bridge was built for construction of Bridge 152.20.

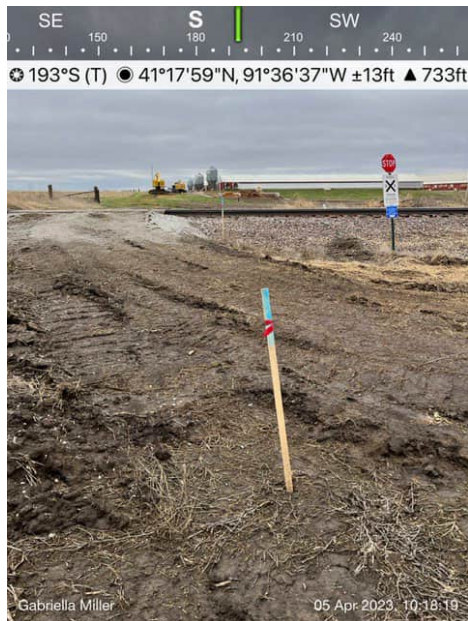
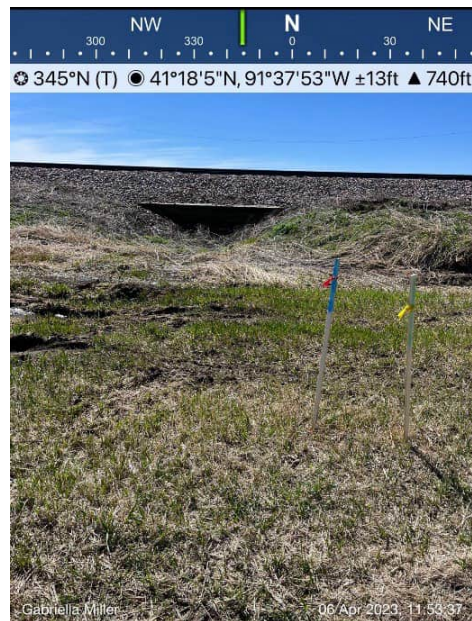
ROW boundary/limits were marked by blue survey stakes. All wetlands were marked with yellow and green lath. All work was performed within the ROW limits.

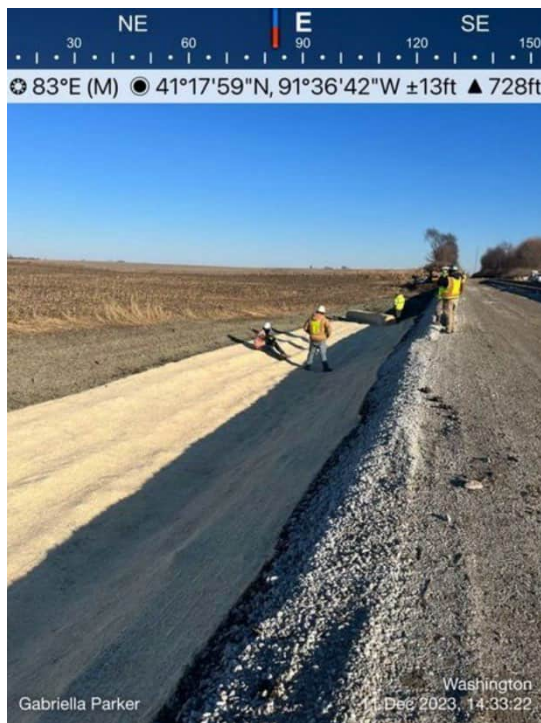
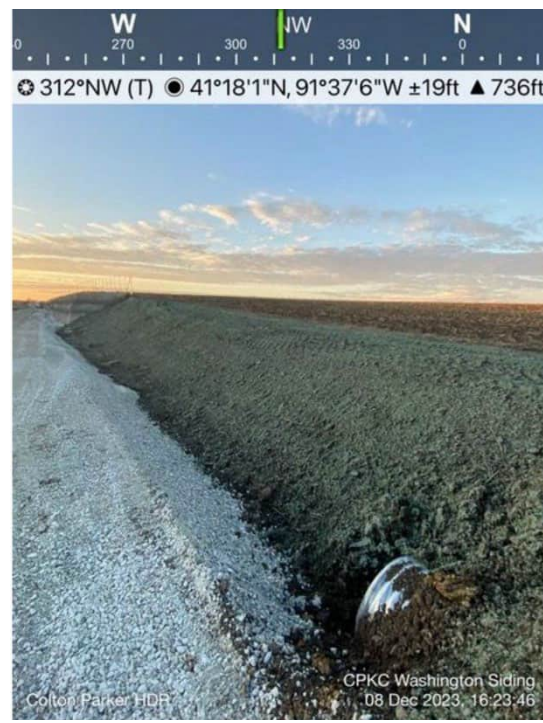
Contractors ensured stabilization with hydro mulch, seed, and erosion matting measures on areas where vegetation clearing took place within the 7-day period. Post construction inspections have ensured re-stabilization measures have taken place along the entire ROW.

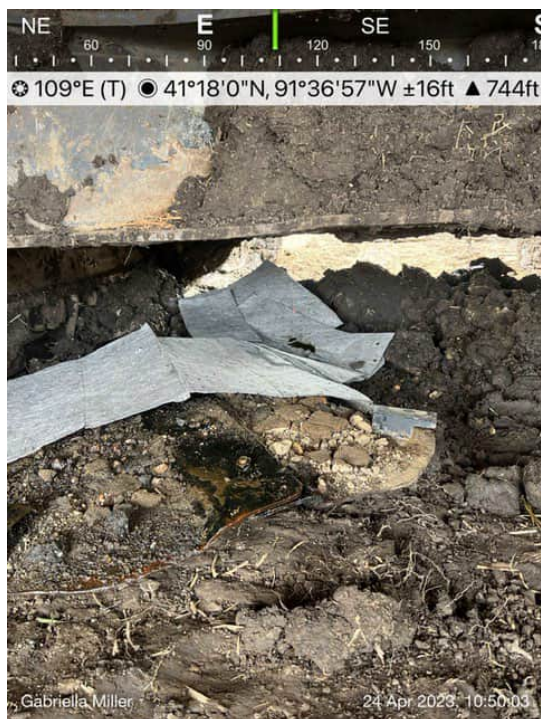
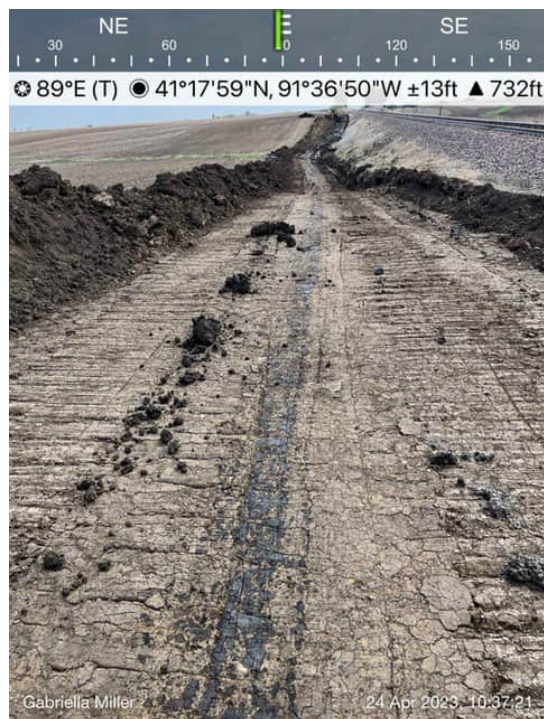
On 7/24/2023 a hydraulic hose broke on a dump truck. Absorbent pads were used to soak up the liquid and shovels were used to remove contaminated soil. Please see Appendix A for spill forms.

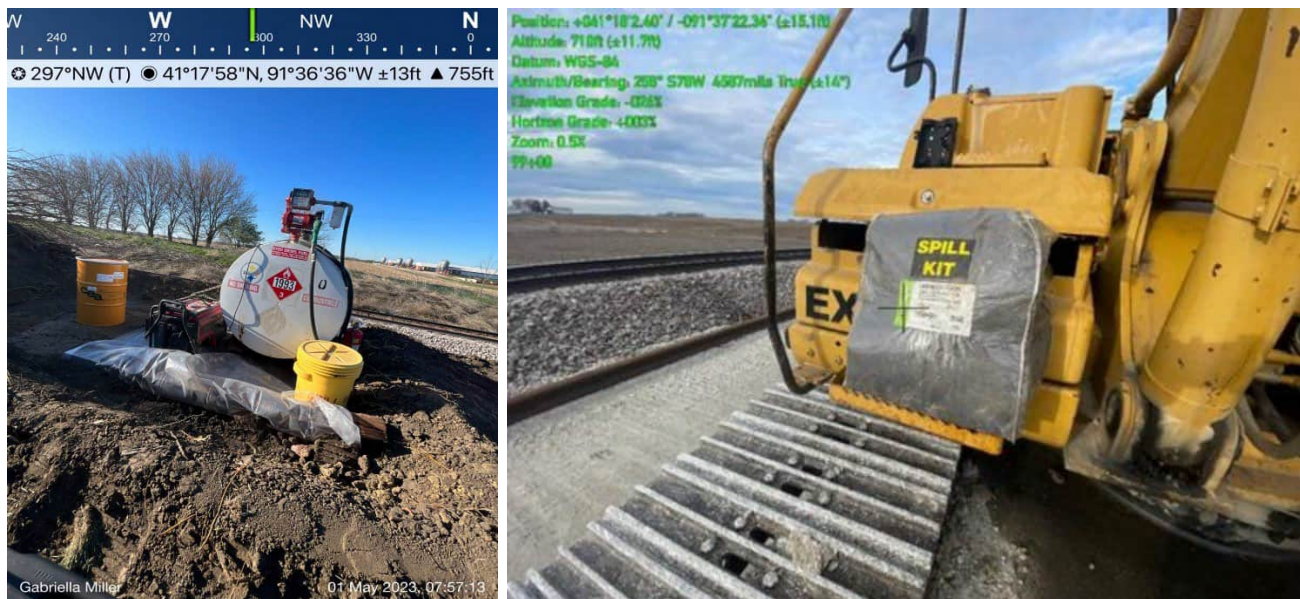
Any extensive maintenance or large quantity fluid change has been performed off site to minimize risk of a spill or impact to surrounding environment. Contractors utilized secondary containment when refueling equipment at the turnaround area on east side of farm crossing at Hog Farm. Each piece of equipment contained spill kit materials in preparation of a spill or leak.

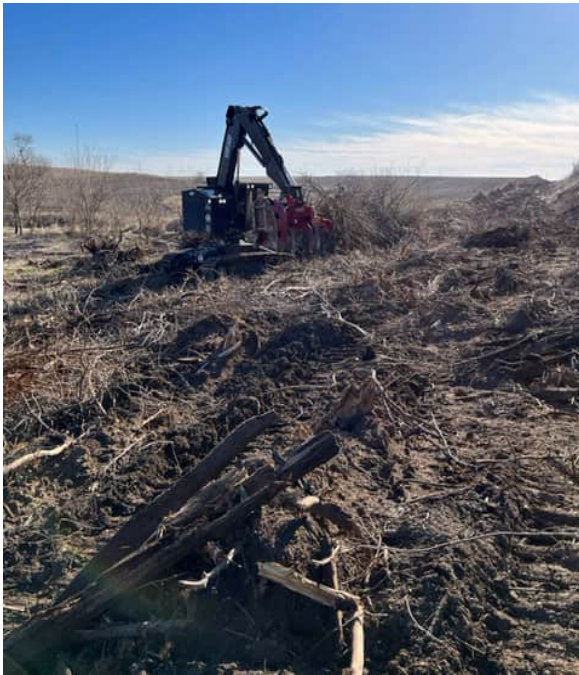
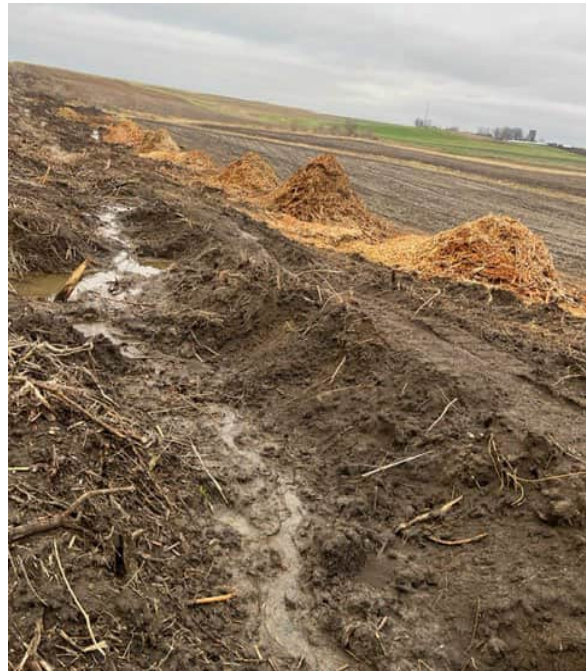
All tree clearing at Washington site was completed prior to April 1, 2023 with the exception of a 50 square foot area on 4/25/2023 approved by CP. The area was inspected by the environmental monitor for any signs of birds or nesting. No active bird nests were observed at Washington site during clearing operations or construction.

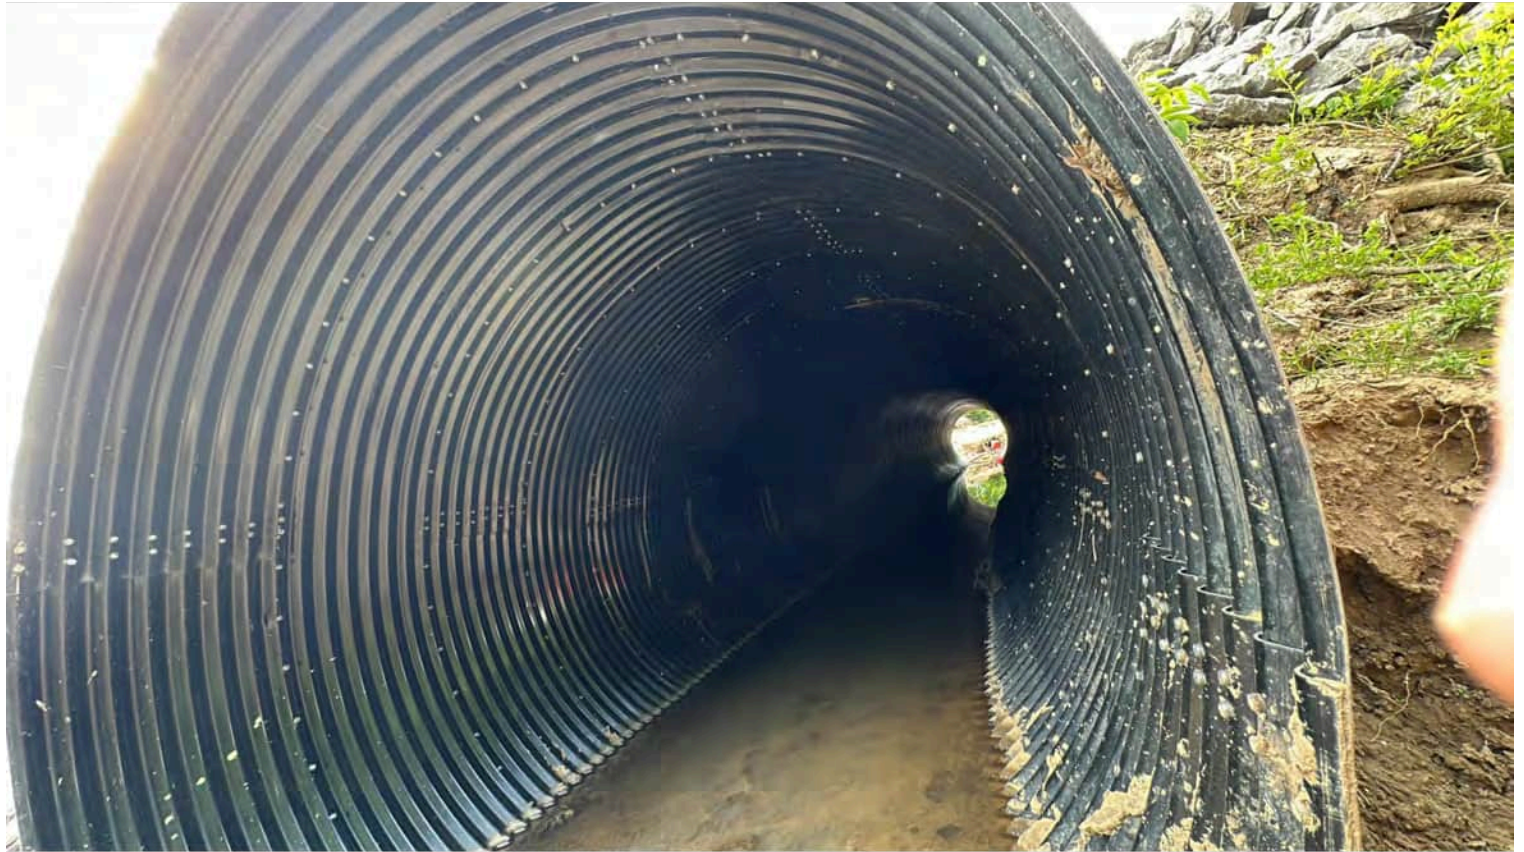
Picture 2: View of 96'x 86'' culvert north of Bailey Road at WQS point number 1.

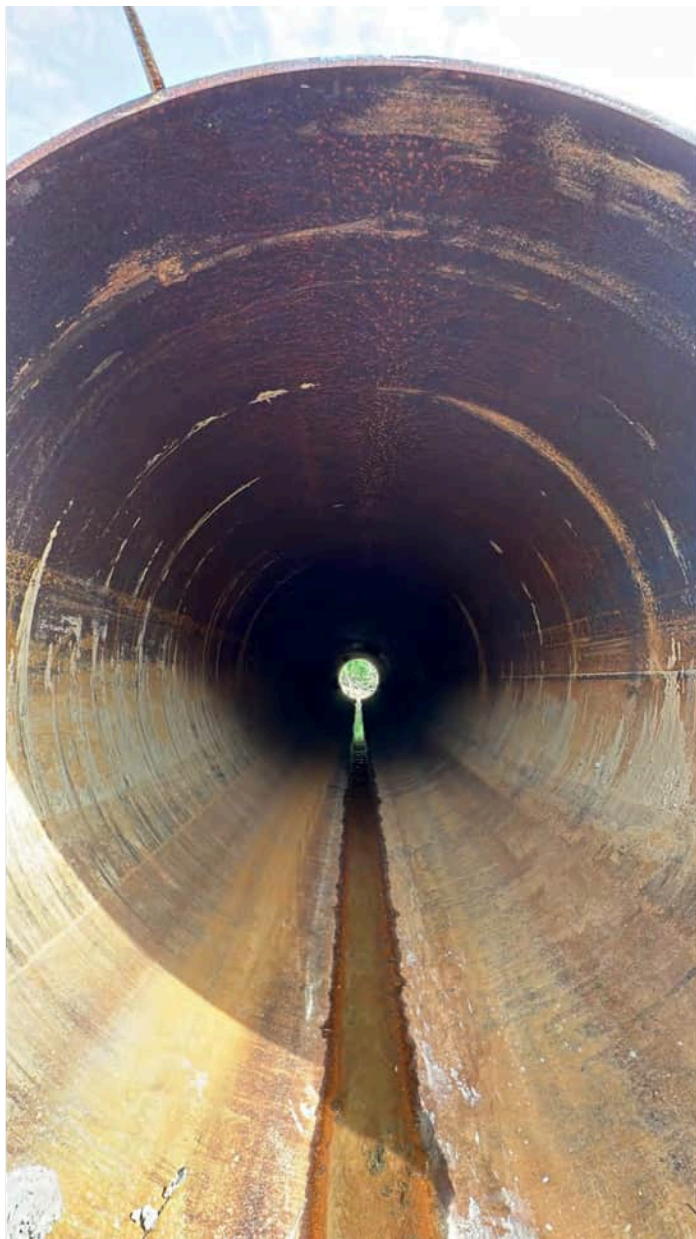
Picture 3: View of 84' by 86'' culvert north of Bailey Road at WQS point number 1.

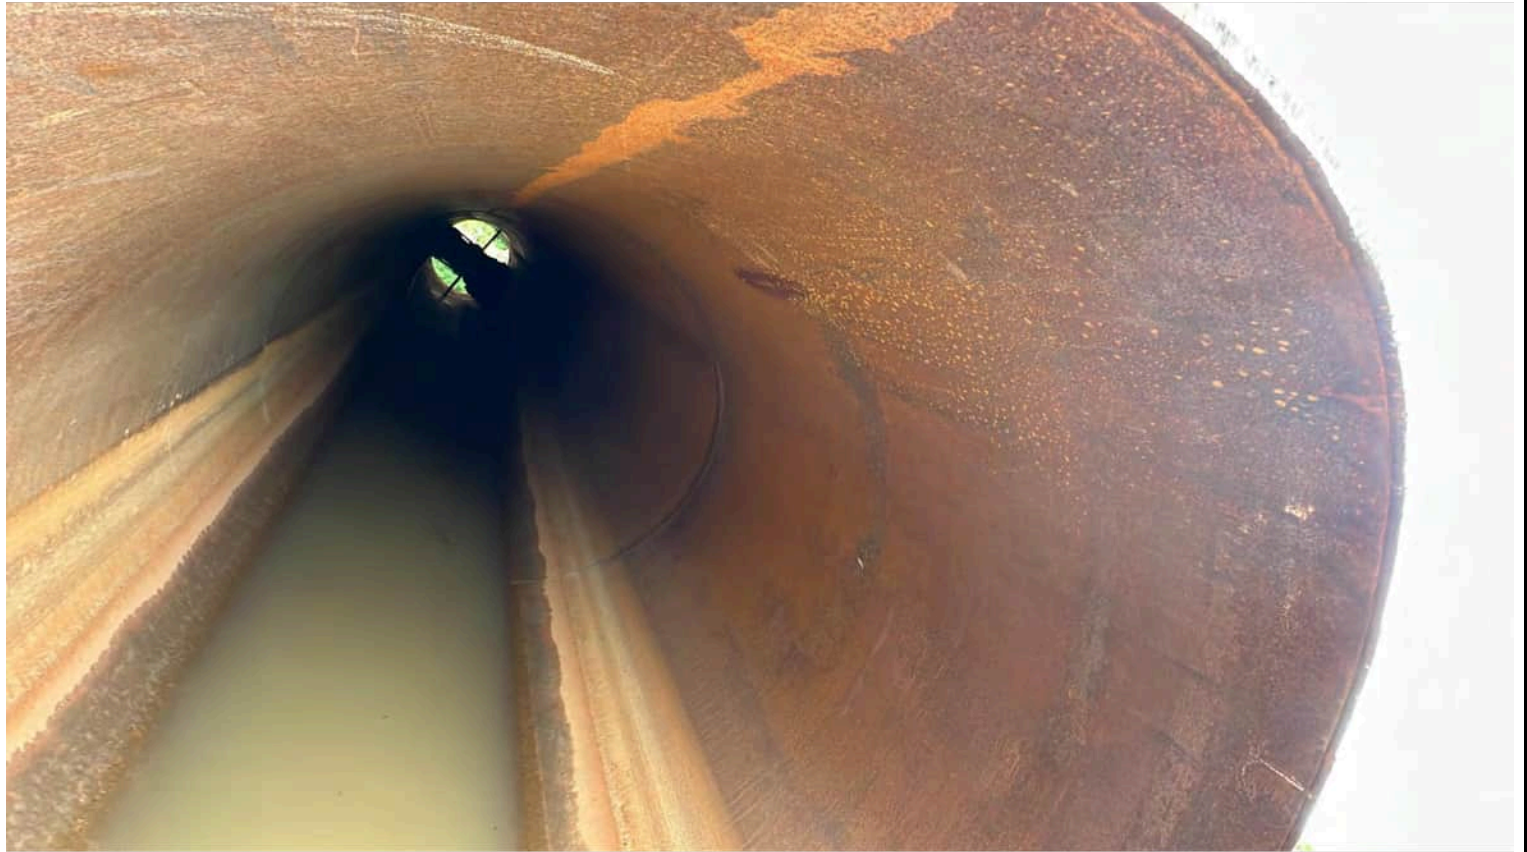
Picture 4: View of 84' by 86'' culvert north of Bailey Road at WQS point number 1.

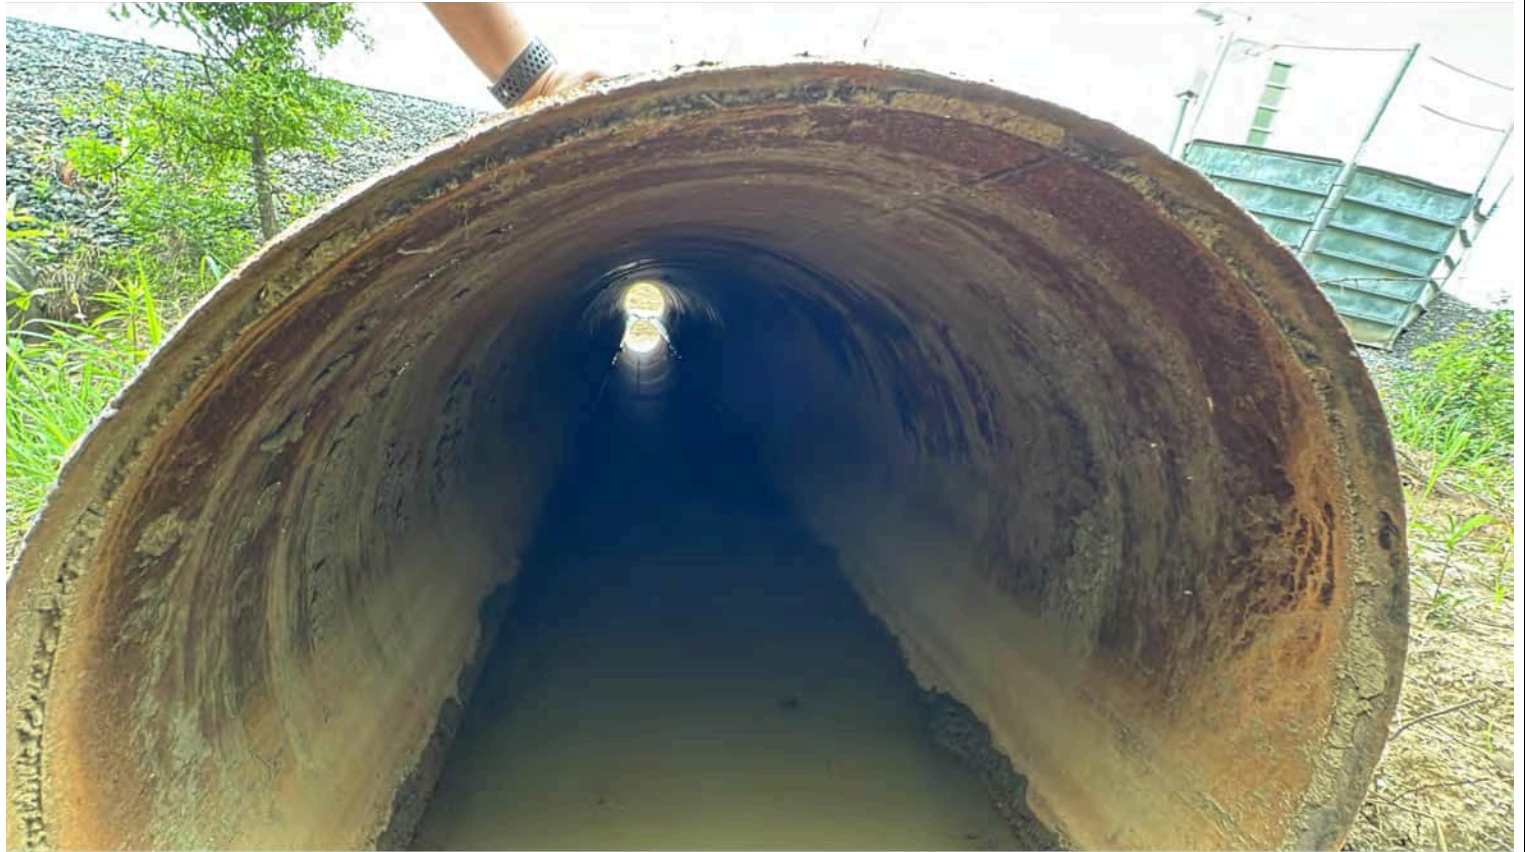
Picture 3: View of 24'x 80'' culvert south of Bailey Road at WQS point number 4.

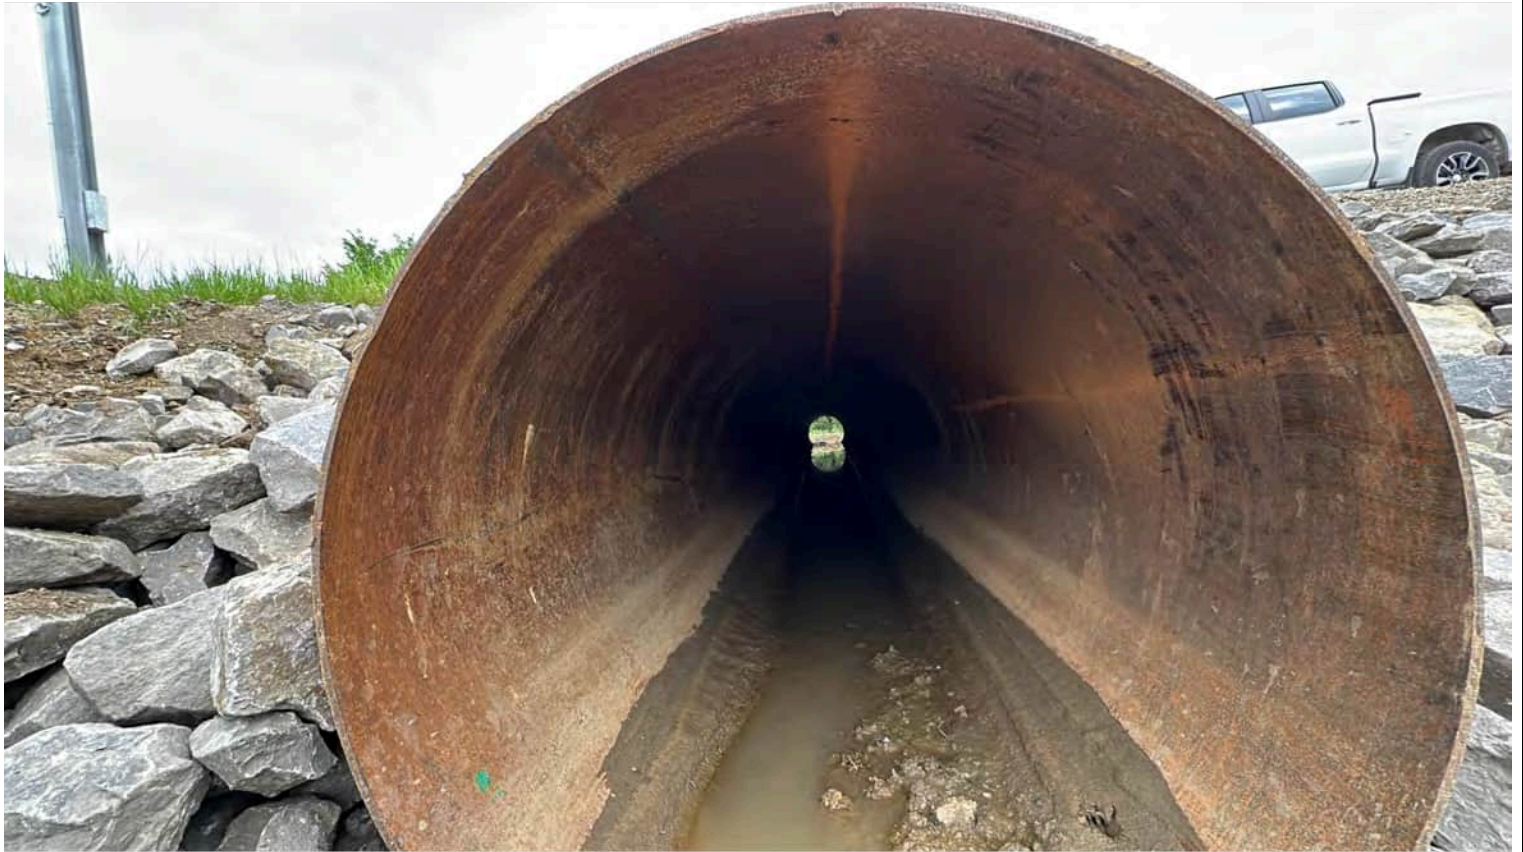
Picture 4: View of 24'x 80'' culvert south of Bailey Road at WQS point number 4.

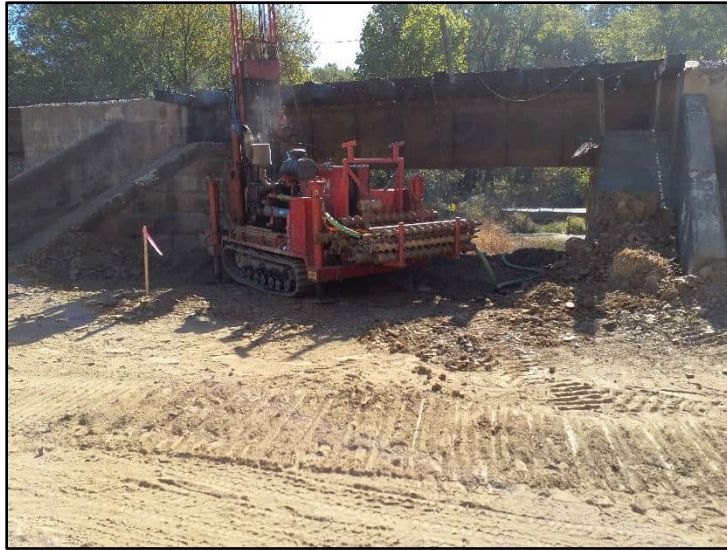
**Figure 13. Drilling for core samples near bridge to be replaced; view facing southeast. (Photograph by R. Cline 10/17/23.)**

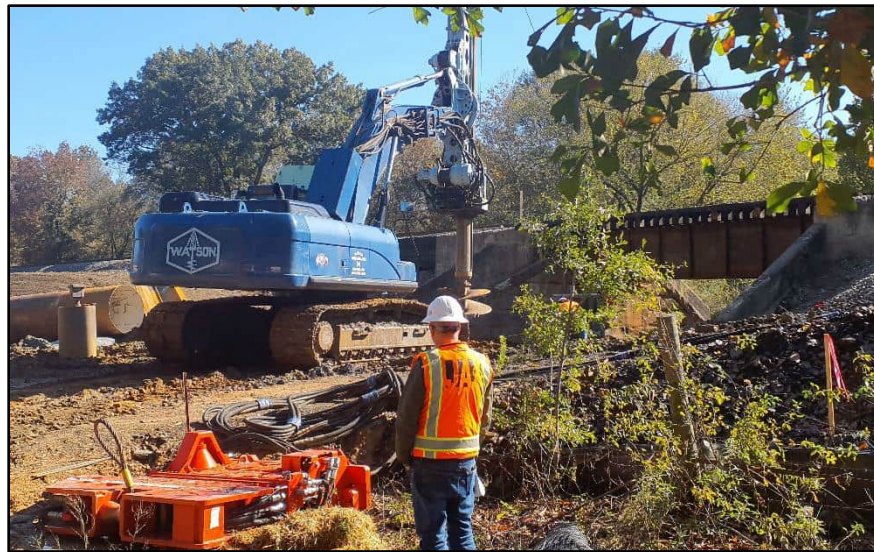
**Figure 14. Drilling for beam installation; view facing east. (Photograph by T. Himebaugh 10/30/23.)**
