Re: Docket No. FD 36500, CPKC Quarterly Environmental Mitigation  
Measures Report for June 15 to September 14, 2025

# CPKC Quarterly Environmental Mitigation Measure Compliance Report Number 10

This report includes compliance activities completed between June 15, 2025 and September 14, 2025 (Quarter 2, Year 3 of the STBs oversight period following the acquisition of KCS by CP, STB Docket FD 36500).

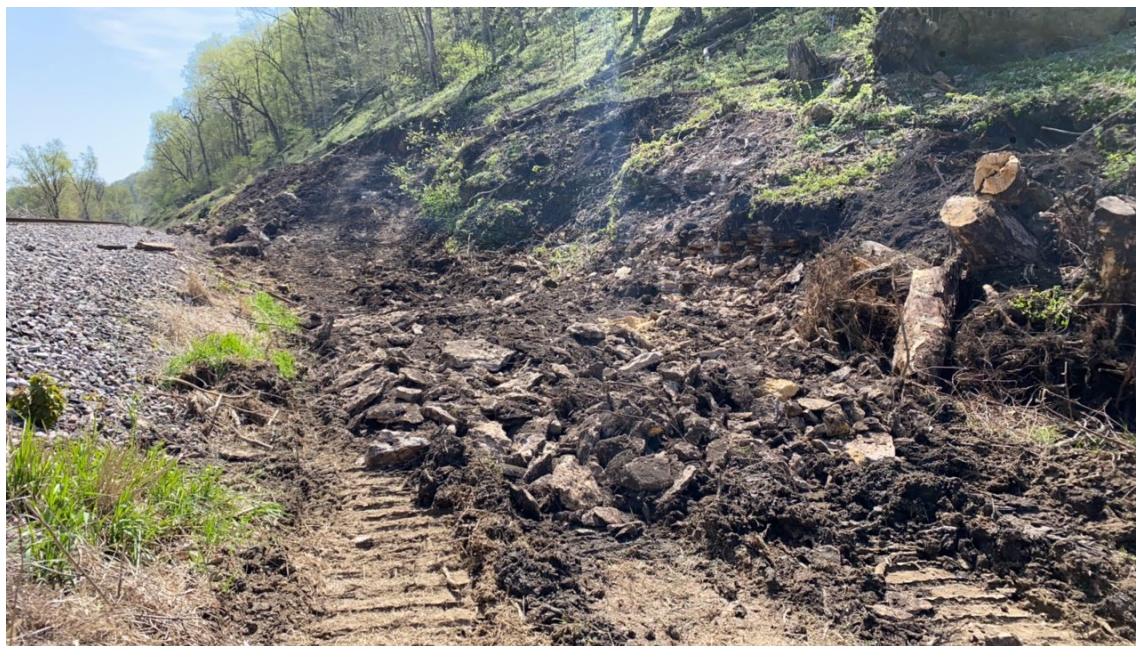
**Figure 1. Initial topsoil clearing for railroad siding construction; facing East. (M. Richison 04/25/24)**

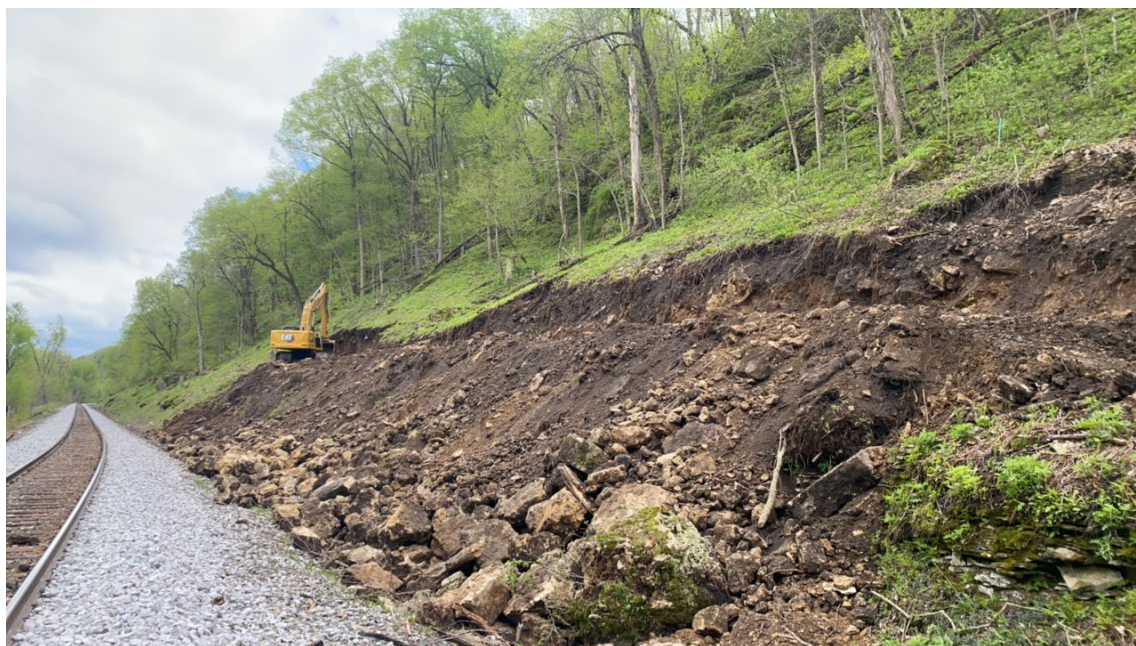
**Figure 2. Initial topsoil clearing near MP 69.48; facing Southeast. (M. Richison 04/29/24)**

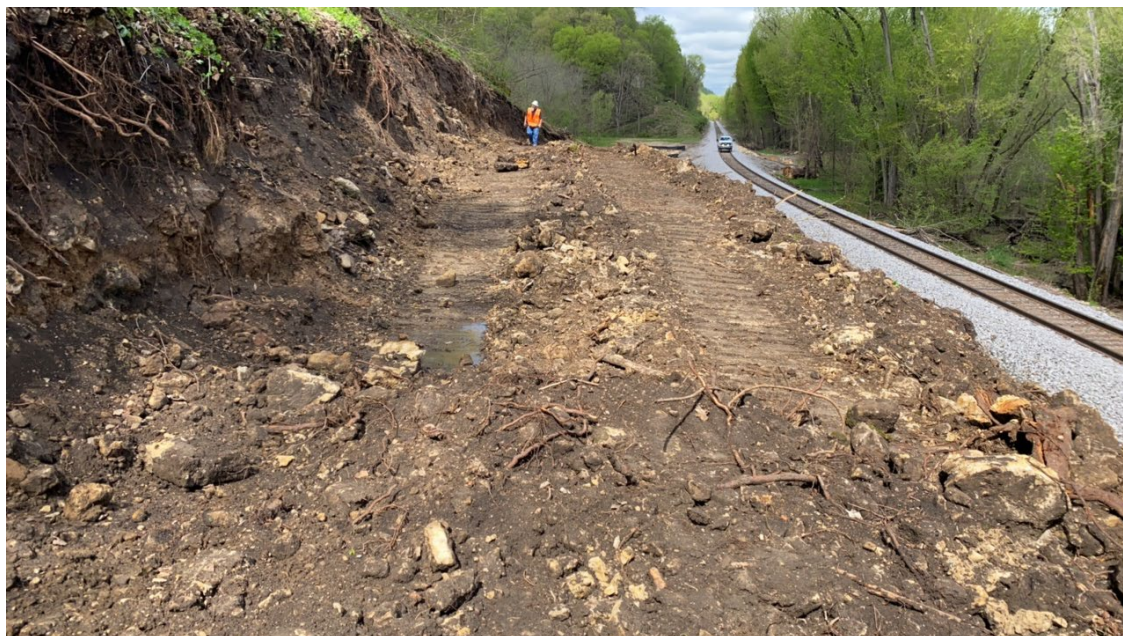
**Figure 3. Initial topsoil clearing and berm construction with undisturbed portions of ROW visible in background; facing Northwest. (M. Richison 04/29/24)**

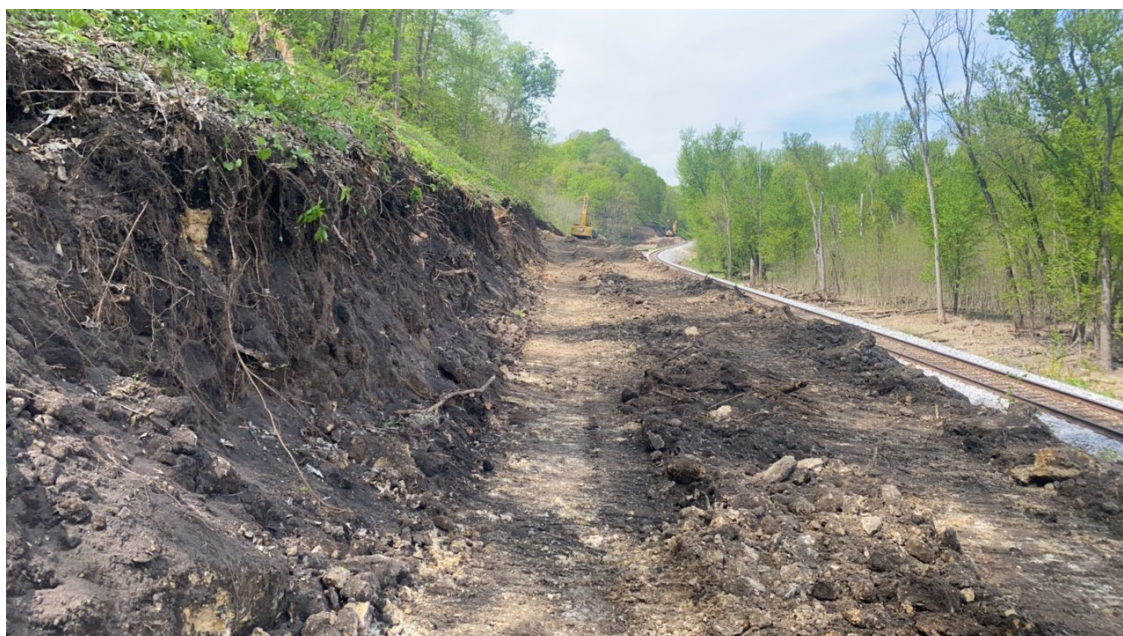
**Figure 4. Initial topsoil clearing near private farm access road, eastern portion of project; facing Northwest. (M. Richison 05/01/24)**

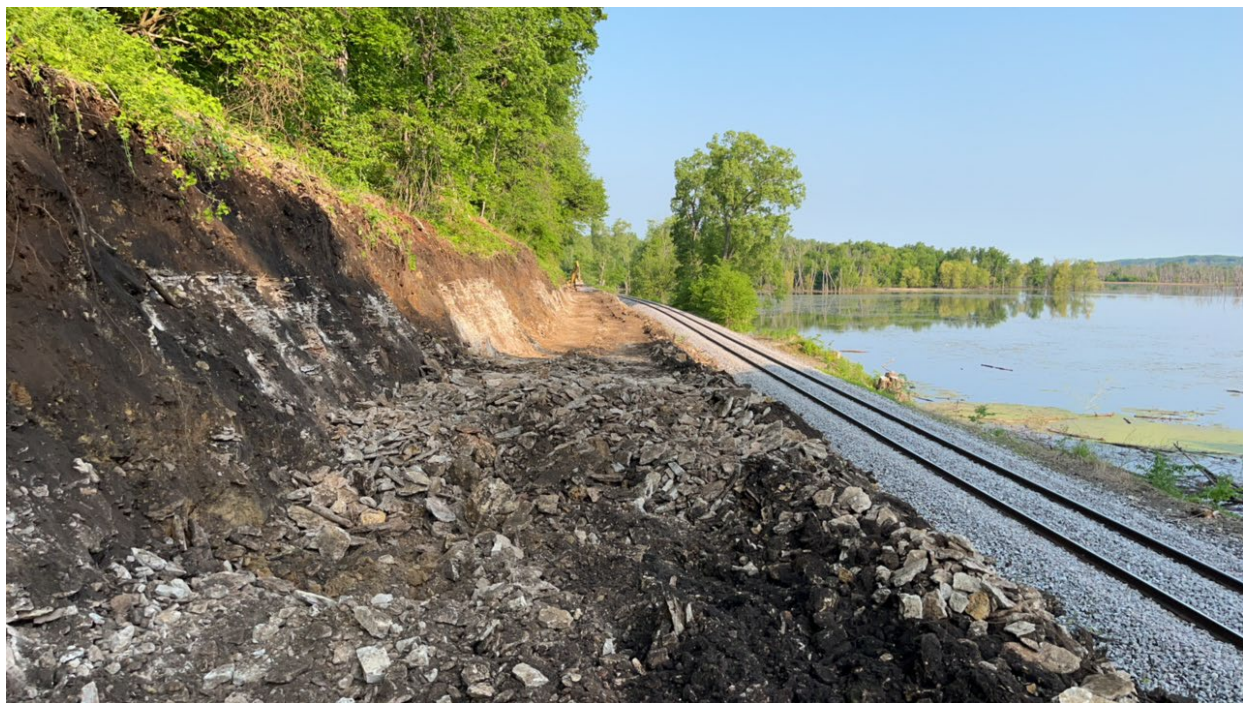
**Figure 5. Topsoil and overburden removal; facing Northwest. (M. Richison 05/15/24)**

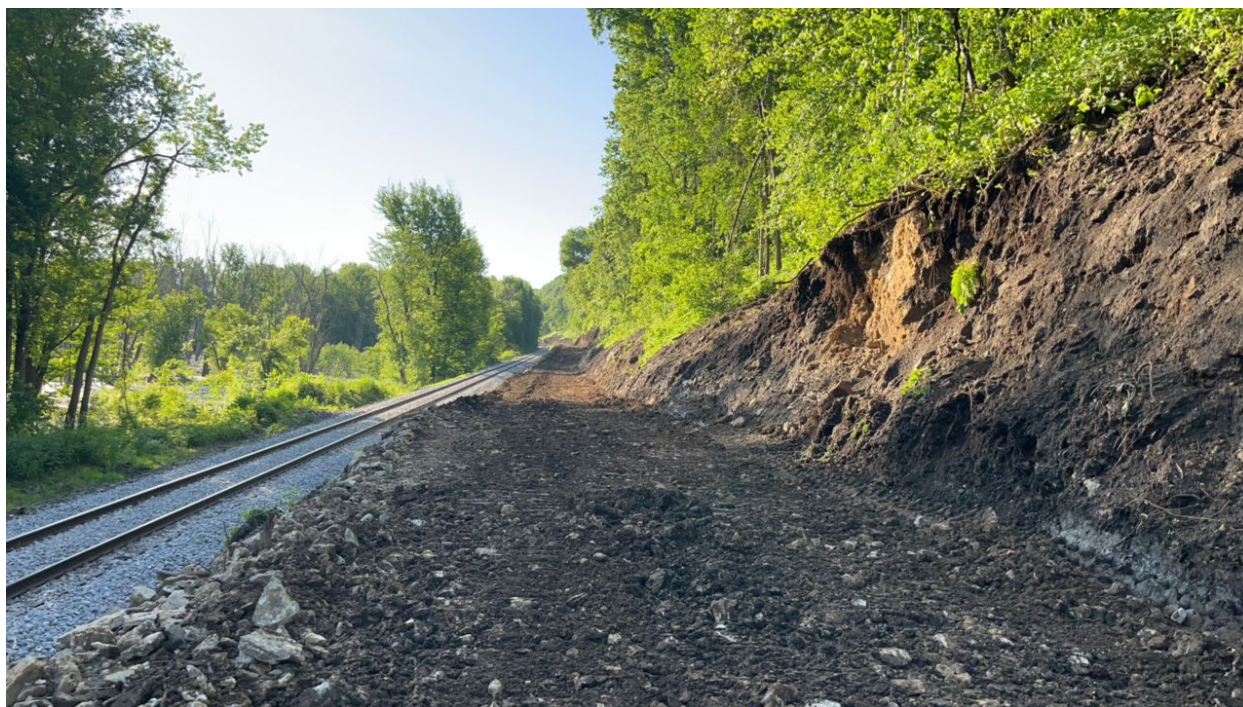
**Figure 6. Topsoil and overburden removal; facing East. (M. Richison 05/30/24)**

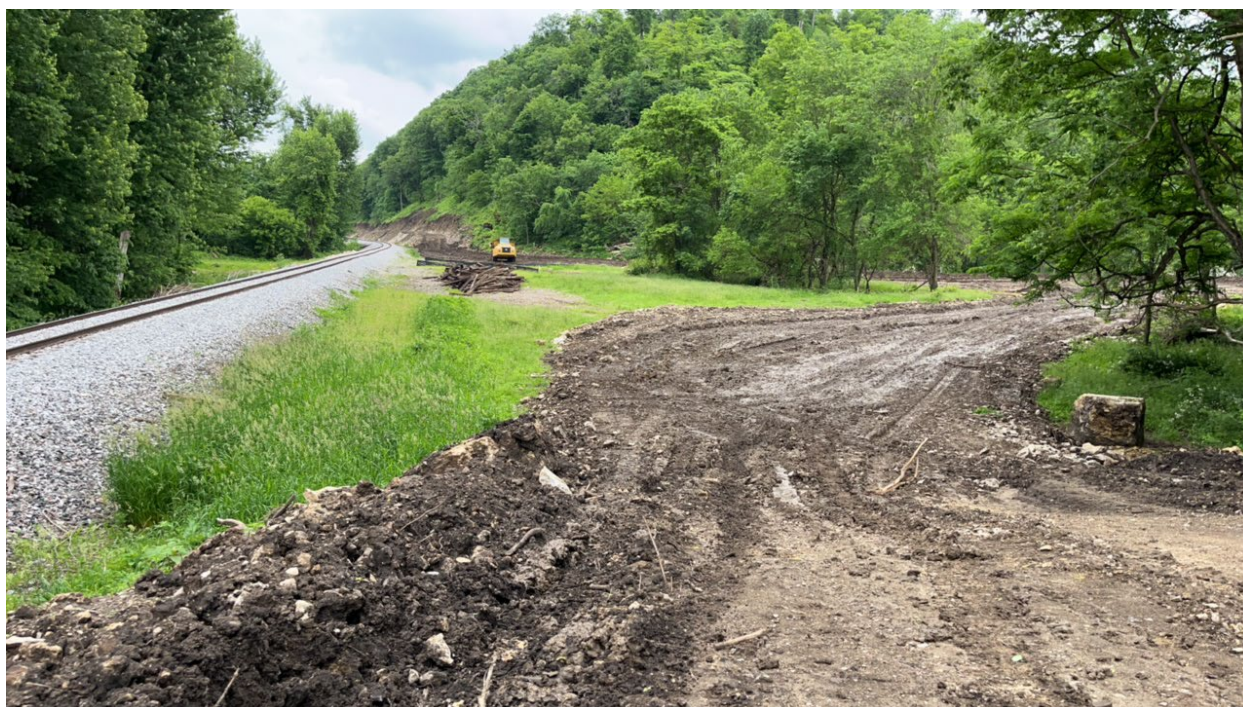
**Figure 7. Topsoil removal in staging area, near three-pipe box culvert; facing Southeast. (M. Richison 06/04/24)**

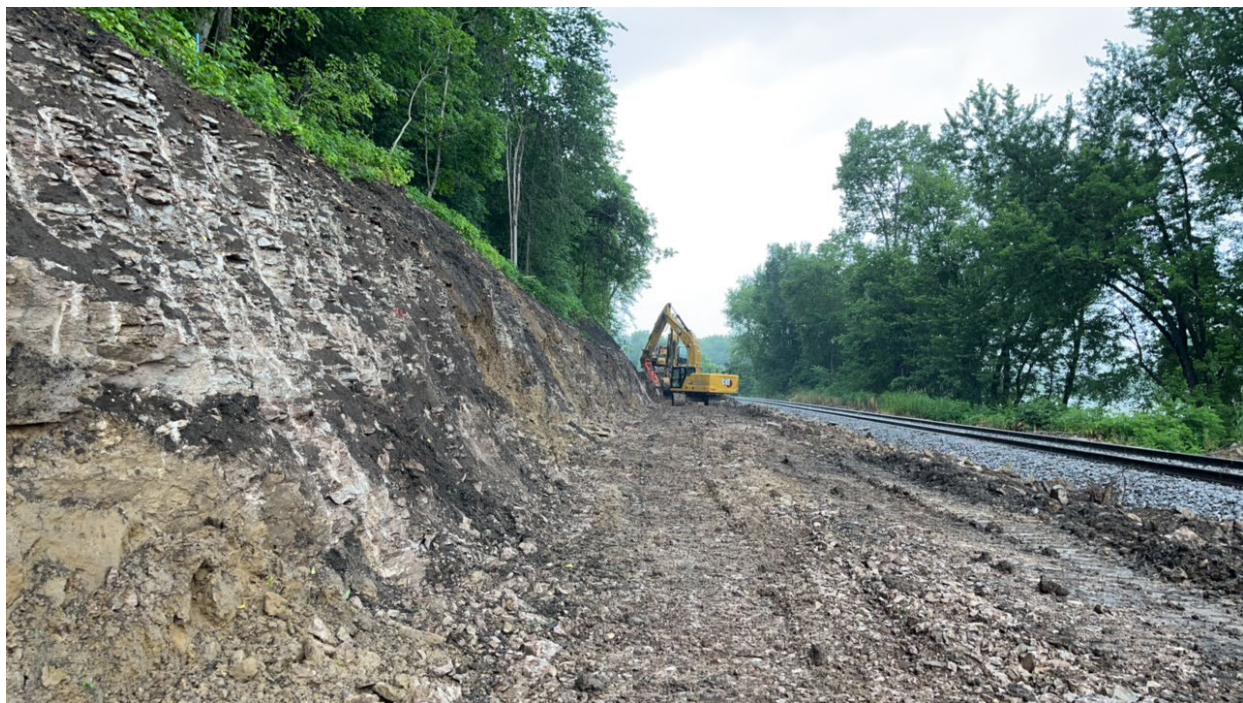
**Figure 8. An example of overburden removal and extent of bedrock in ROW area, western section of project area; facing West/Northwest. (M. Richison 06/20/24)**

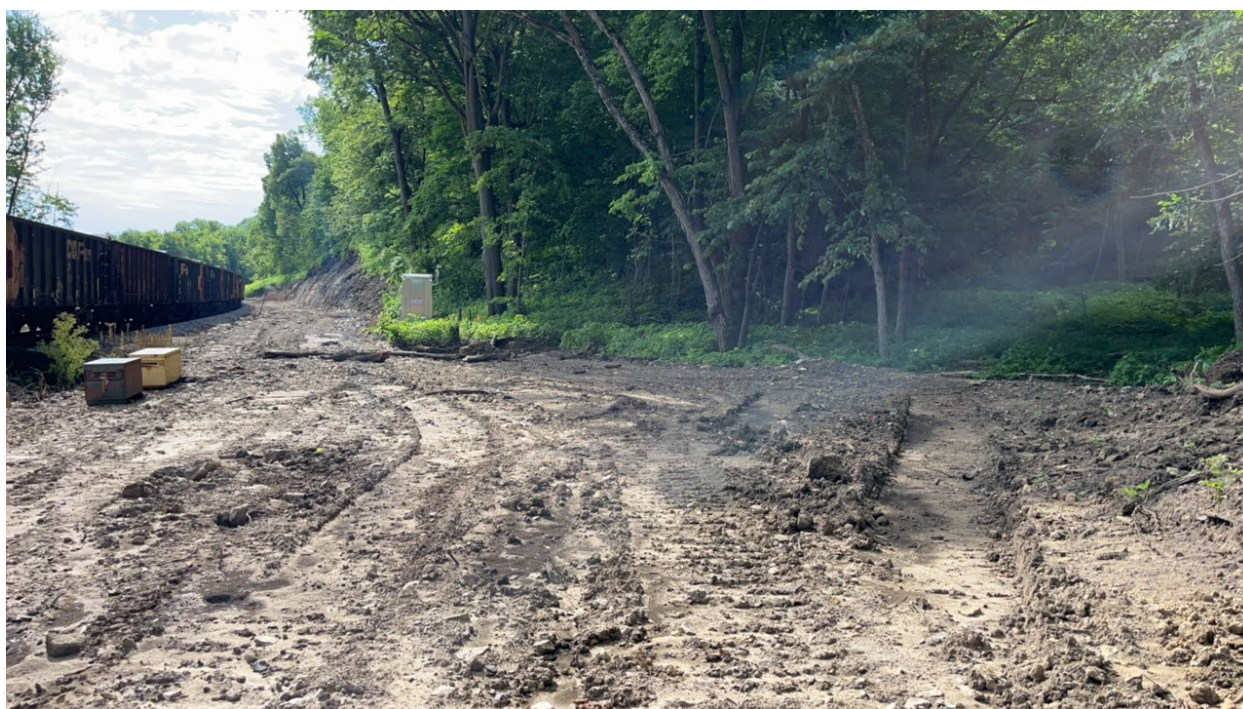
**Figure 9. Access to southern bridge and staging area topsoil removal, easternmost extent of project area; facing Southeast. (M. Richison 06/26/24)**

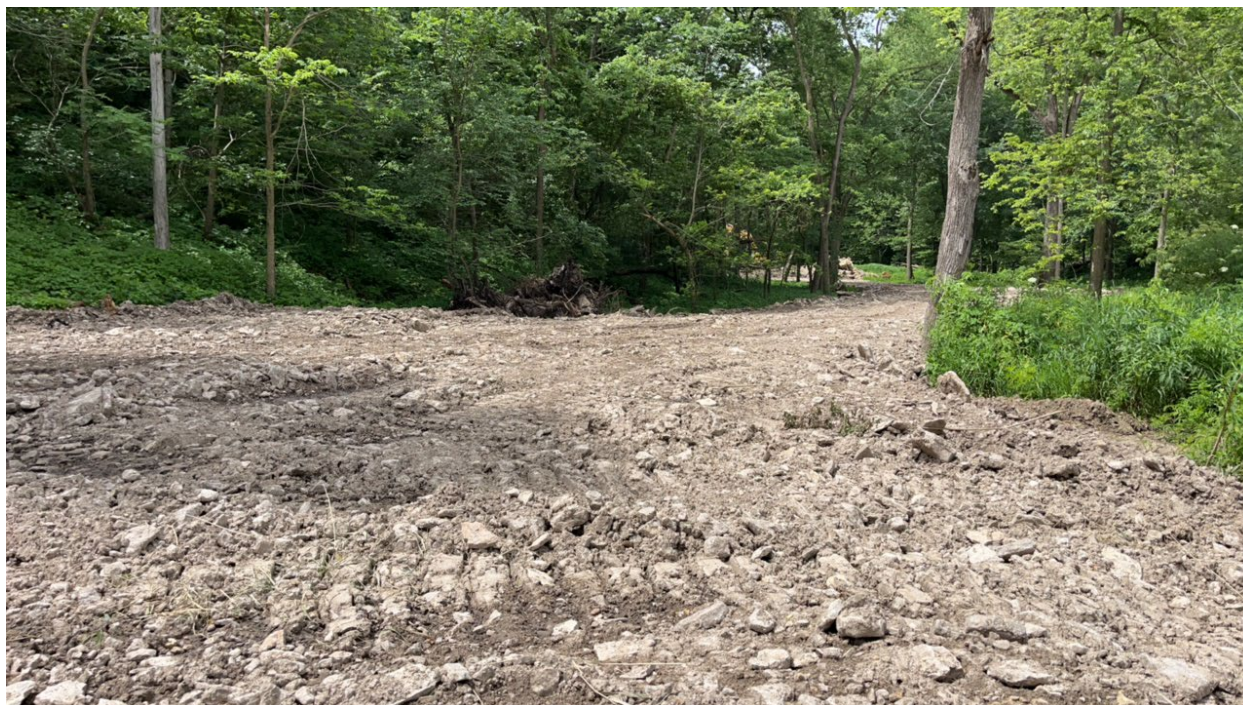
**Figure 10. Topsoil removal and access road construction, western portion of project area; facing South. (M. Richison 07/01/24)**

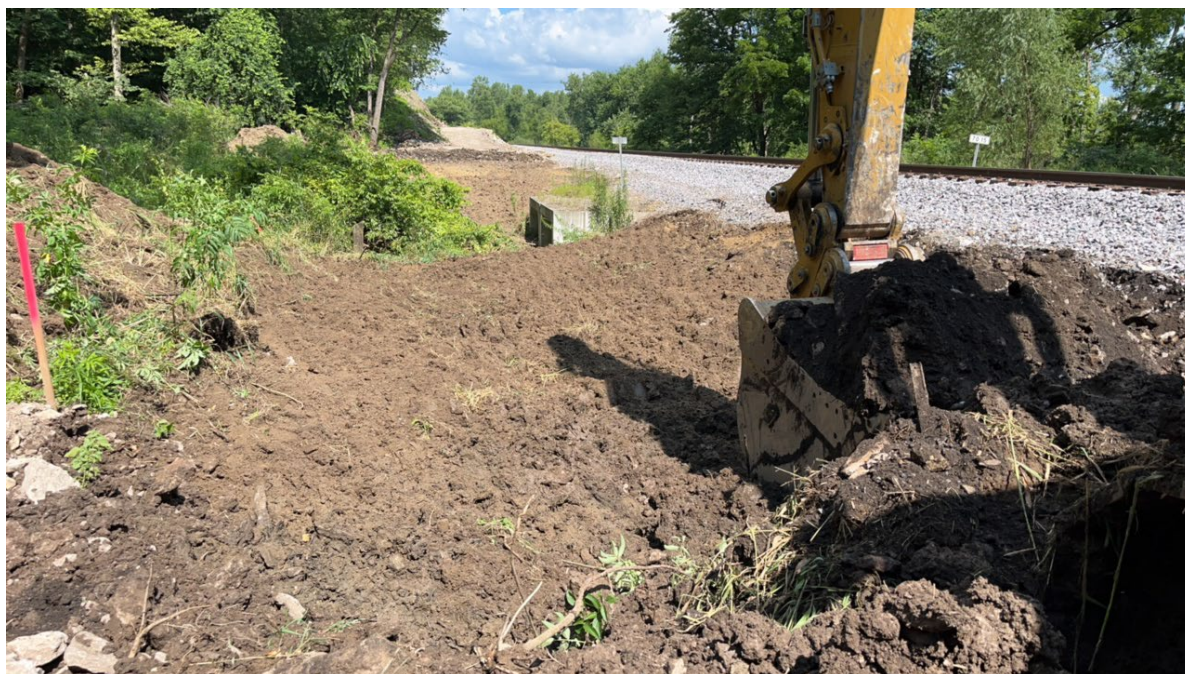
**Figure 11. Topsoil removal and bridge construction staging area, at MP 70.15; Facing west. (M. Richison 07/11/24)**

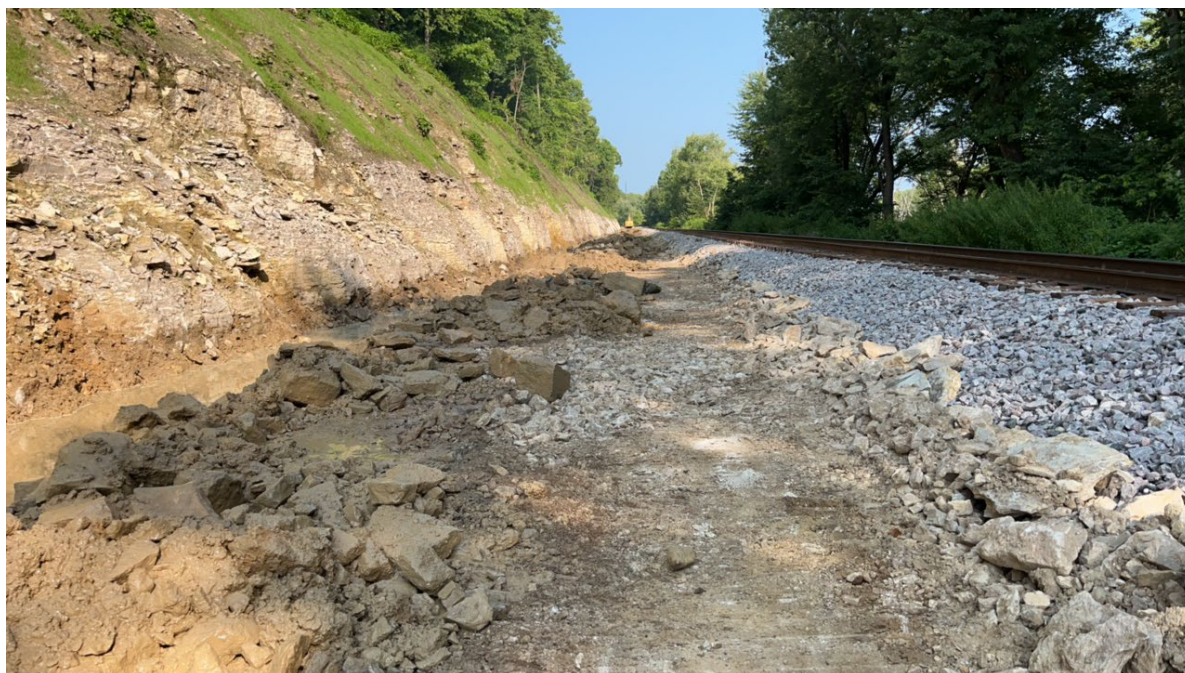
**Figure 12. Ditch construction example throughout ROW; facing West. (M. Richison 07/26/24)**

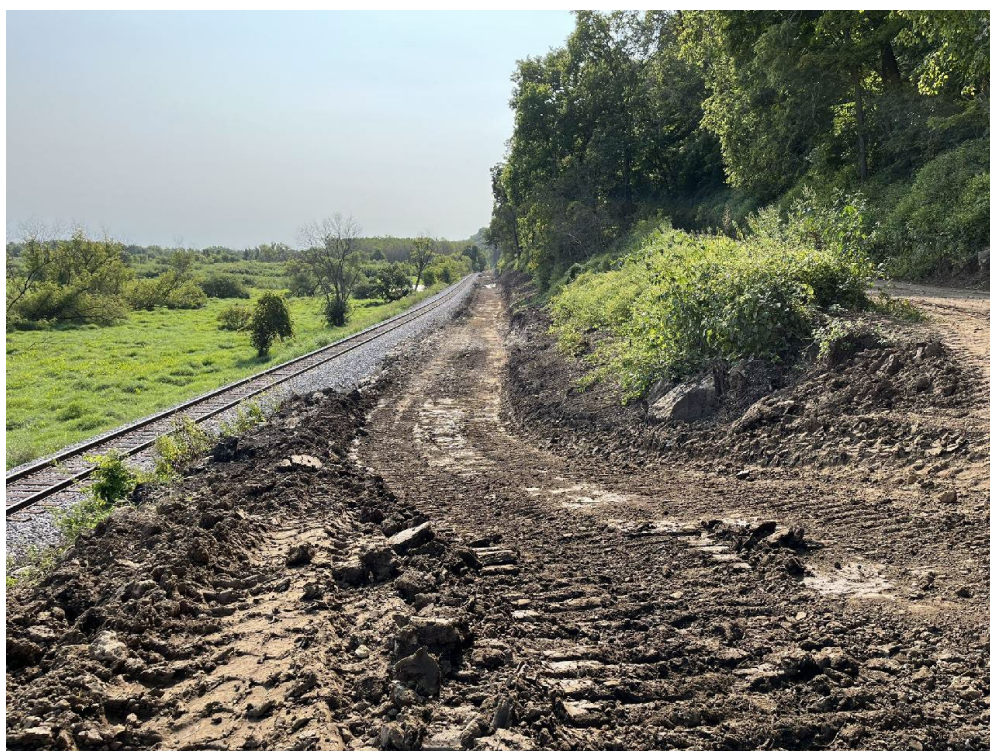
**Figure 16. Access from 360<sup>th</sup> St to ROW with topsoil and overburden removed, turn around point for haul truck traffic; facing East. (M. Richison 09/09/24)**

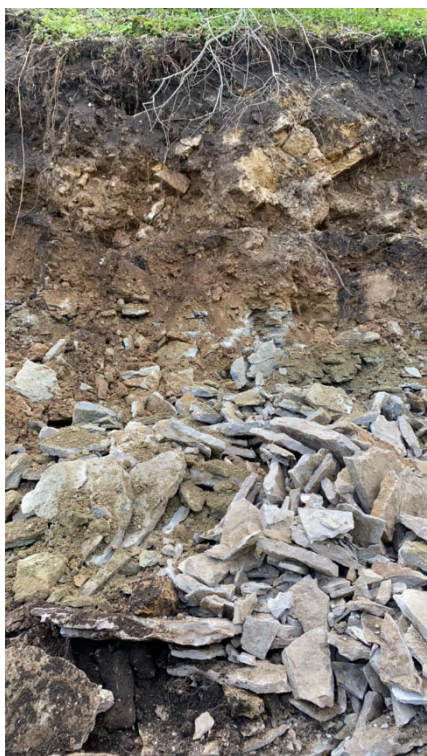
**Figure 22. Example of sediments and bedrock found throughout project area, facing South. (M. Richison 05/01/24)**

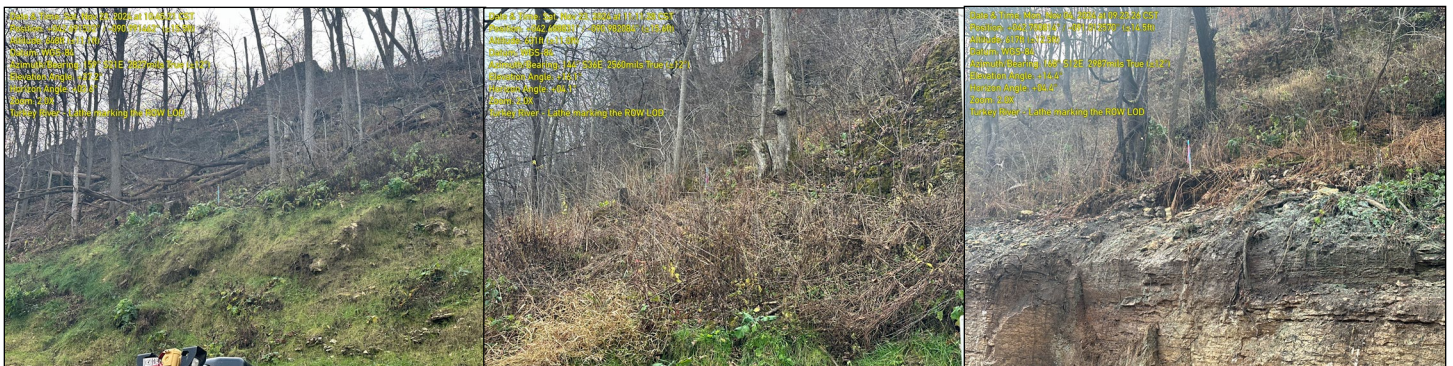
Right of Way (ROW) boundaries were marked with blue lath and all workers on site were made aware that they were to make sure work stayed within the ROW. Work on the project was successfully kept within the ROW with minimal disturbance to wetland areas. The photos below show these color-coded boundaries.

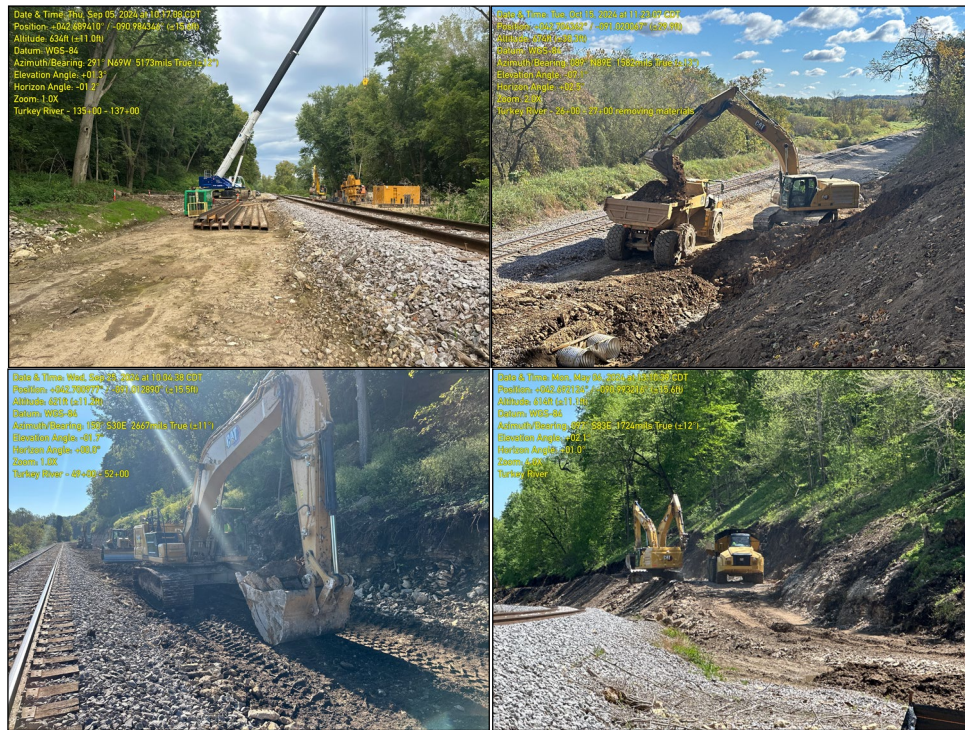
The Anti-Idling procedure was discussed during the initial and weekly briefings held by the EM. These briefings occurred during Safety/JSA meetings, and all new subcontractors were also briefed as they joined the project and began their work. The Anti-Idling procedure was adhered to throughout the duration of the Turkey River capital improvement project.

The photos below provide examples of some equipment that had to follow this policy during the project's duration.

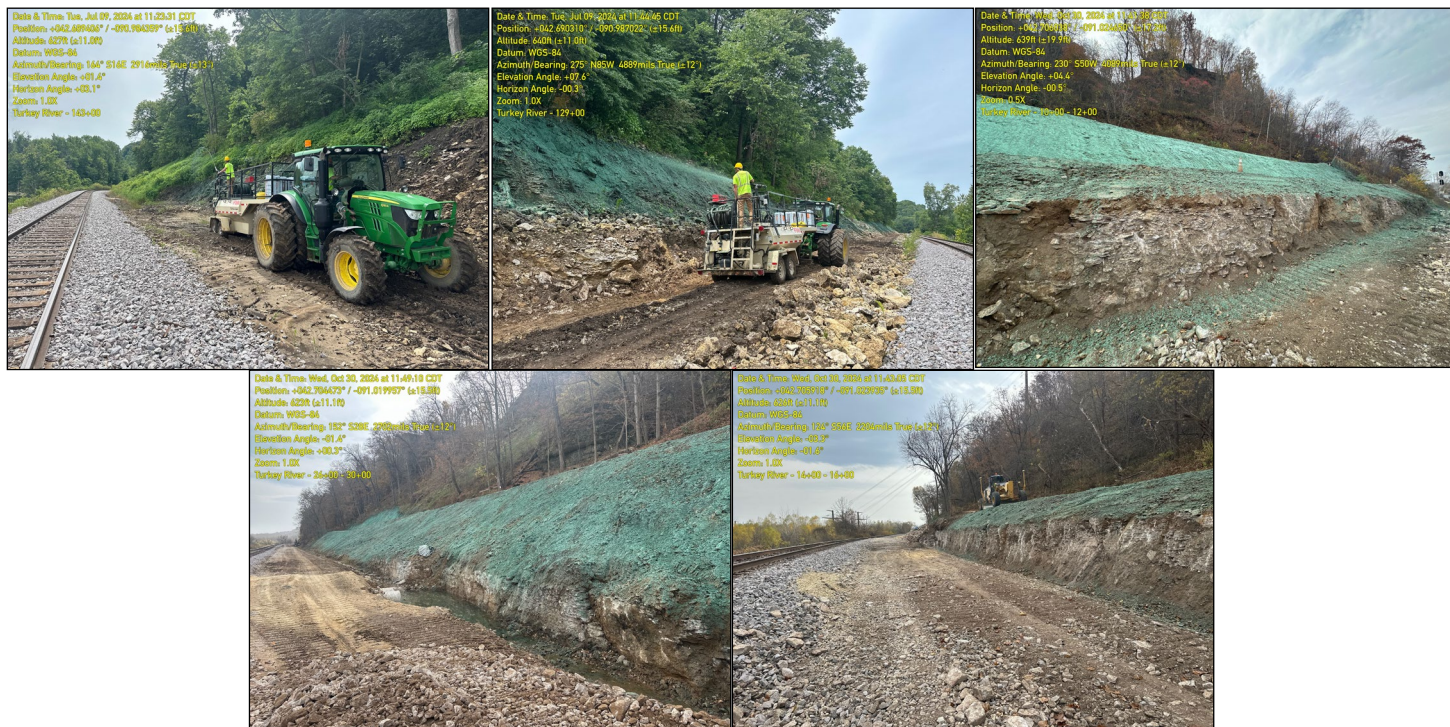
All stabilization measures needed throughout the project were able to be utilized within the 14-day window. This included the reutilization of topsoil material.

The photos below show some of the areas where revegetation measures were implemented along the construction site.

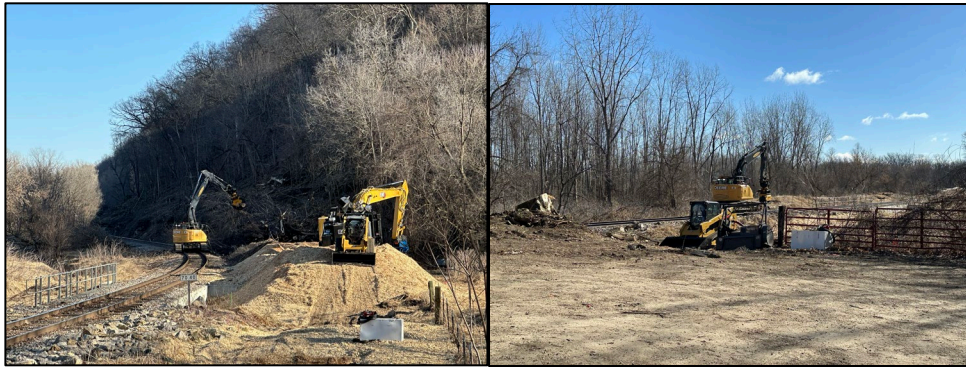
The photos below show the ROW during tree clearing.

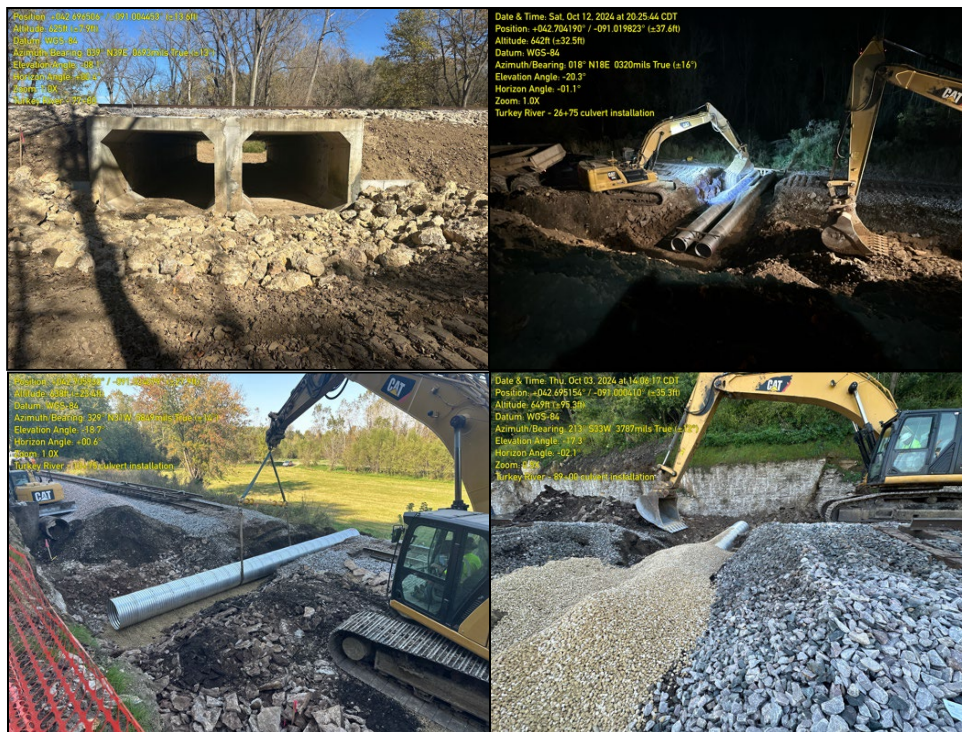
After an inspection that determined no bat species were present, daily monitoring of bat species was completed by the EM, followed by a complete inspection by Gabriella Parker, biologist for HDR. No bat species were present before or during the installation process.

Photos below show various culvert installations:

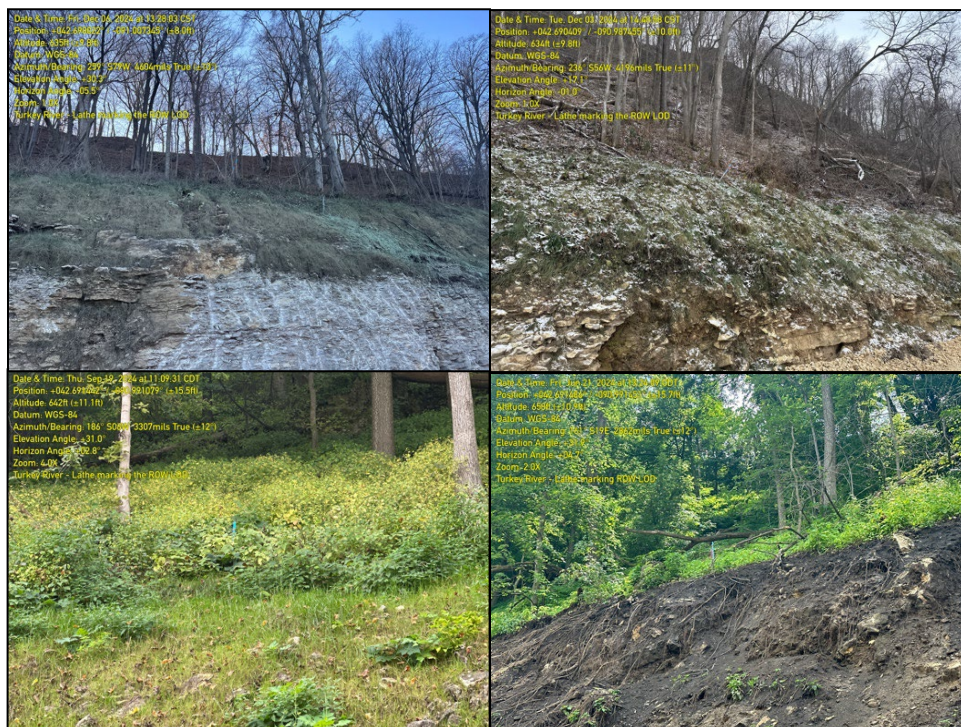
Wetlands were outlined in green lath to indicate sensitive habitats within the ROW. Blue lath was used to identify project ROW boundaries. Construction staging occurred within the ROW but outside of areas identified as sensitive habitats. No barricades or fencing was used.

Photos below show green and blue lath in various locations along the project.

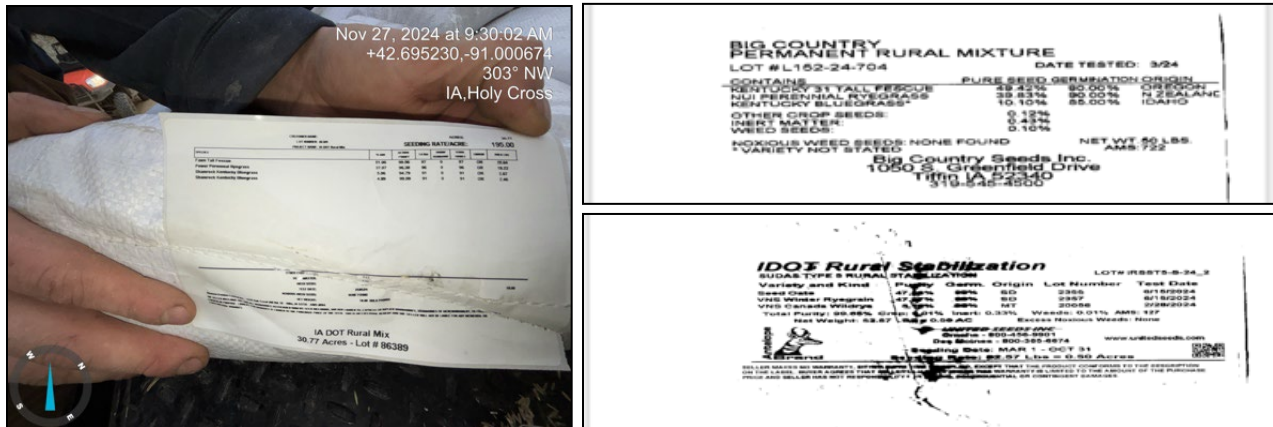
Seed mixes used within the Turkey River capital improvement project for the minimization of the introduction and spread of noxious weeds were verified by the EM prior to use. The seed tag shown in the photo below as provided by the seeding contractor specifies No Noxious Weeds found and the IDOT Seeding type Requirements in Section 250.07 of the Iowa Standard Specifications for Highway Construction. No herbicide spray methods were used on the project.

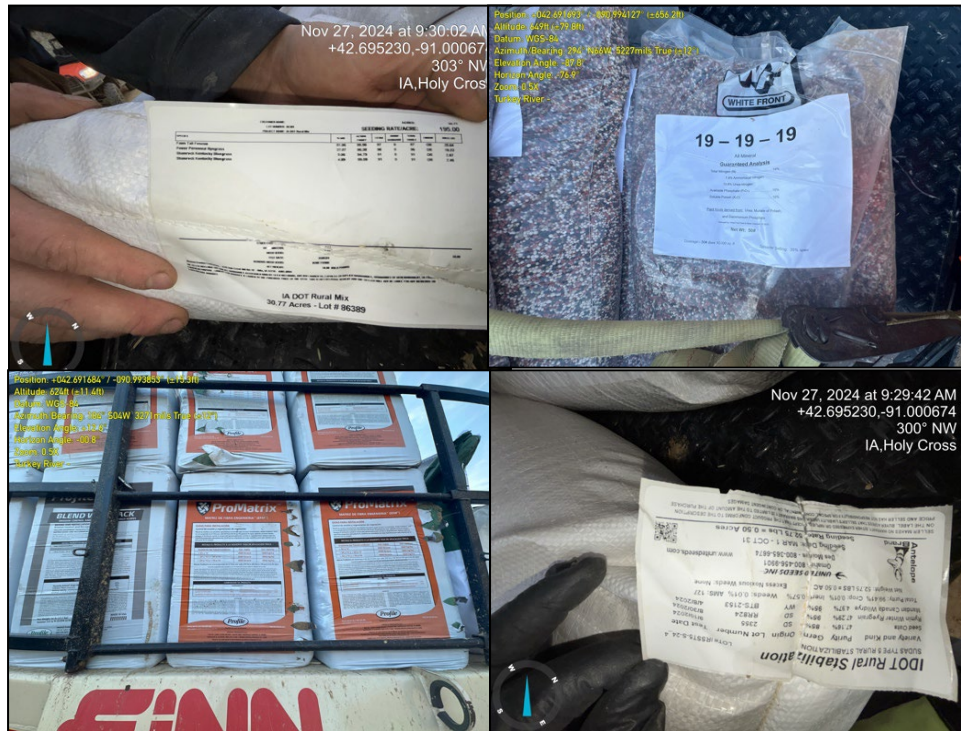
Seed mixes used for revegetative efforts on the Turkey River capital improvement project were verified according to seed tags and the IDOT Seeding Type Requirements in Section 250.07 of Iowa Standard Specifications for Highway Construction.

See below photos for various seed mix types used on the project for revegetation in addition to the ones shown above under VM-Biological-11.

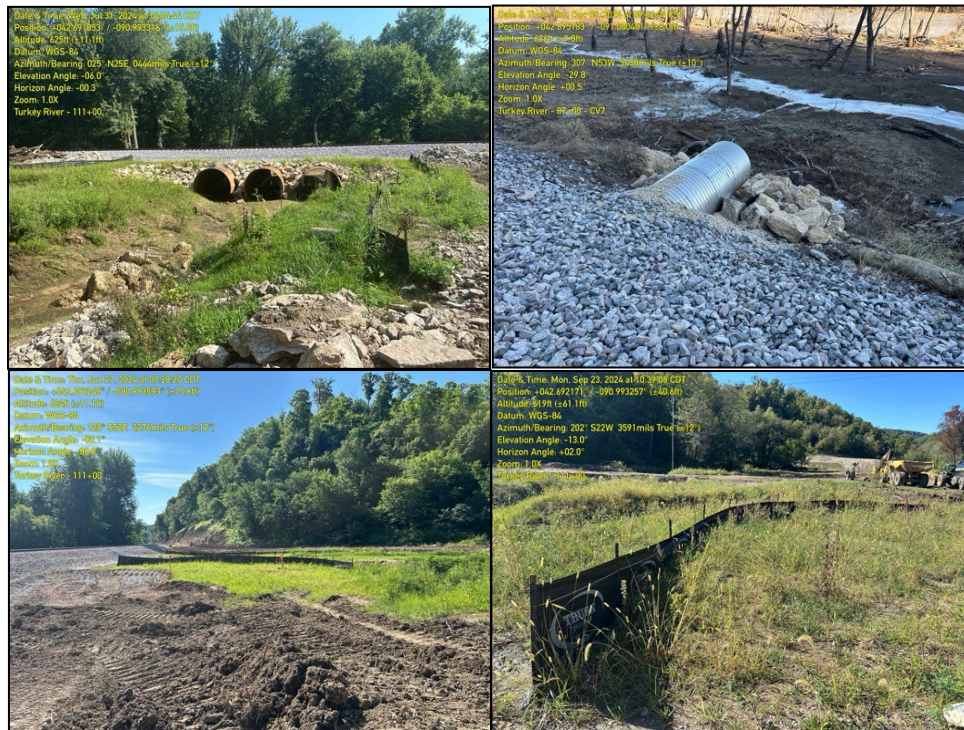
Weekly and post rain event SWPPP inspections were completed throughout the construction phase of the project and will continue through 70% post construction revegetation.

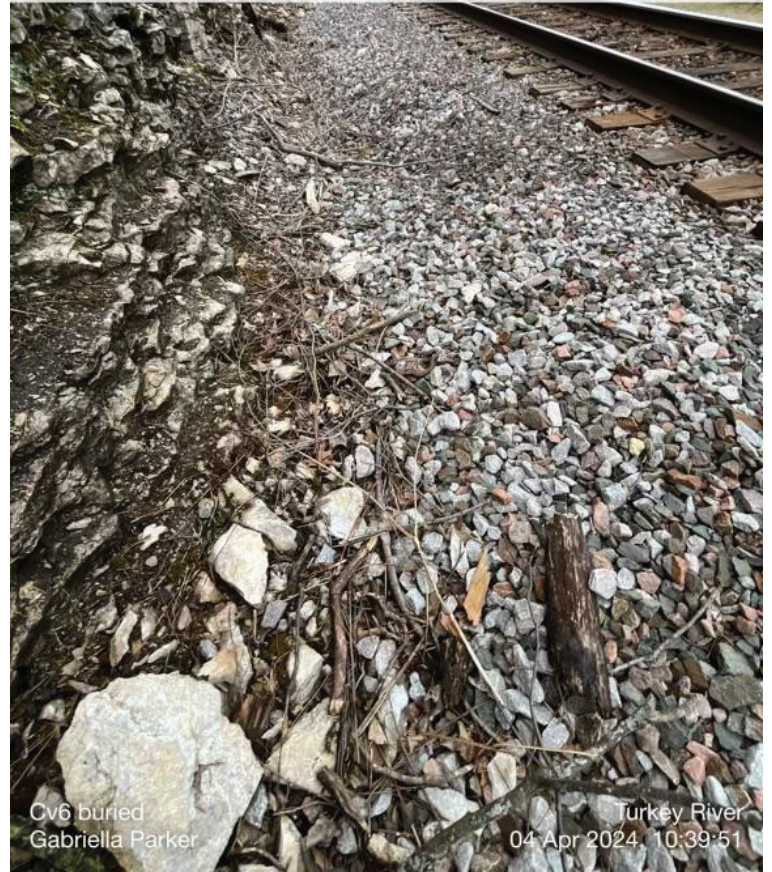
Cv6 buried  
Gabriella Parker
