**Re: STB Finance Docket No. 34284, Southwest Gulf Railroad Company**

# Field Report

Project: SGRR Medina County

Subject: Existing Structure Site Observation – HDR-AR-06

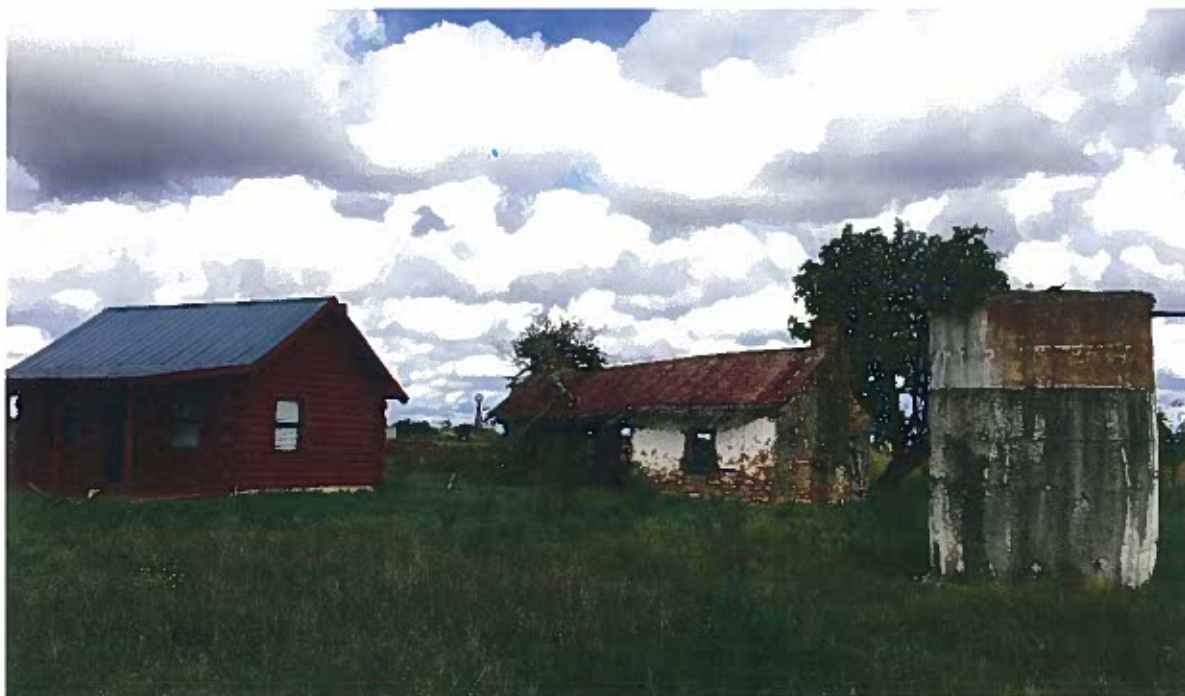
PHOTO 1: OVERALL SITE

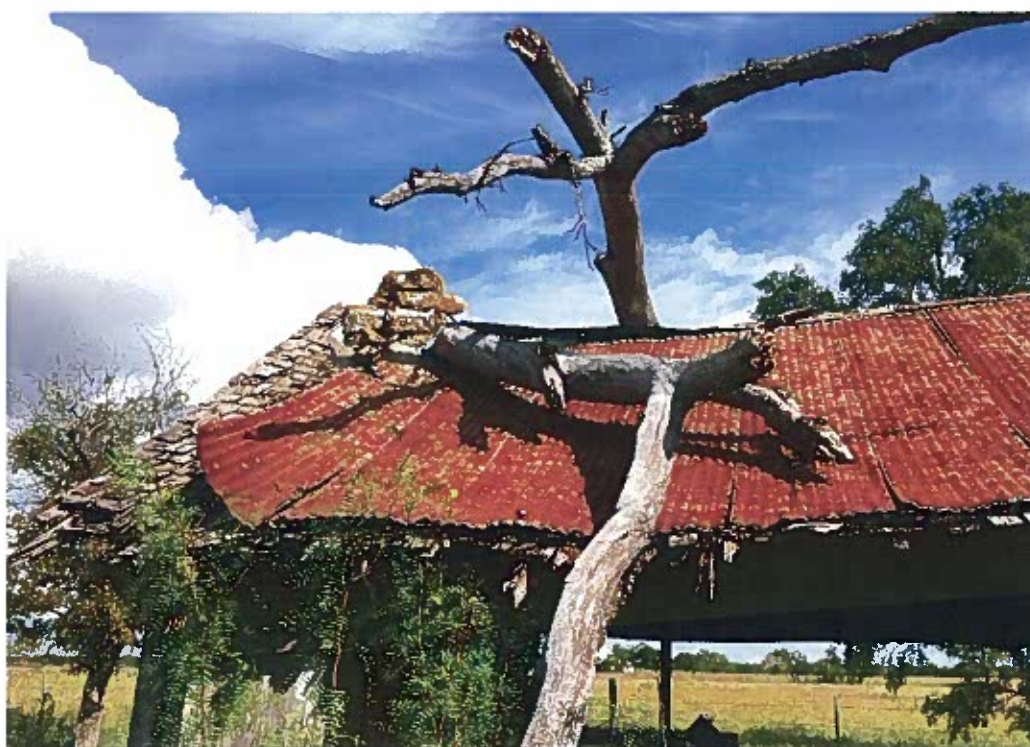
PHOTO 2: TREE TRUNK AND BRANCH ON TOP OF ROOF

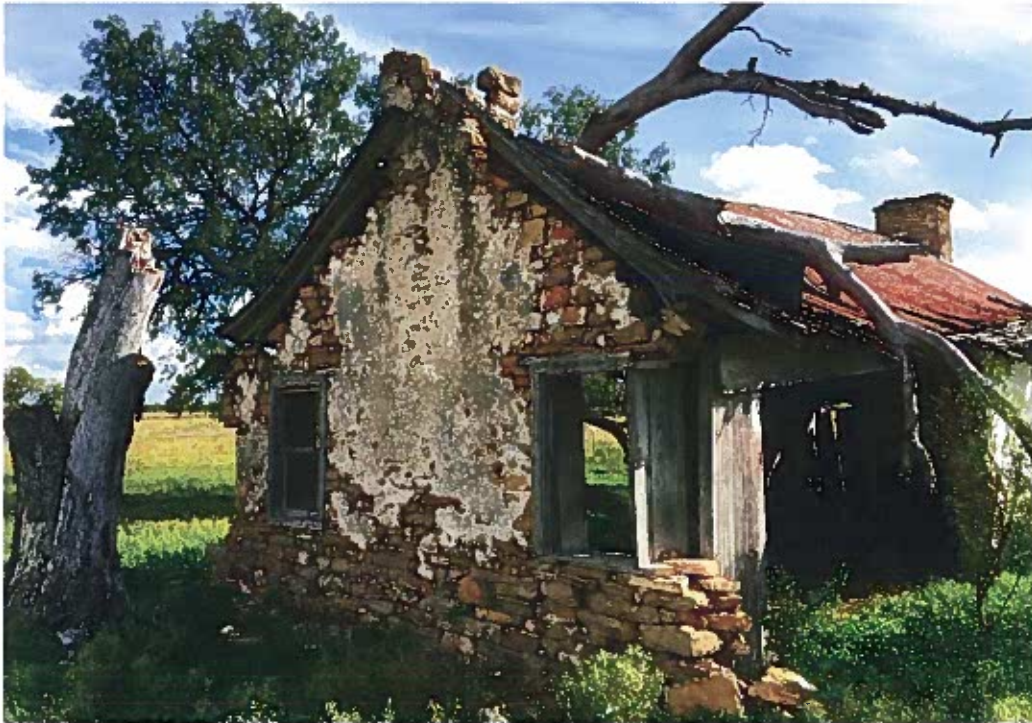
PHOTO 3: TREE ON ROOF AND EXCESSIVE DEFLECTIONS AND DISTRESS

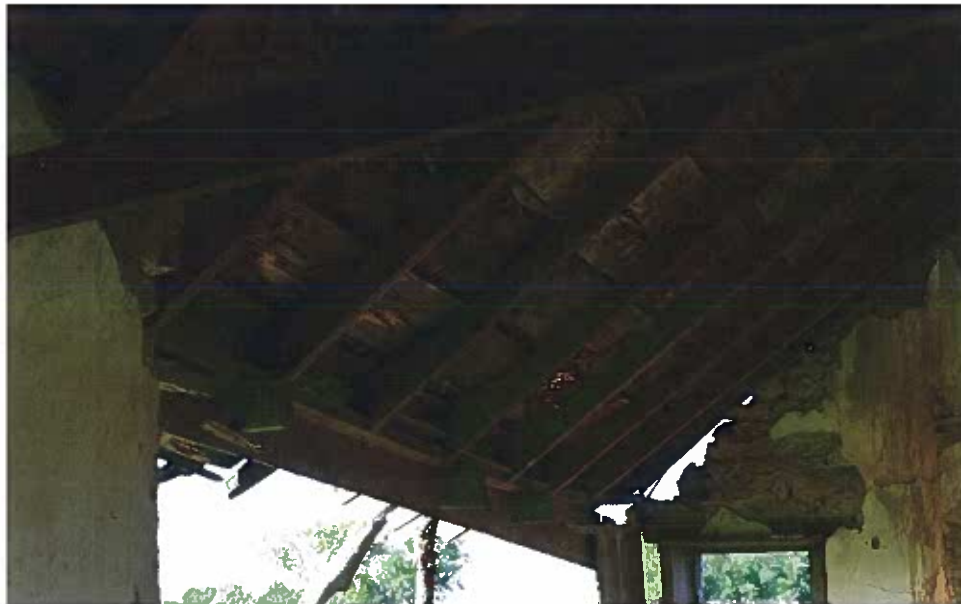
PHOTO 4: LOCALIZED PUNCTURE IN ROOF AT CENTER OF PICTURE

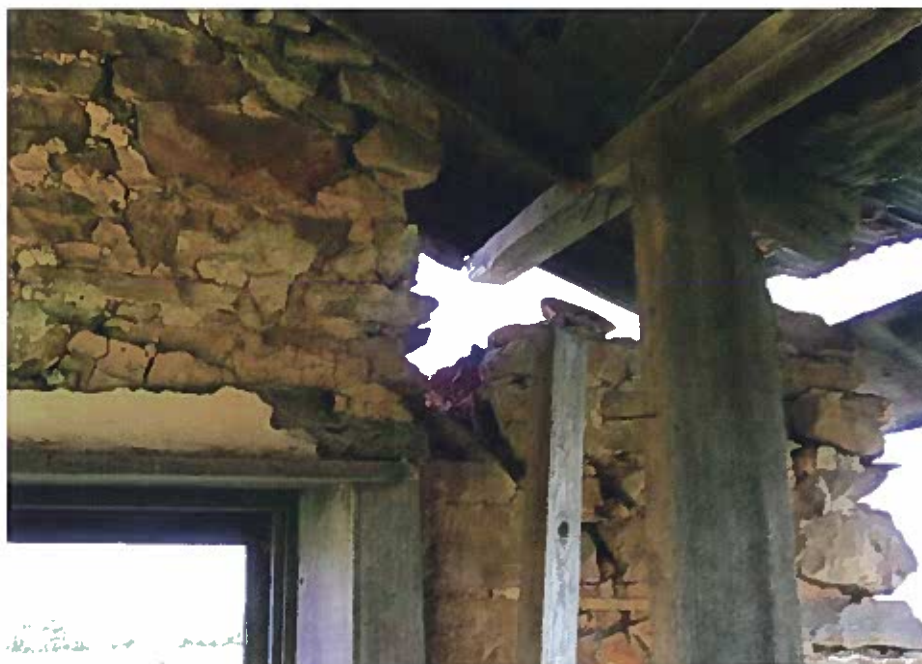
**PHOTO 5: VIEW AT NORTH WEST END OF HEADER BEAM**

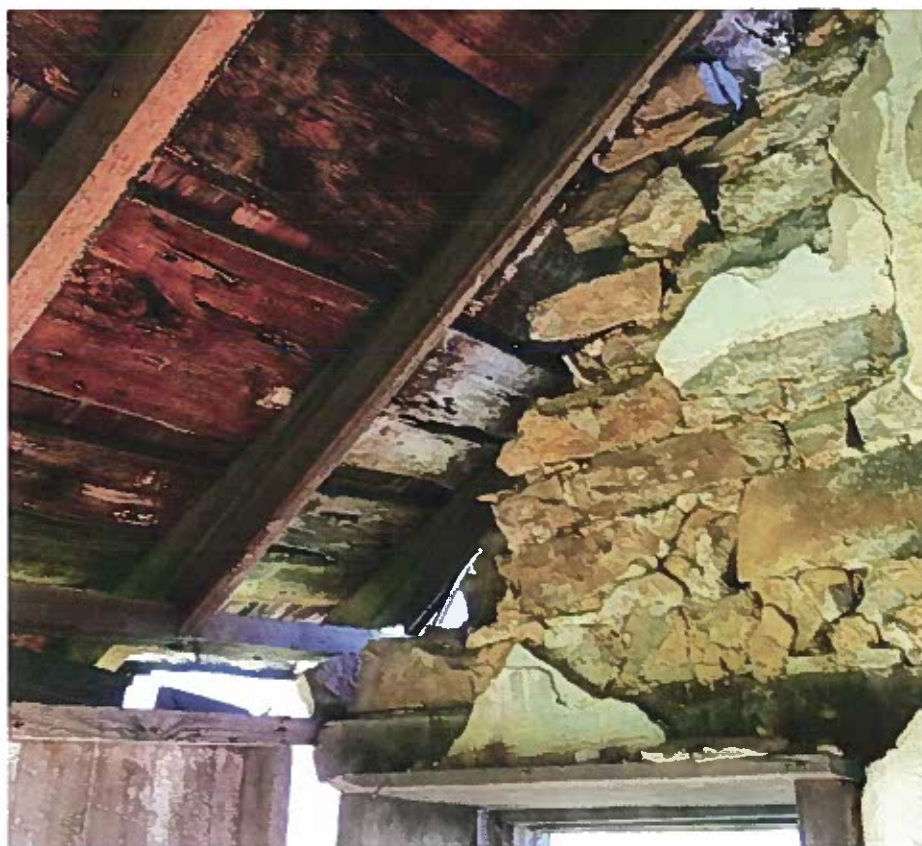
**PHOTO 6: VIEW OF SOUTH WEST END OF HEADER BEAM**

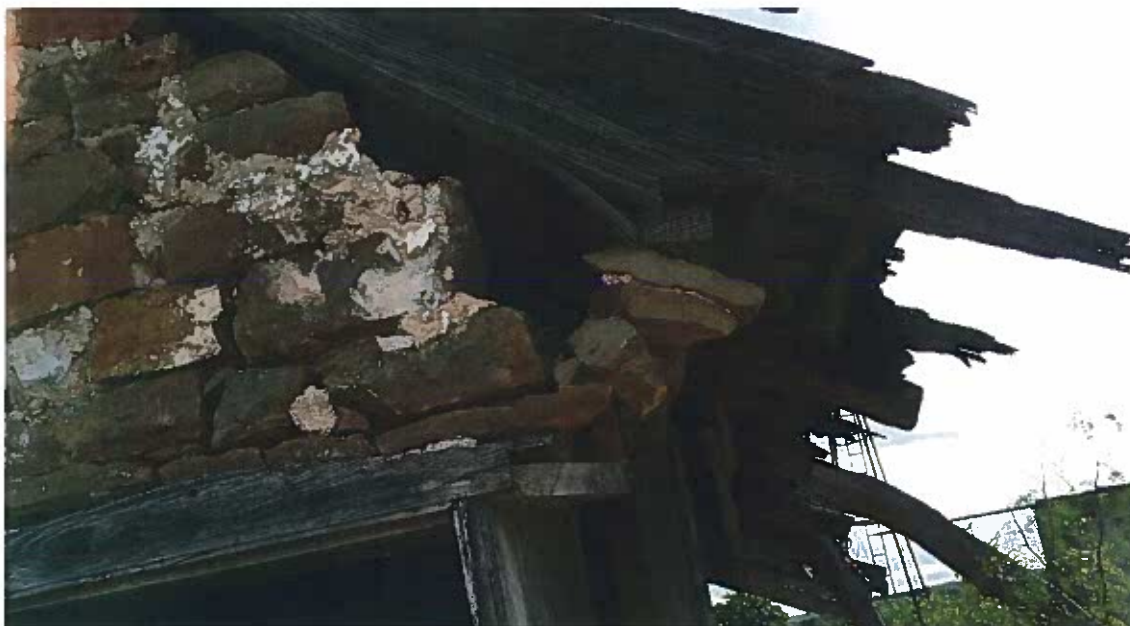
**PHOTO 7: VIEW OF OUTSIDE OF SOUTH WEST HEADER BEAM SITTING ON STONE**

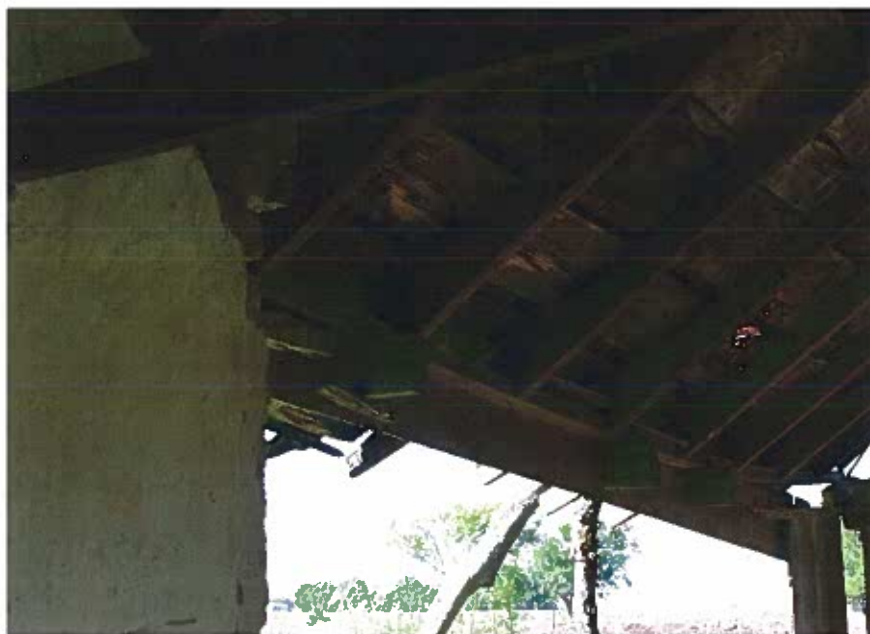
**PHOTO 8: VIEW SHOWING REMOVED TIE BEAMS FOR RAFTER ON WEST SIDE**

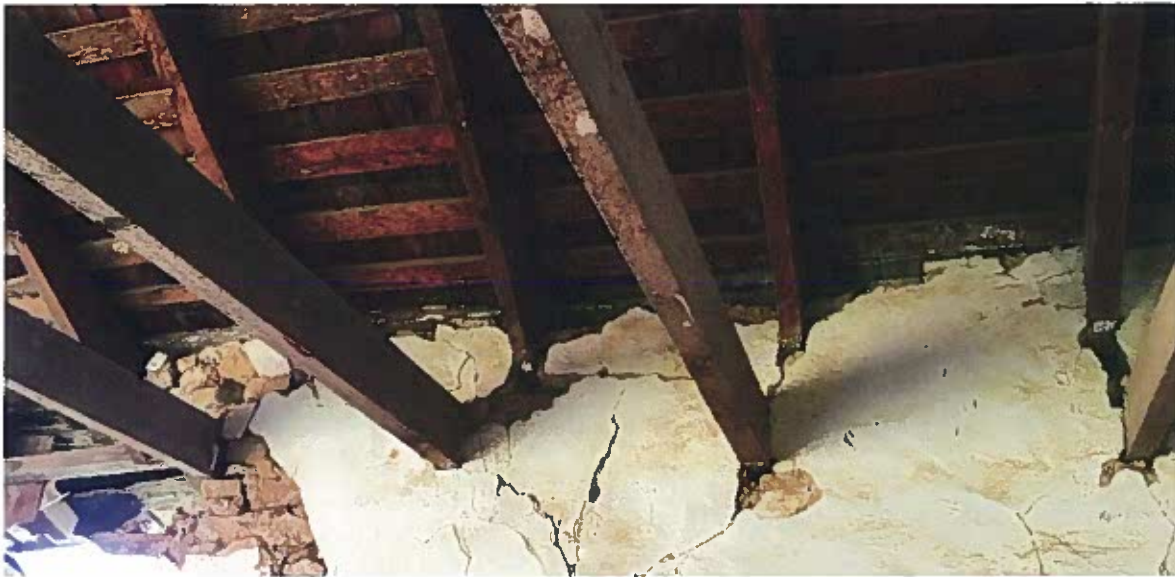
**PHOTO 9: VIEW SHOWING TIE BEAM FOR RAFTER ON EAST SIDE**

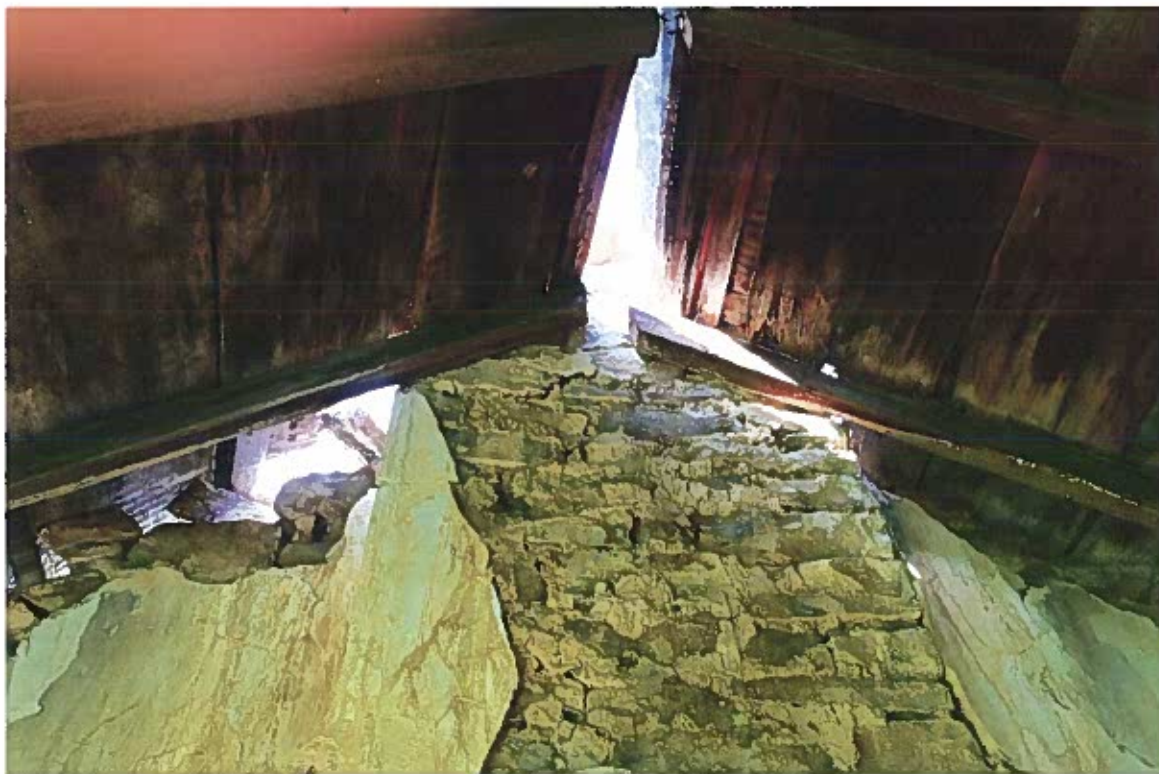
**PHOTO 10: RAFTER BEAM STARTING TO OPENING UP AT THE ROOF RIDGE ON WEST END.**

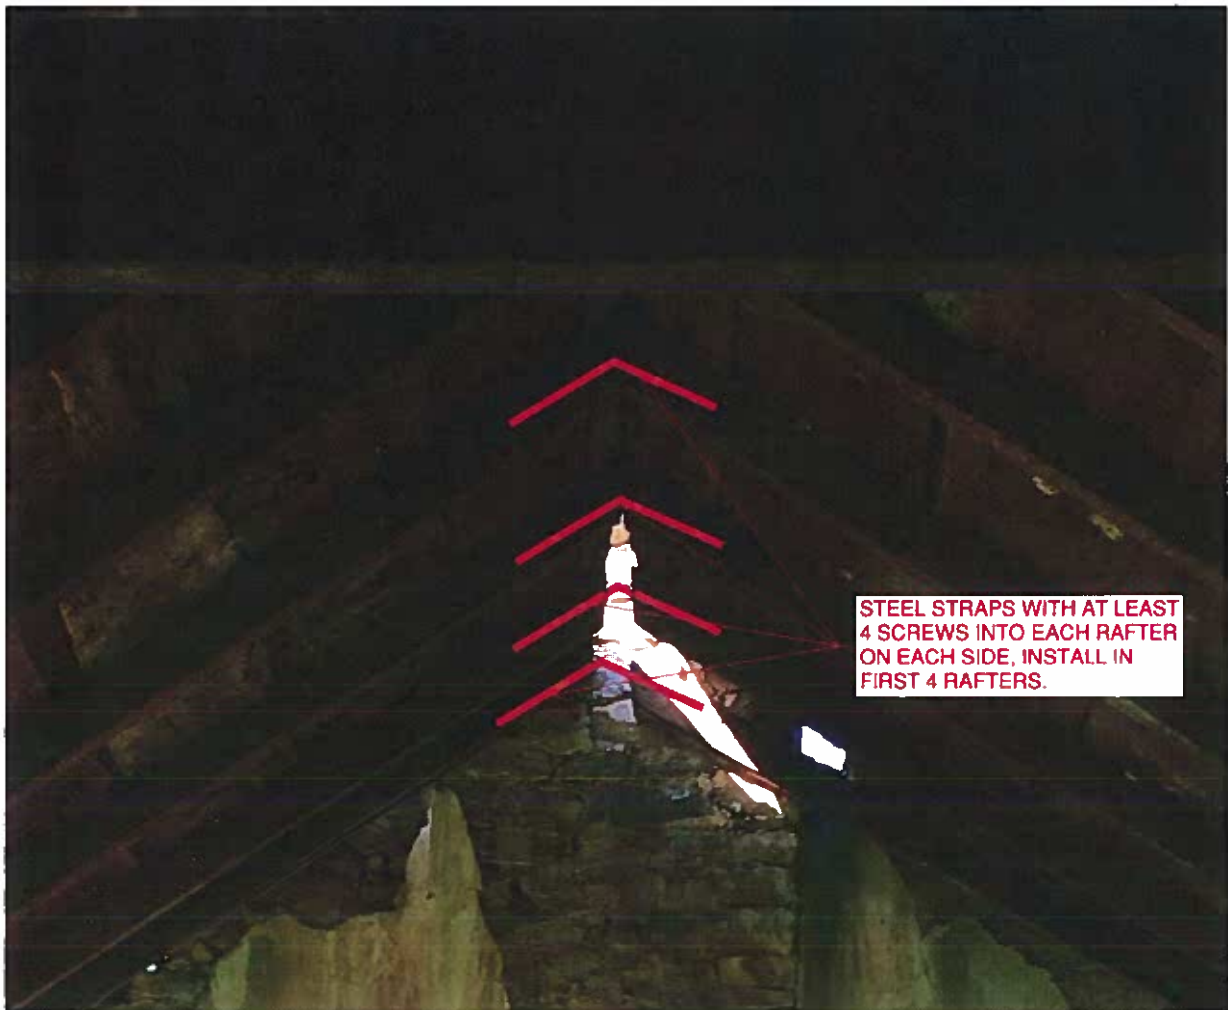
**Figure 1: Rafter ridge modifications**

The building condition at the time of the site visit is considered unstable and not recommended that anyone go in the building or conduct survey of the members due to the risk of localized collapse of the east wall and/or east roof of the building. It is not recommended that any jacking or removal of the trees should be done. It is thought that this would cause collapse. Although any modifications at this point could cause collapse, it is recommended that any modifications that could be done at this point would be to minimize the risk of collapse and keep the structure from moving any further than it already has to this point. It is recommended that the following items are performed in the order presented below in order to better stabilize the structure. It is recommended that steel straps be added to the first 4 rafters from the west end to prevent any future opening up of the ridge. It is also recommended that two 8X8 wood posts be added about 2 to 4 feet from the end of the west wall to support the north and south header beams. The posts should be embedded about 4 feet into the ground with concrete and connected with the header beam. Due to risk of vibration and the sensitive state of the structure, all connections should be made with screws and no nails shall be used. After the posts are installed, it is recommended that a tie beam be placed between the two columns to connect them together. See Figures 1 and 2 for recommended stabilization measures. Considering all recommendations have been followed, it is then acceptable for the HABS documentation to be completed.

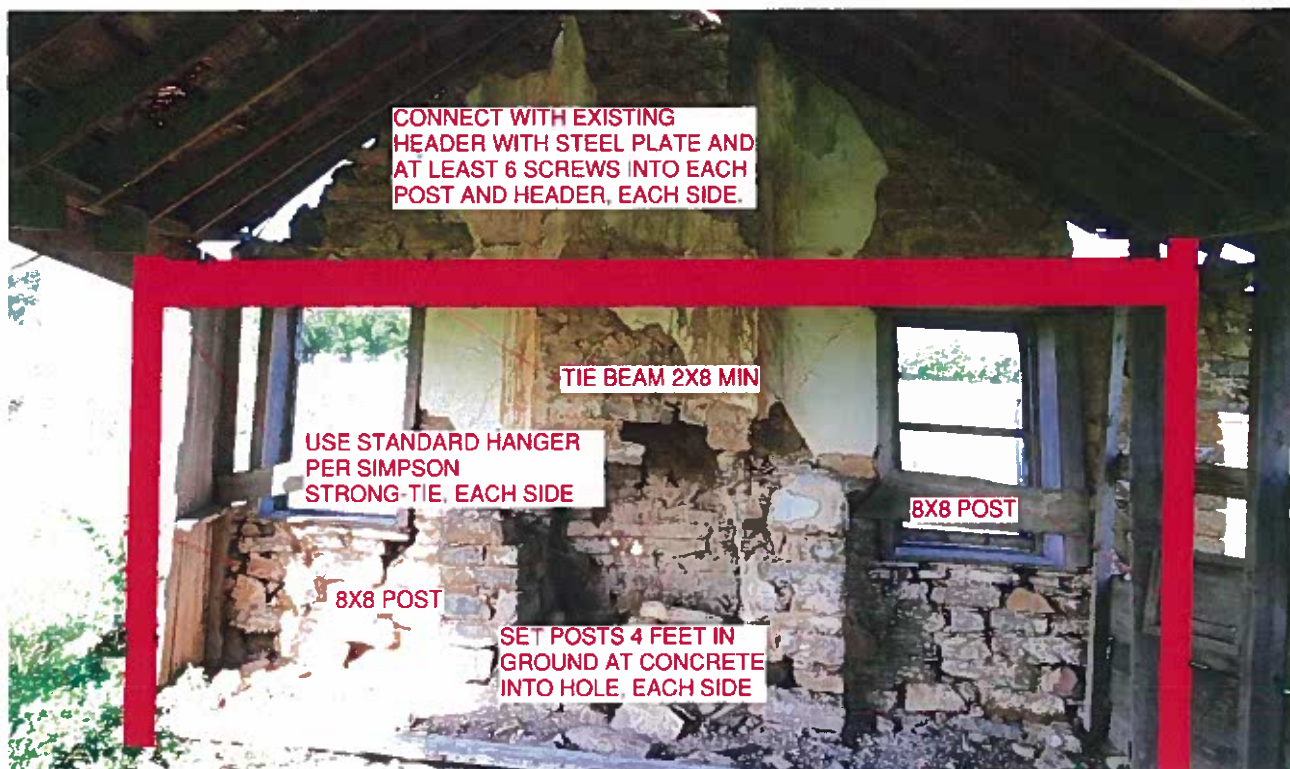
**Figure 2: Posts and tie beam modifications**
