**OREGON INTERNATIONAL PORT OF COOS BAY  
—FEEDER LINE APPLICATION—  
COOS BAY LINE  
OF THE CENTRAL OREGON & PACIFIC RAILROAD, INC.**

# Coos Bay Rail Link Bridge Condition Assessment

September 26, 2008

DAVID EVANS  
AND ASSOCIATES INC

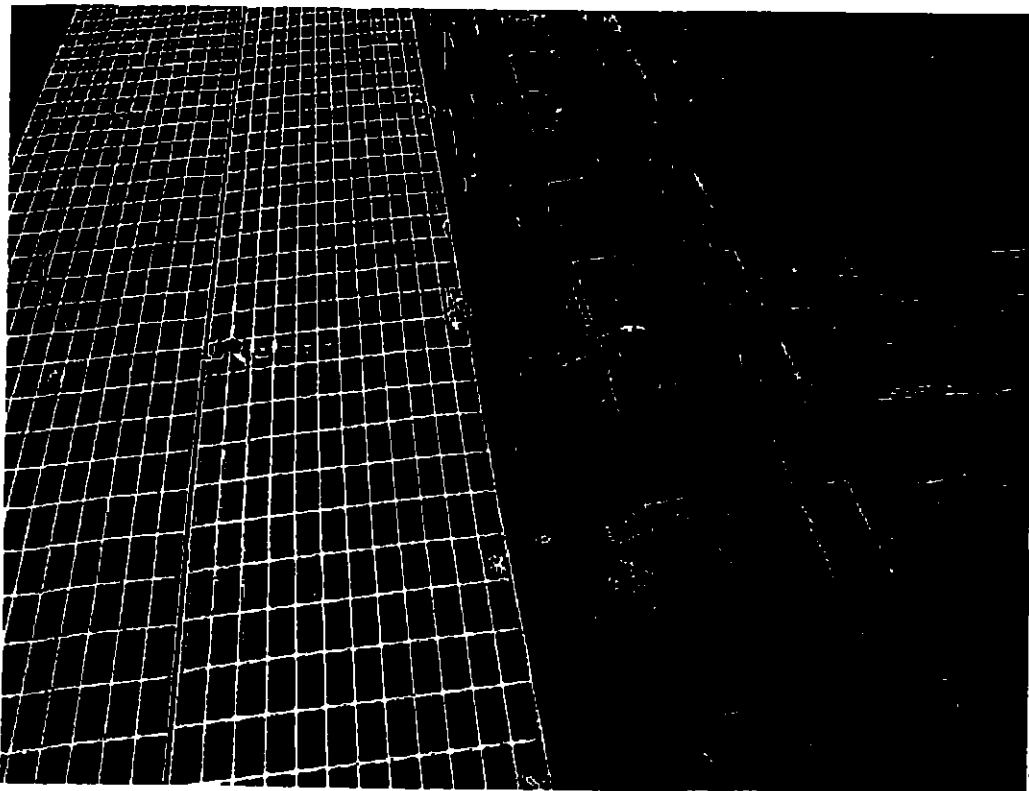
**4 Guard Timber Damage**

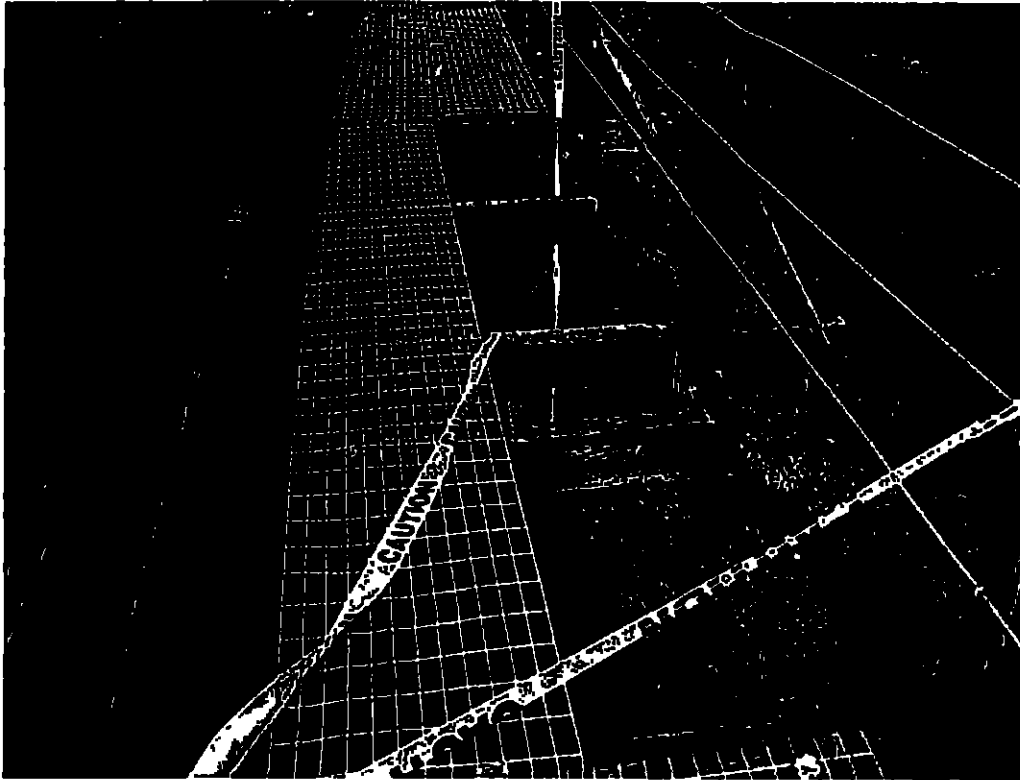
**5 Missing Walkway Panel**

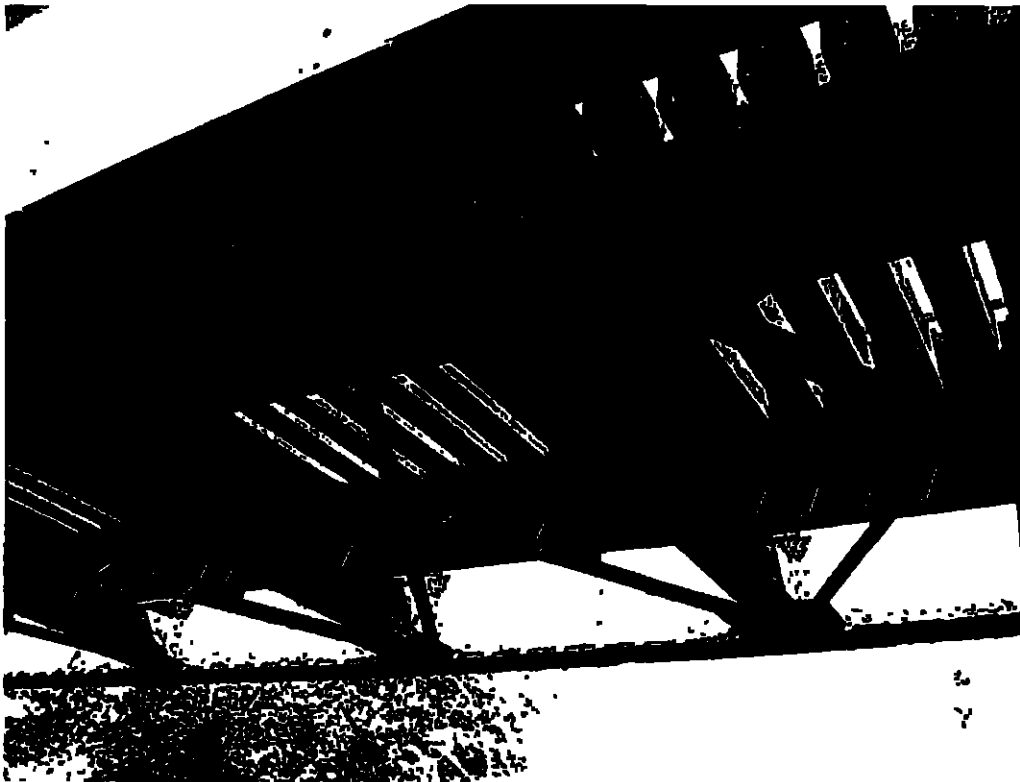
**6. Paint/Surface Rust Underneath**

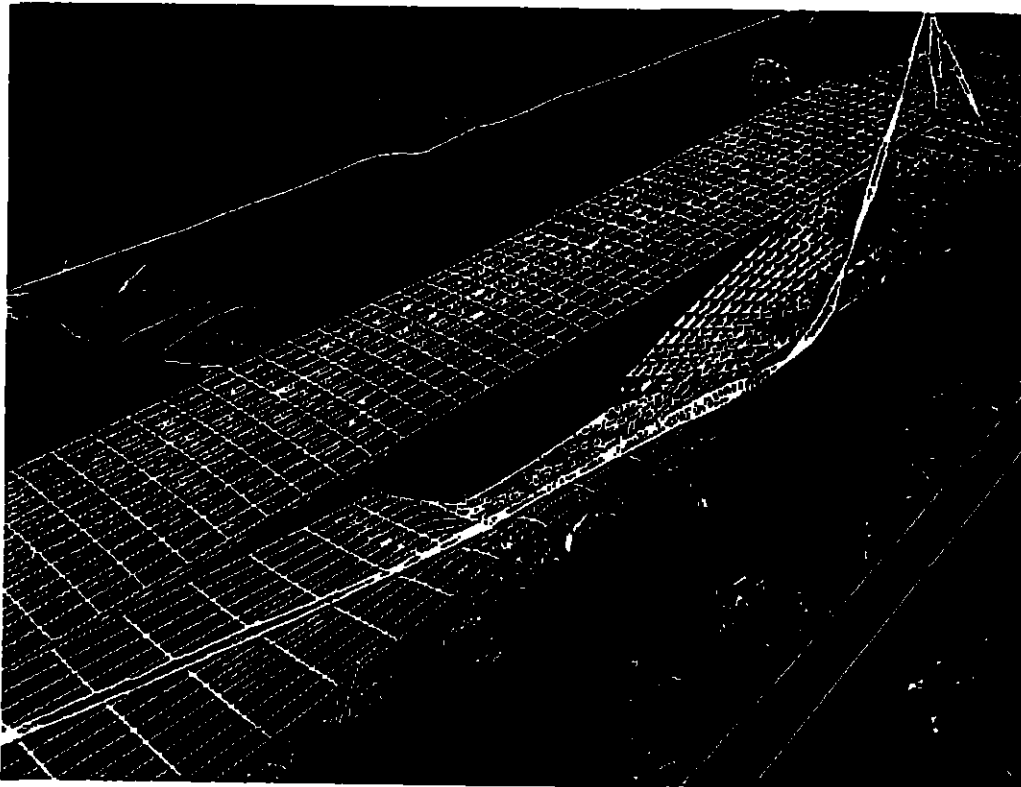
**5. Walkway Damage**

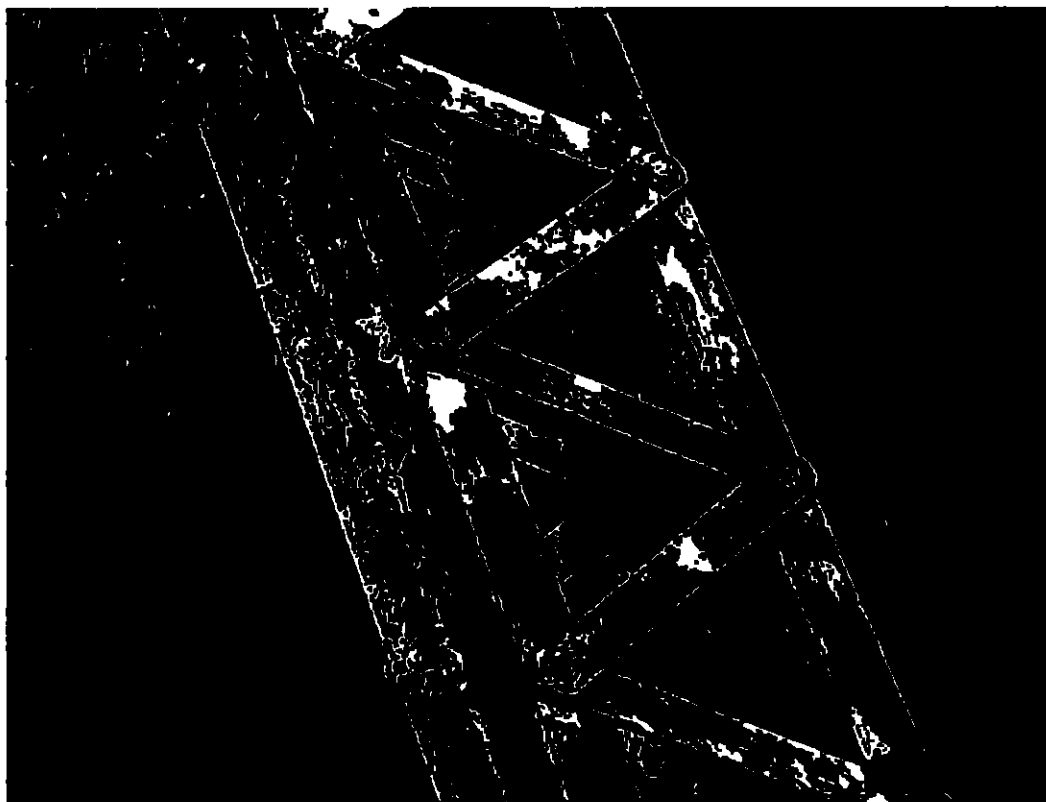
**4 Corrosion- Rust**

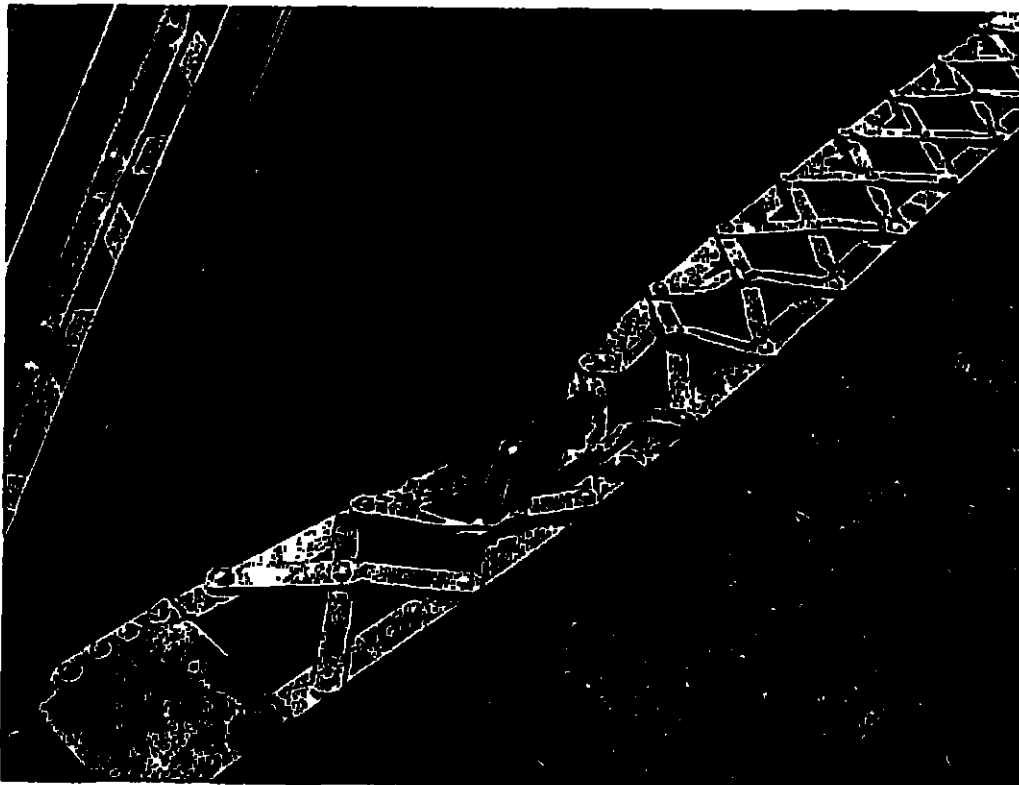
**6. Damaged East Bottom Chord, Span 2 Panel 3**
