**From:** Joe Van Humbeck <[Joe.Vanhumbeck@cpkcr.com](mailto:Joe.Vanhumbeck@cpkcr.com)>  
**Sent:** Thursday, May 18, 2023 1:53 PM  
**To:** [kathryn\\_bulliner@fws.gov](mailto:kathryn_bulliner@fws.gov)  
**Cc:** Webster, Elizabeth <[Elizabeth.Webster@stb.gov](mailto:Elizabeth.Webster@stb.gov)>  
**Subject:** CPKC Bat Inspection Protocol

## APPENDIX D: Bridge/Culvert and Structure Bat Assessment Form

### **Federal Transportation Agency/State Department of Transportation (DOT) Preliminary Guidelines for Using the Bridge/Culvert and Structure Bat Assessment Form**

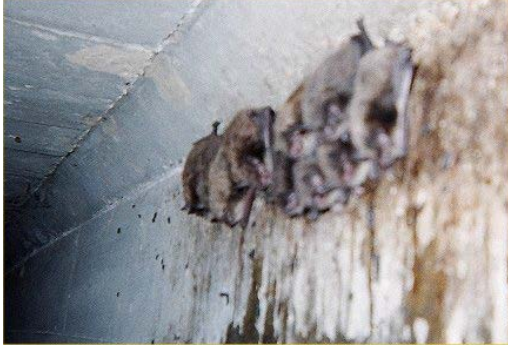
Photo 1: Bats hanging from cracks along support beams

Cracks in the concrete are used by bats as a foothold in roosting (Photo 1). In addition, some bats may be hidden from sight in wider cracks in the concrete and behind deteriorating concrete sections in the ceiling or walls. Look for cracking along support beams and inner walls especially below a fillet (a concrete filling between ceiling and vertical beam). During inspection, sounds may be heard coming from behind such cracks and/or expansion joints.

Day: Look for bats flying or roosting (hanging) during the assessment (Photo 1, 2, & 8). A flashlight or headlamp will be needed and binoculars may be necessary when viewing higher areas. If bats are present; record numbers as best as possible and their locations. Note any dead or injured bats. A sketch map would helpful (use bridge plan sheet as base for sketch).

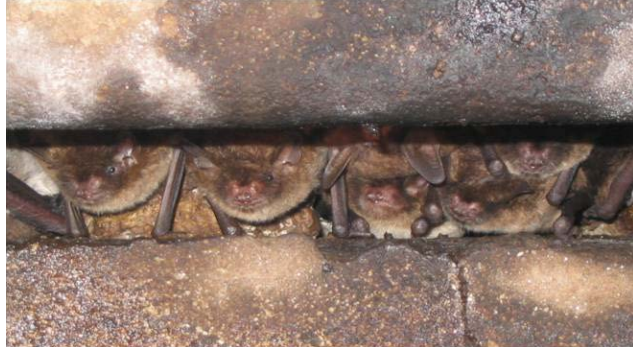
Photo 2: Visible bats within an expansion joint

Expansion joints can provide protected cover for bats (Photos 2 and 5), but do not always provide habitat, depending upon whether they are obstructed by road debris or other blockages. If possible during the assessment, individuals should use a flashlight to look into expansion joints or cracks. Guano may be present under joints if being used by bats (Photos 7 and 8).

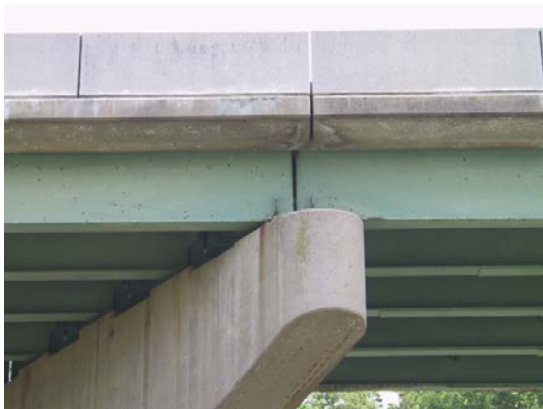
Photo 3: Example of open concrete joint used by bats

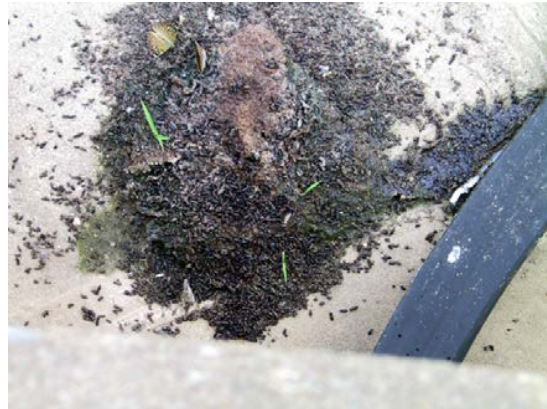
Photo 4: Guano deposits visible from bridge deck on top of pier

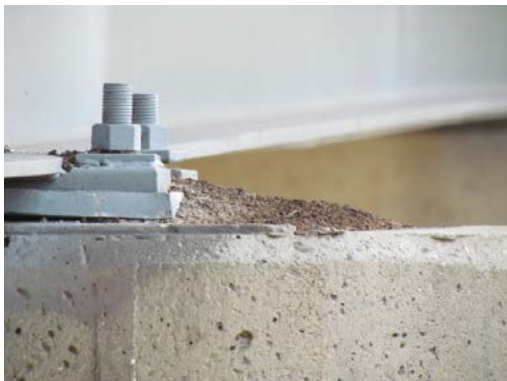
Photo 5: Guano deposit on pier, obscuring structural features.

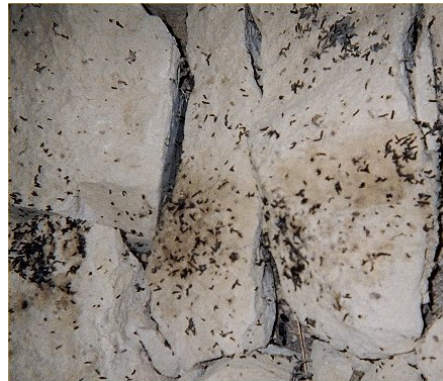
Photo 6: Bat Guano on riprap

Bat droppings are small (mouse-like in appearance but less regular) brown or black pellets (Photos 6 - 8). Older droppings may be gray in color. These droppings will accumulate on the ground; floor of a covered bridge/culvert or structure; or on structural components below where bats roost. Droppings may also adhere to support beams and walls below roosts.

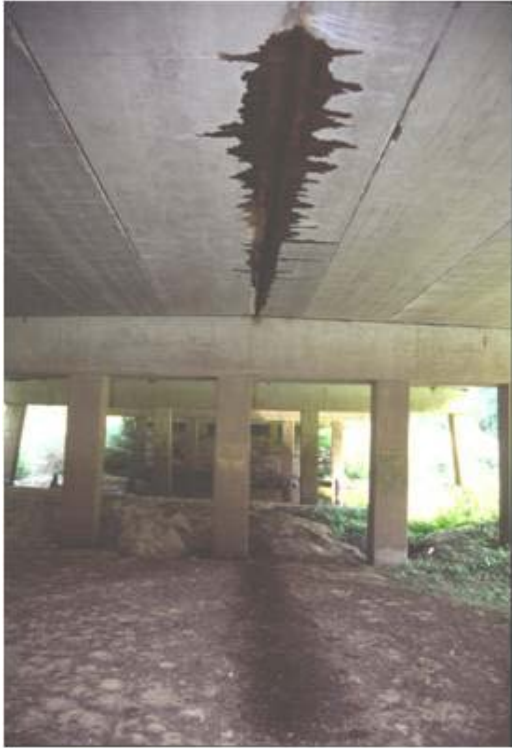
Photo 7: Staining along longitudinal joint.  
Guano deposits on the ground.

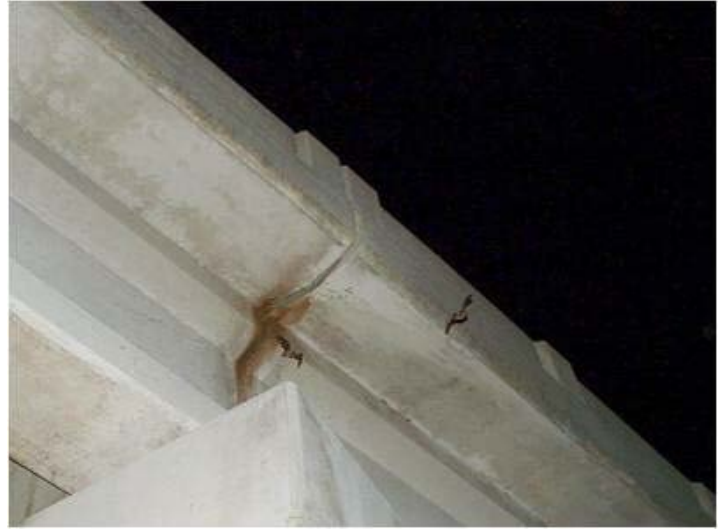
Photo 8: Staining on underside of expansion joint from bat use.

Stains may appear wet and are usually found in dark places. Look for four to six inch wide dark stains located on concrete support beams and walls immediately below the ceiling of the bridge or culvert, and beneath joints (Photos 8 - 11).

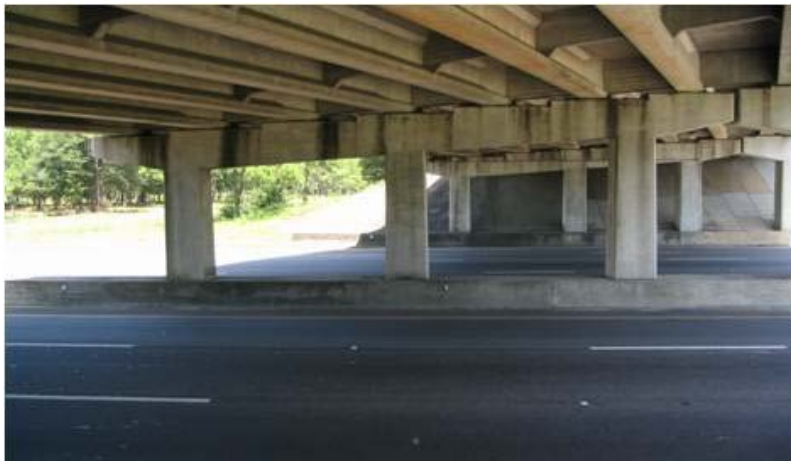
Photo 9: Staining on sides of pier caps

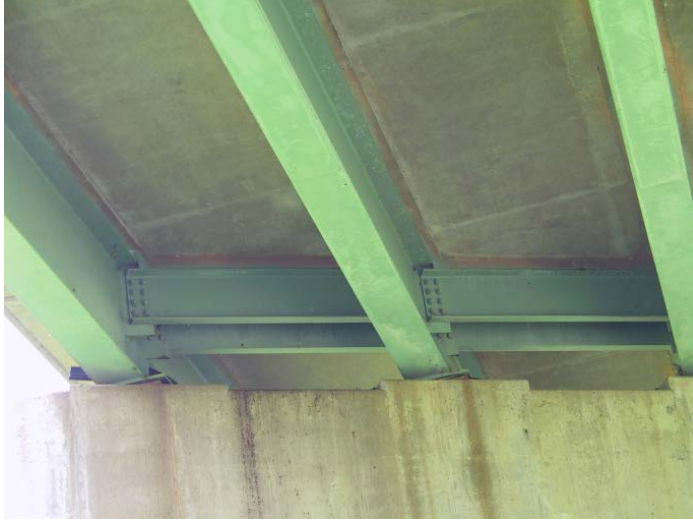
Photo 10: Guano staining on side of pier

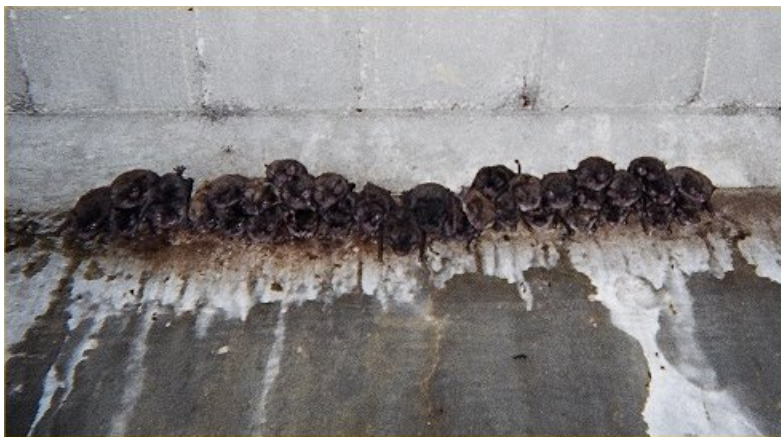
Photo 11: Bats roosting & associated staining

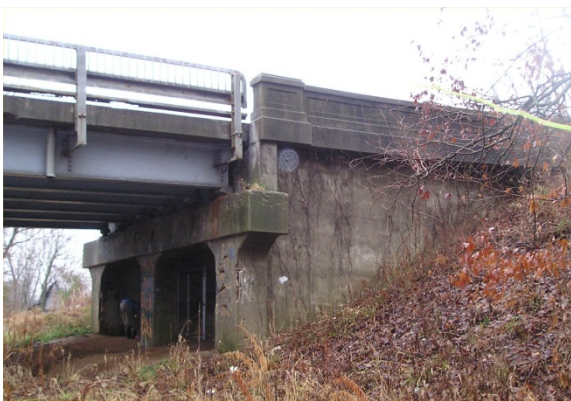
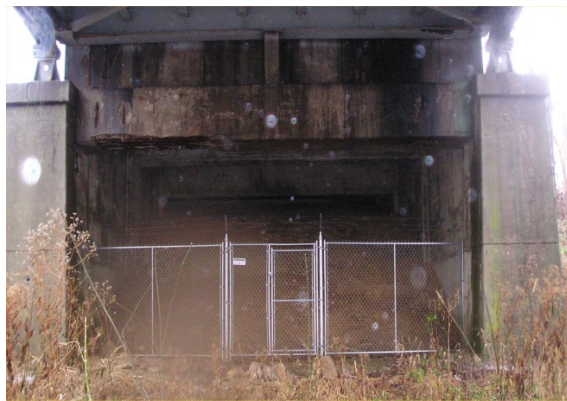
Photo 12 and 13: Bridge design mimicking “cave-like” atmosphere

While assessing bridges/culverts or structures, look for dark environments that mimic cave-like conditions such as under the deck in the case of a bridge (Photos 12 and 13) or an attic in the case of a

structure. This may involve crawling under low areas so a hard hat is recommended. Such places (e.g., a concrete bunker secreted into a hillside with an open front) provide protection from wind, rain, sleet, hail and predators. Bats do not roost near the ground where predators (cats, raccoons, etc.) can reach them. Roosting is usually at least 4 ft. from the ground.

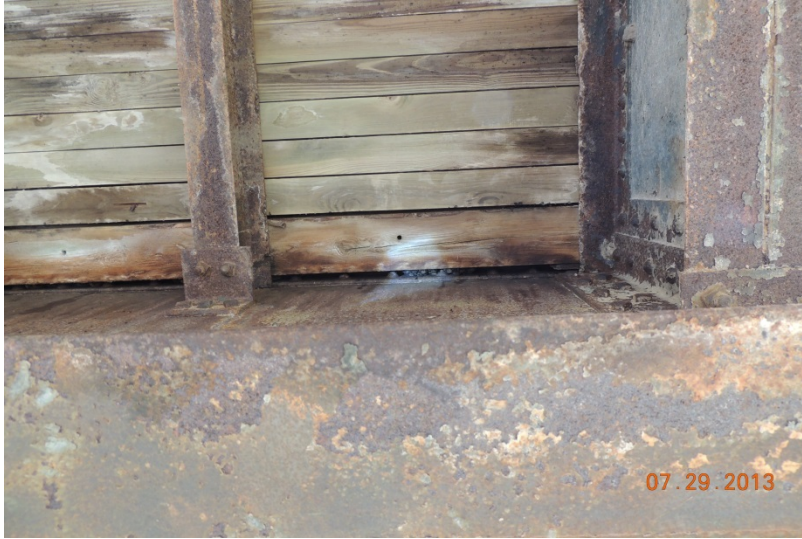
Photo 14: NLEBs roosting under a timber decked bridge
