Re: Docket No. FD 36500, CPKC Quarterly Environmental Mitigation  
Measures Report for September 15 to December 14, 2023

# CPKC Quarterly Environmental Mitigation Measure Compliance Report Number 3

This report includes compliance activities completed between September 15, 2023, and December 14, 2023 (Quarter 3, Year 1 of the STBs oversight period following the acquisition of KCS by CP, STB Docket FD 36500)

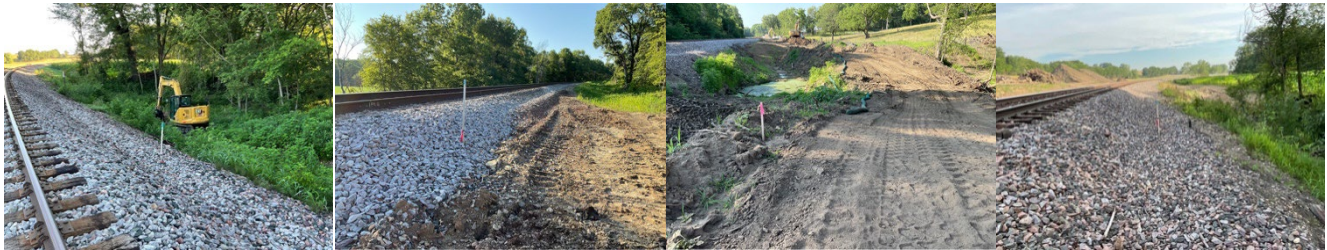
Right of Way (ROW) boundaries were marked with blue and pink lath and all workers on site were made aware that they were to make sure work stayed within the ROW. Work on the project was successfully kept within the ROW with minimal disturbance to wetland areas. The photos below show these color-coded boundaries.

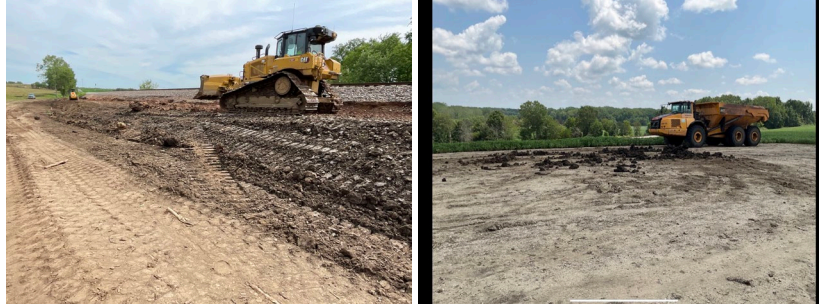
The two photos below provide examples of some of the equipment that had to follow this policy during the project's duration.

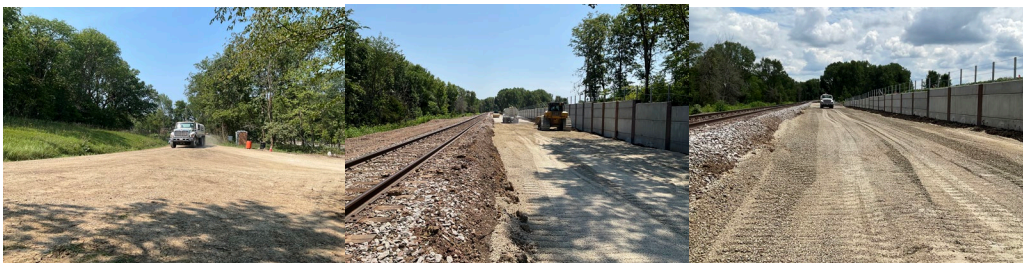
Fugitive dust suppression controls were put in place at various points throughout the project when it was determined that the work would potentially create significant dusting. The primary method of dust suppression was the use of dust control water trucks, which were needed periodically on the ROW and roadways throughout the duration of the Laredo capital improvement project. See below photos of these trucks in use on site.

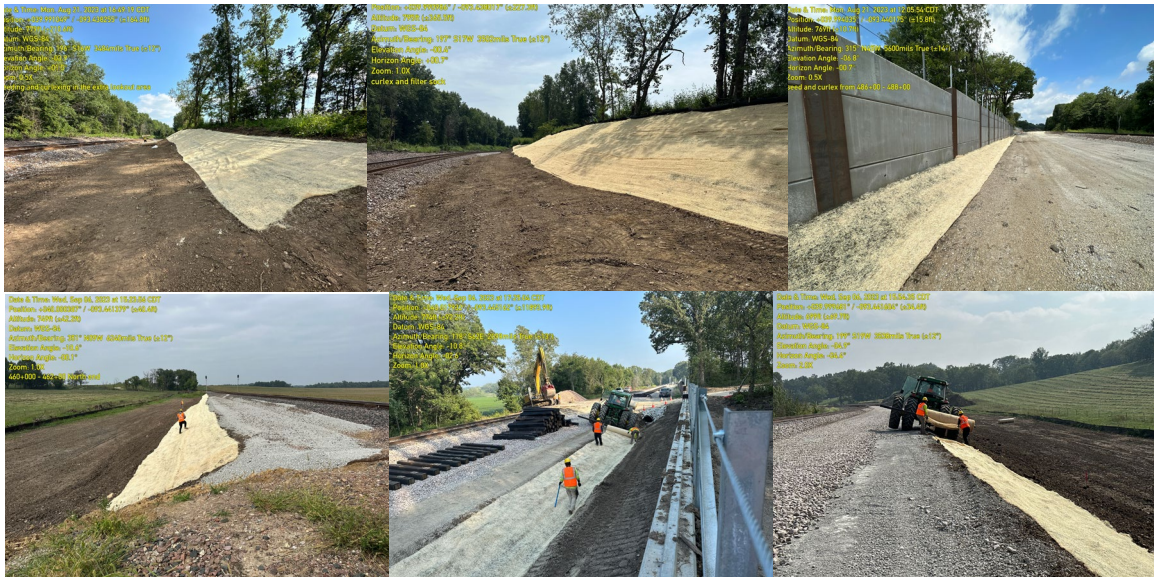
The photos below show some of the areas where revegetation measures were implemented along the construction site.

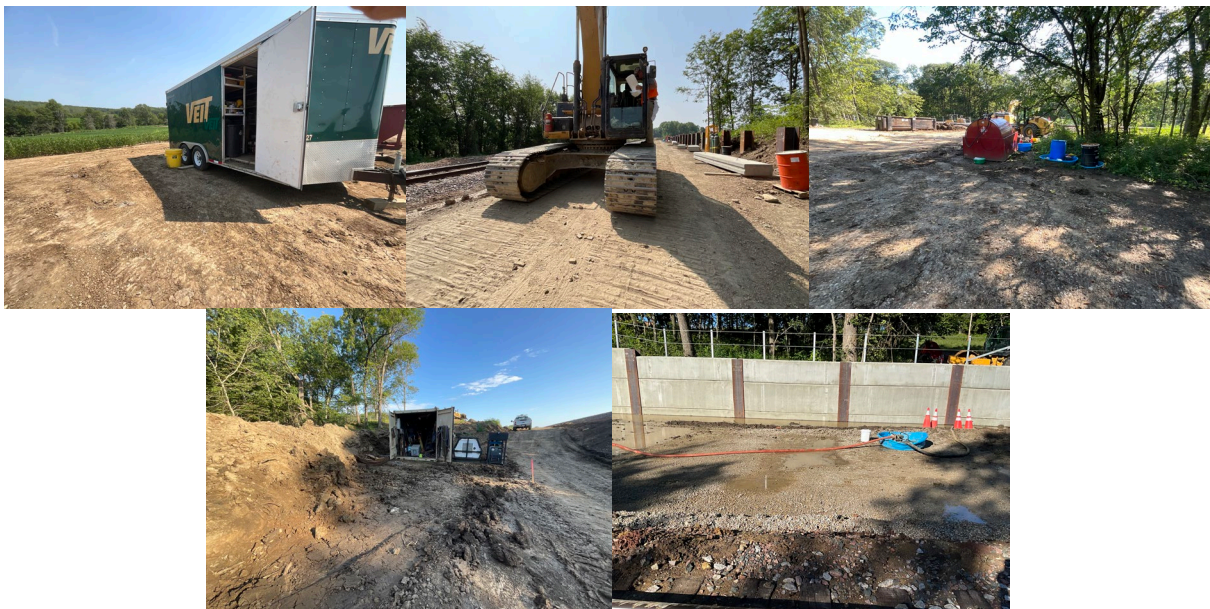
Petroleum products used during the Laredo capital improvement project were all handled properly either with a secondary containment method or storage within an enclosed job trailer. Each piece of equipment used on the project was also equipped with its own spill kit to manage containment immediately in the case of a spill. The photos below show these containment measures.

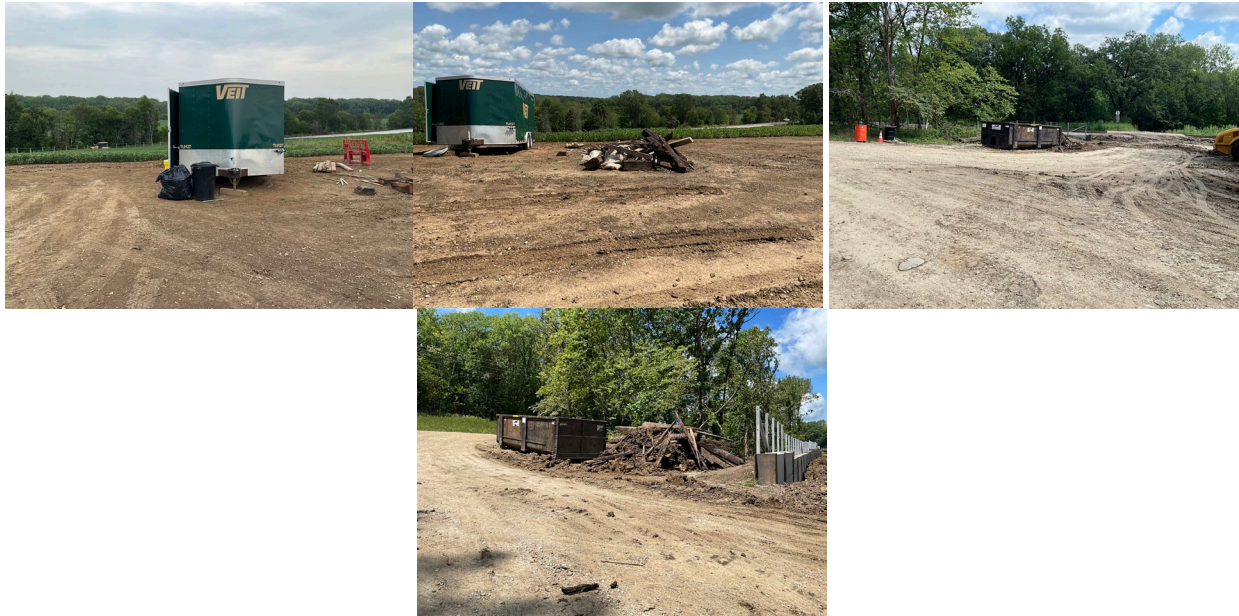
In accordance with the Materials Management Plan, all waste products requiring disposal throughout the Laredo capital improvement project were placed in dumpsters and hauled to the state permitted Rapid Removal Solid Waste Transfer Station in Trenton, Missouri, which is certified for construction waste. The photos below show the filling of the dumpsters in preparation for disposal.

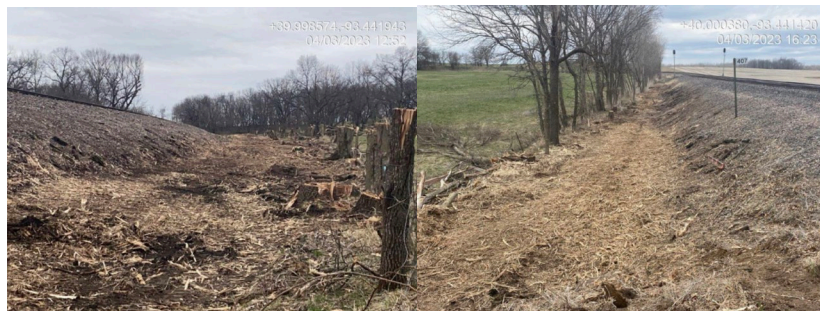
Tree clearing at Laredo was completed before April 01, 2023. No eagles nests or other active bird nests were identified on the project site during tree clearing or construction, and no more trees were cleared than were necessary for construction. The photos below show the ROW after the completion of tree clearing but before construction began.

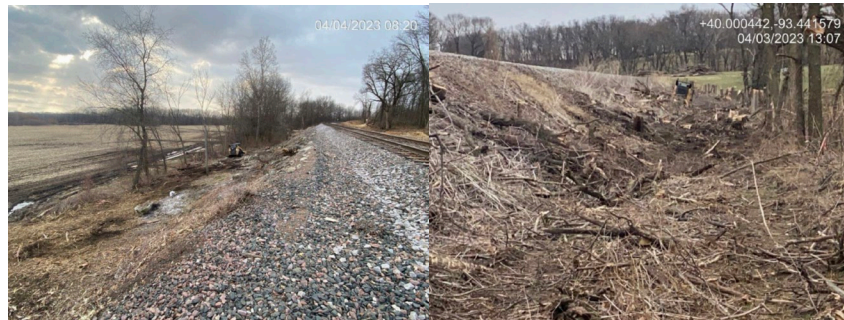
After tree clearing was complete, areas where trees had been cleared were marked with flagged survey limits so contractors could easily identify any areas within ROW where bat species could potentially be present. No bat habitat or nesting was identified throughout the Laredo capital improvement project.

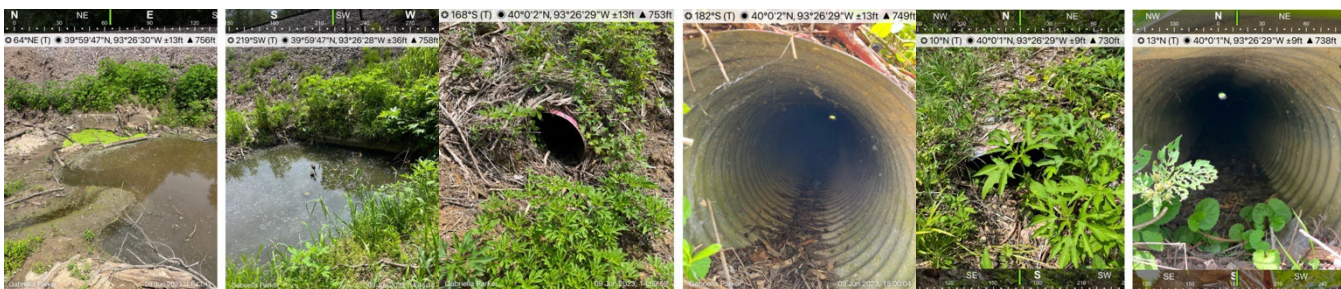
The EM completed daily inspections of all four culverts at MP 407.30, MP 407.05, MP 407.65 and MP 407.03 prior. At no time did the EM find evidence of bats or bat use. Gabriella Miller, biologist for HDR, completed a final bat inspection with a report on 6/9/2023 on all culverts, with no identifying bats or nests present. Please see Appendix B for the Bat Inspection report.

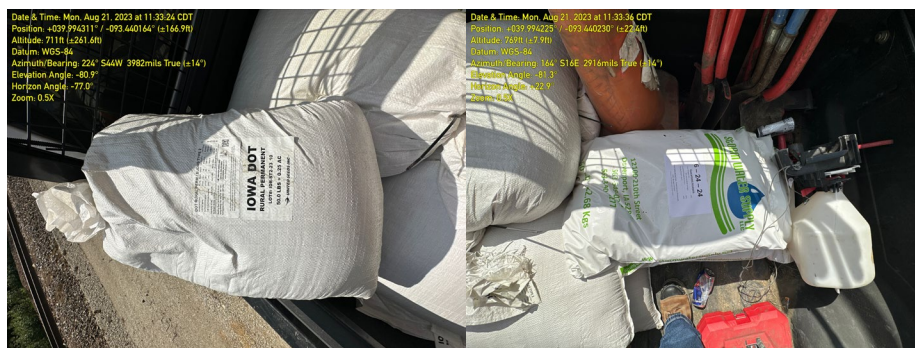
Seed mixes used within the Laredo capital improvement project for the minimization of the introduction and spread of noxious weeds were verified by the EM prior to use. The seed tag shown in the photos below as provided by the seeding contractor specifies No Noxious Weed Found and the MoDOT Seeding Type Requirements in Section 805.2.1 of Missouri Standard Specifications for Highway Construction. No herbicide spray methods were used on the project.

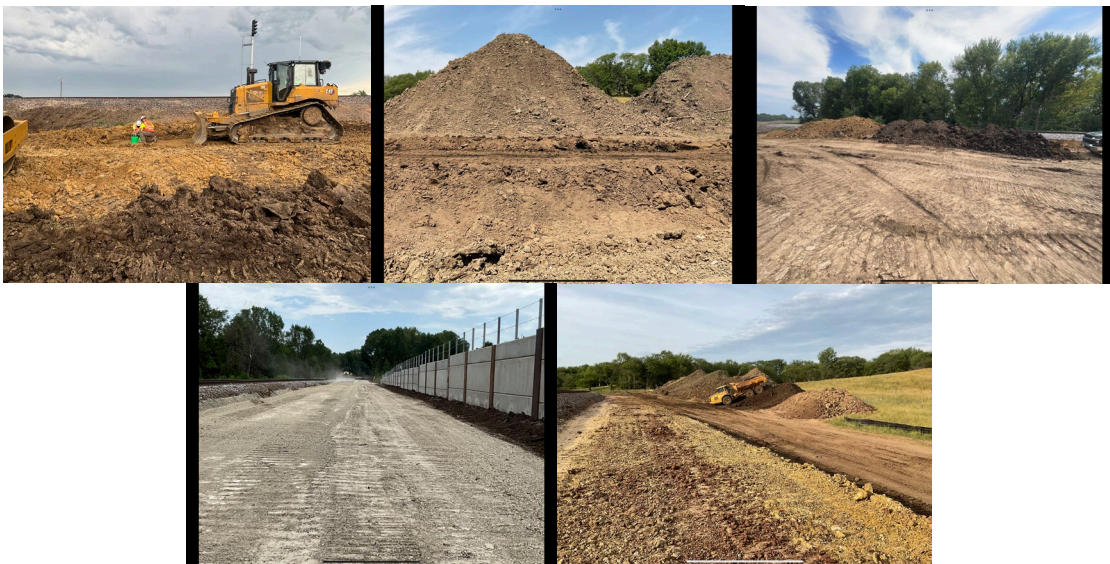
Suitable fill materials used within the Laredo capital improvement project consisted of primary reused Native soils, Clean Fill and ballast material previously approved by project engineers and contractors and from state licensed local sources.

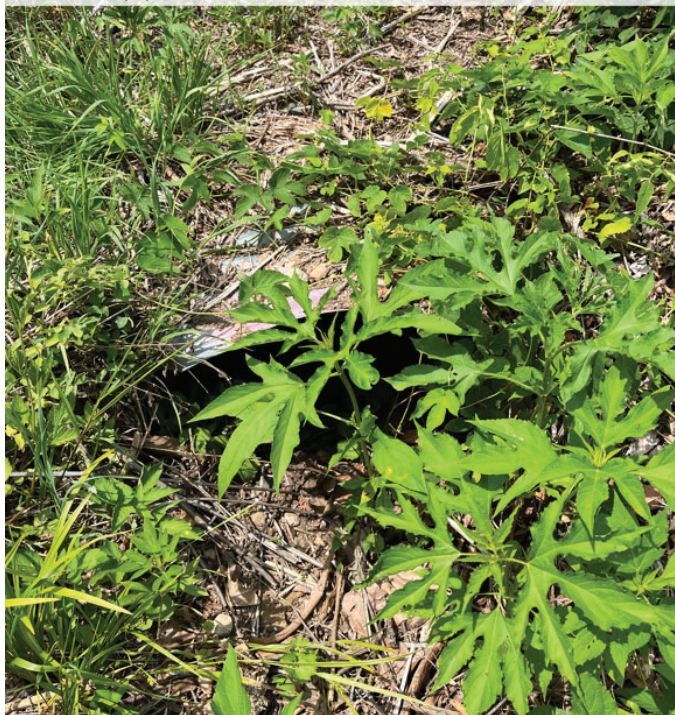
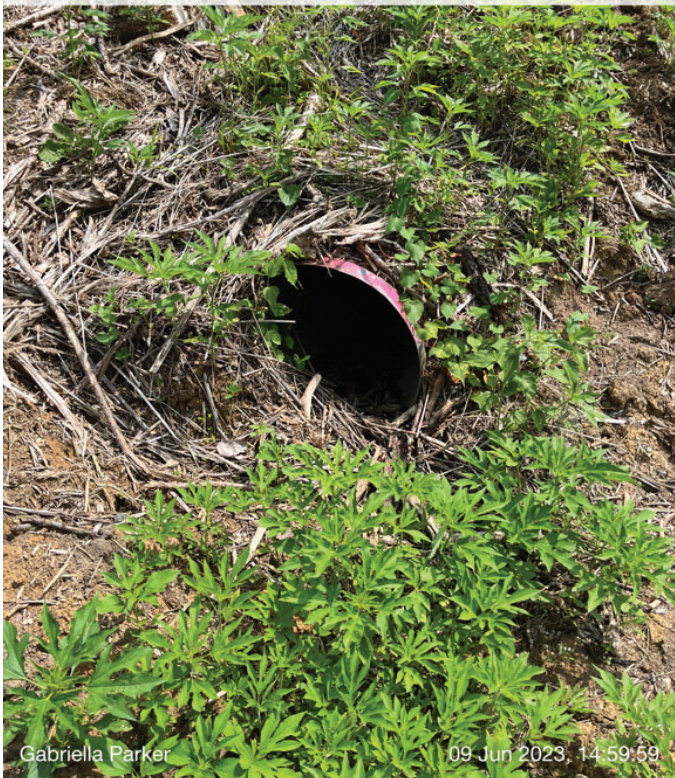
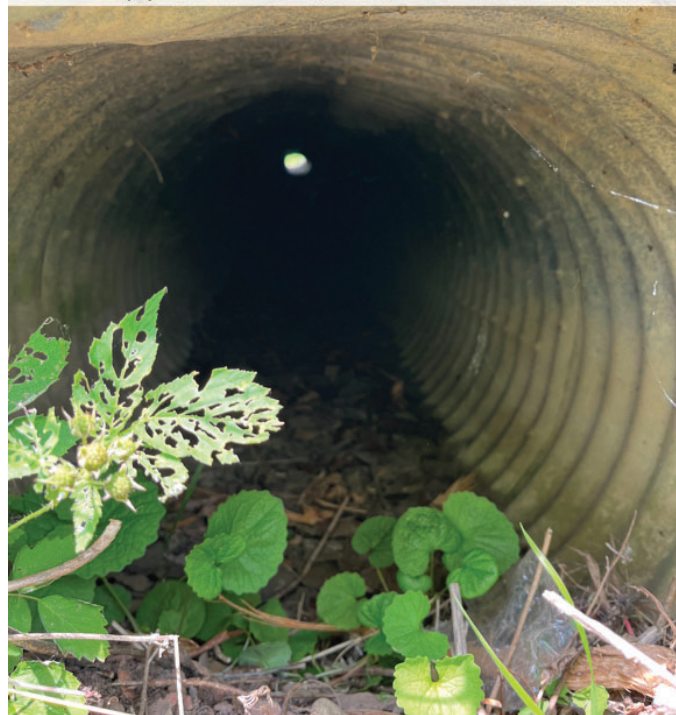
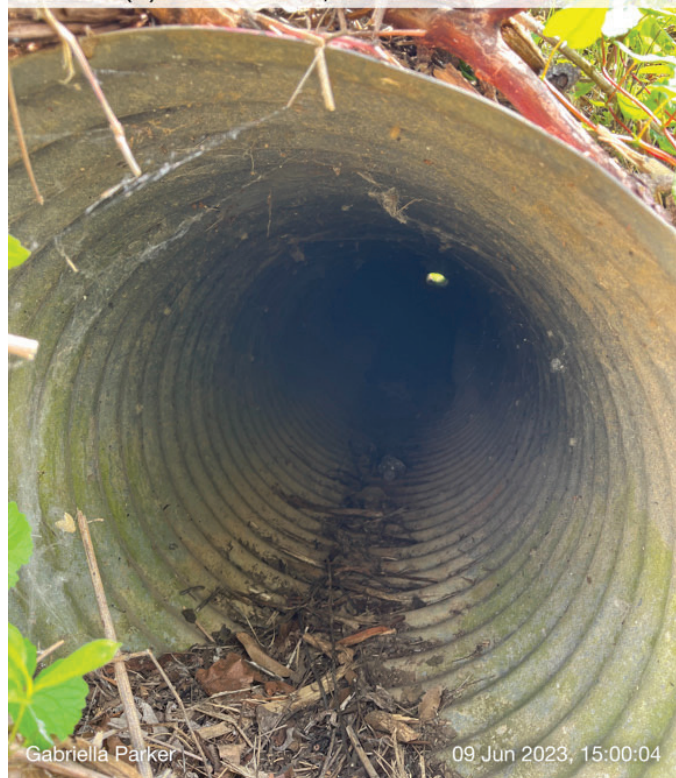
| <input checked="" type="checkbox"/> All crevices and cracks:<br><b>Bridges/culverts:</b> rough surfaces or imperfections in concrete<br><b>Other structures:</b> soffits, rafters, attic areas | | <input type="checkbox"/> Not present | | <input checked="" type="checkbox"/> Visual - live # 0 dead # 0 <input type="checkbox"/> Audible <input type="checkbox"/> Species<br><input type="checkbox"/> Guano <input type="checkbox"/> Odor N/A<br><input type="checkbox"/> Staining <input type="checkbox"/> Photos | | | |
| <input type="checkbox"/> Crack between concrete railings on top of the bridge deck<br> | | <input checked="" type="checkbox"/> Not present | | <input checked="" type="checkbox"/> Visual - live # 0 dead # 0 <input type="checkbox"/> Audible <input type="checkbox"/> Species<br><input type="checkbox"/> Guano <input type="checkbox"/> Odor N/A<br><input type="checkbox"/> Staining <input type="checkbox"/> Photos | | | |

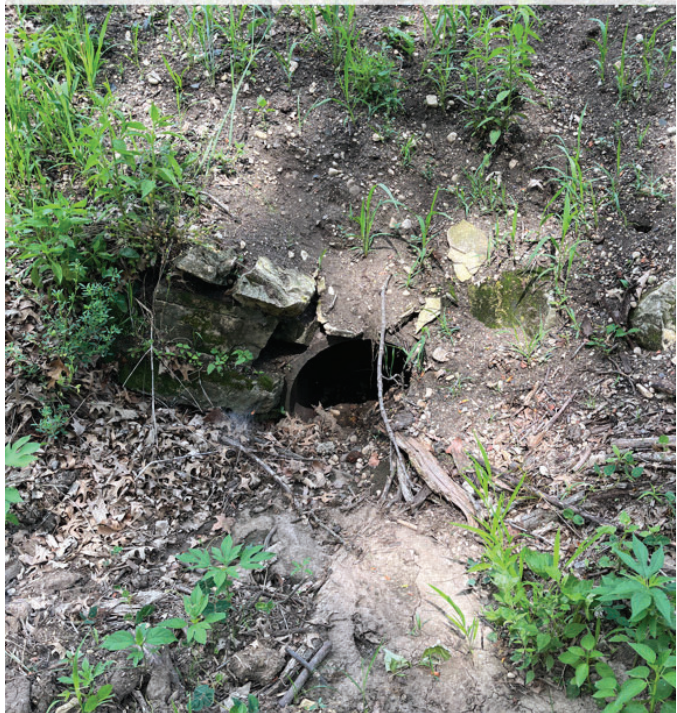
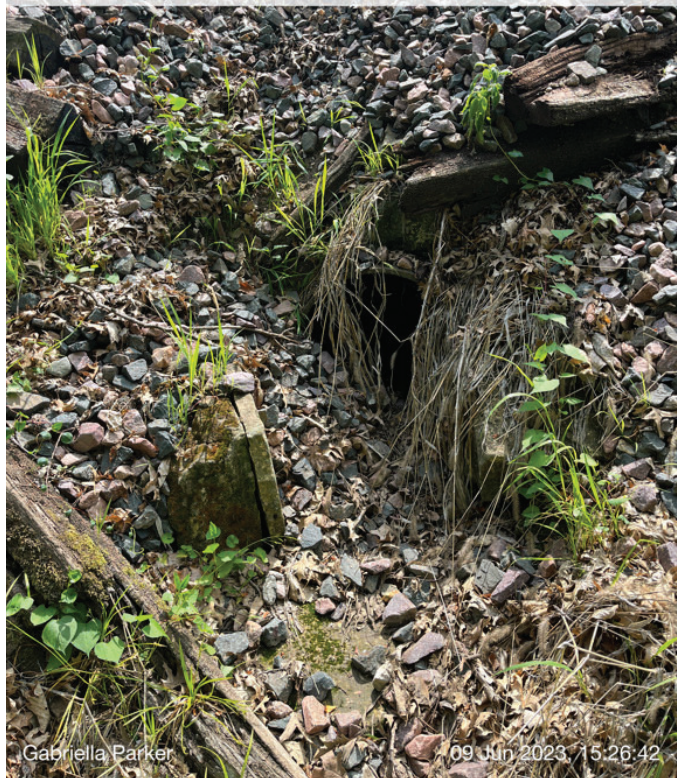
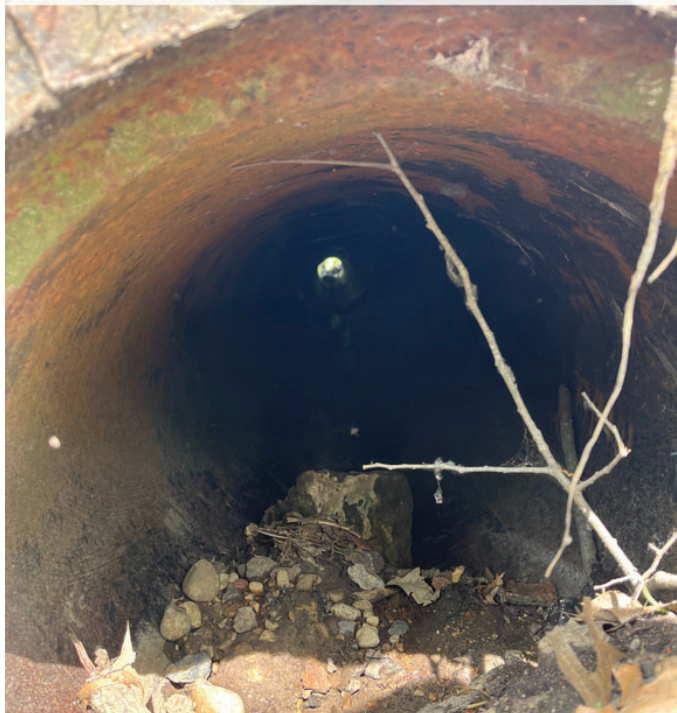
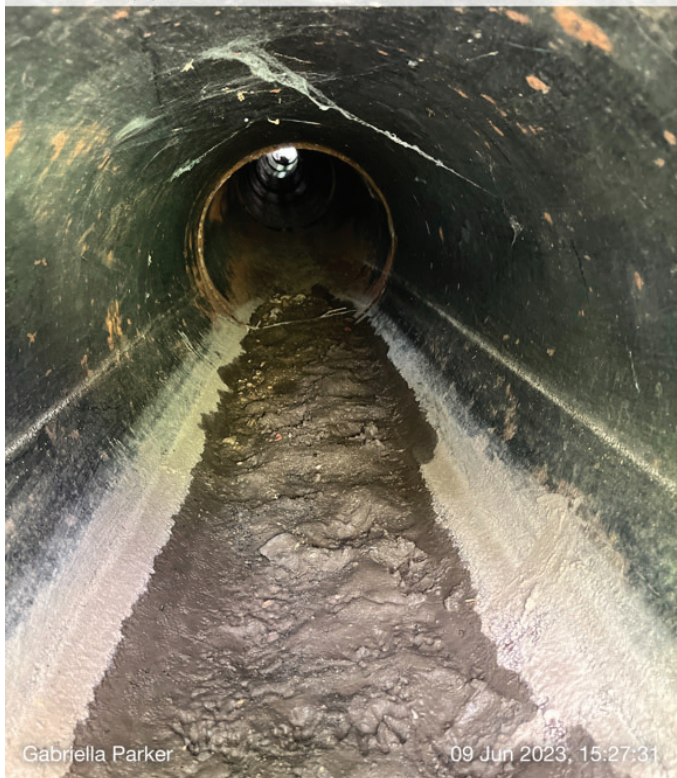
| <input checked="" type="checkbox"/> All crevices and cracks:<br><b>Bridges/culverts:</b> rough surfaces or imperfections in concrete<br><b>Other structures:</b> soffits, rafters, attic areas | | <input type="checkbox"/> Not present | | <input checked="" type="checkbox"/> Visual - live # 0 dead # 0 <input type="checkbox"/> Audible <input type="checkbox"/> Species<br><input type="checkbox"/> Guano <input type="checkbox"/> Odor <input type="checkbox"/> Photos<br><input type="checkbox"/> Staining | | | |
| <input type="checkbox"/> Crack between concrete railings on top of the bridge deck<br> | | <input checked="" type="checkbox"/> Not present | | <input checked="" type="checkbox"/> Visual - live # 0 dead # 0 <input type="checkbox"/> Audible <input type="checkbox"/> Species<br><input type="checkbox"/> Guano <input type="checkbox"/> Odor <input type="checkbox"/> Photos<br><input type="checkbox"/> Staining | | | |

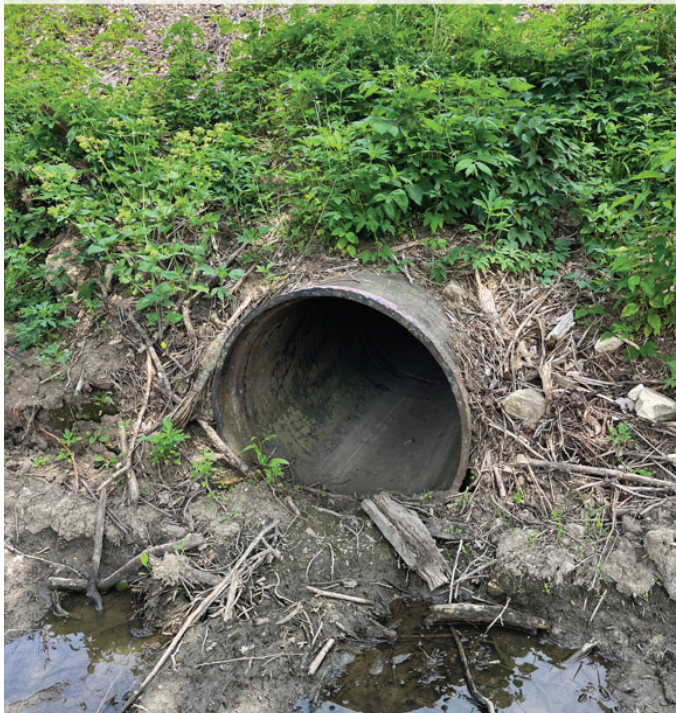
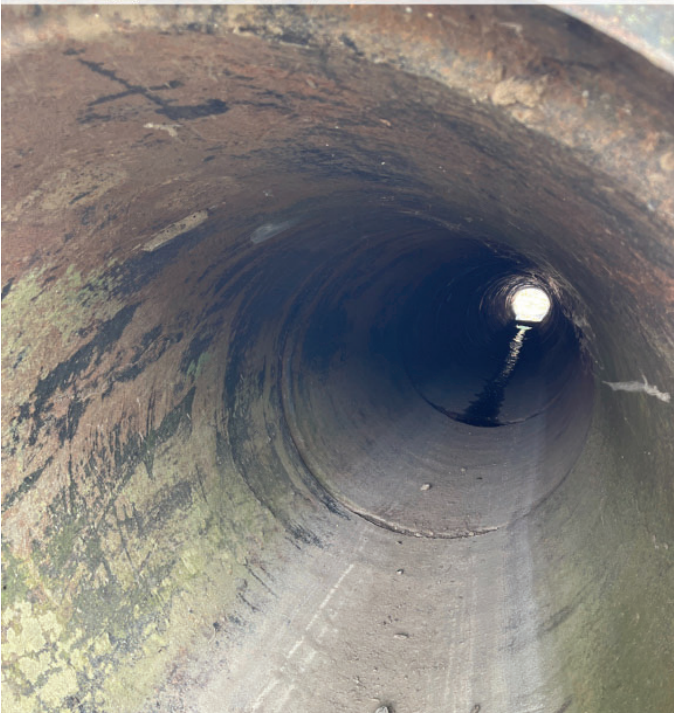
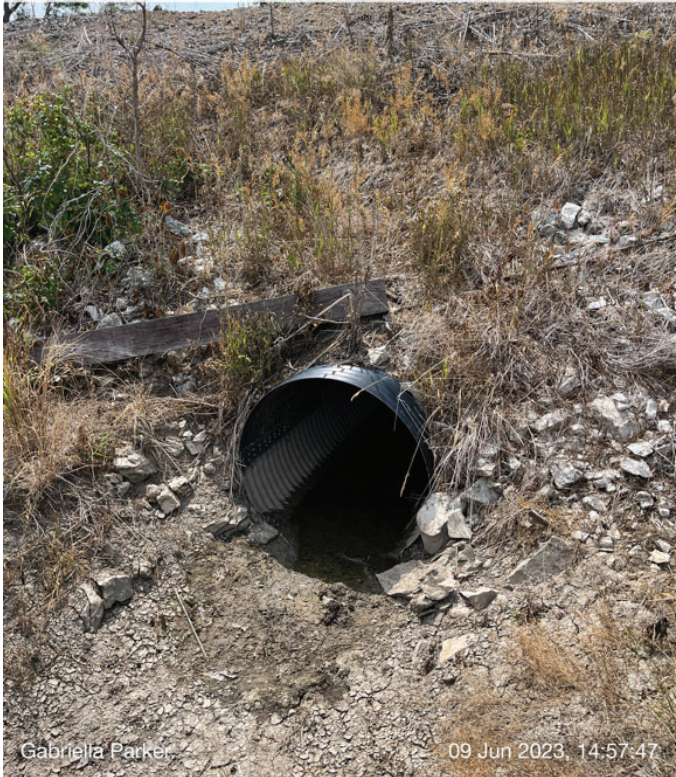
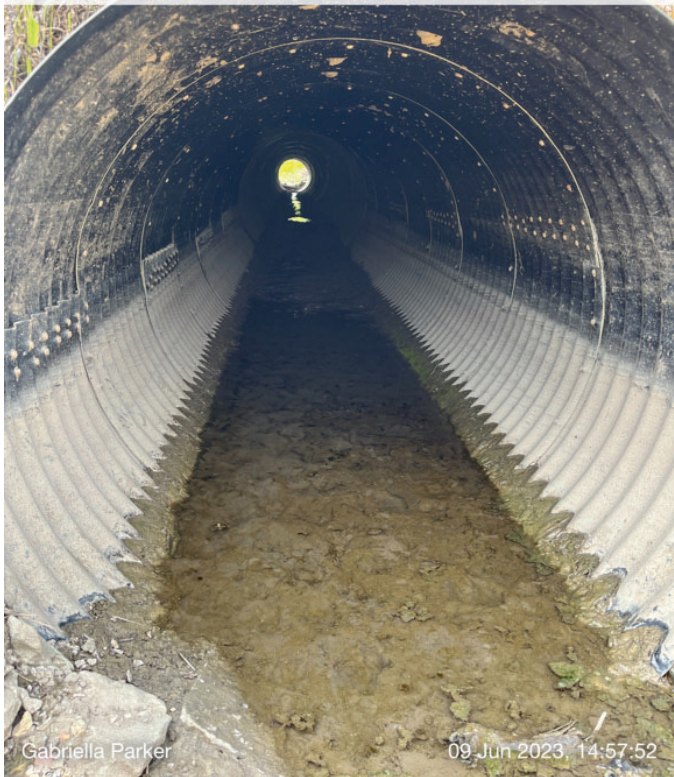
| <input checked="" type="checkbox"/> All crevices and cracks:<br><b>Bridges/culverts:</b> rough surfaces or imperfections in concrete<br><b>Other structures:</b> soffits, rafters, attic areas | | <input type="checkbox"/> Not present | | <input checked="" type="checkbox"/> Visual - live # 0 dead # 0 | | <input type="checkbox"/> Audible <input type="checkbox"/> Species | |
| <input type="checkbox"/> Crack between concrete railings on top of the bridge deck<br> | | <input checked="" type="checkbox"/> Not present | | <input checked="" type="checkbox"/> Visual - live # 0 dead # 0 | | <input type="checkbox"/> Audible <input type="checkbox"/> Species | |

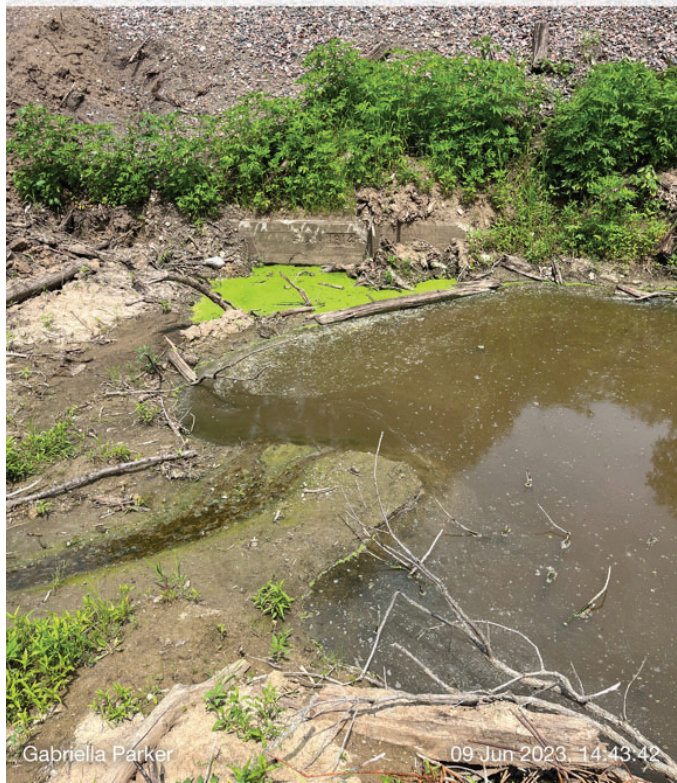
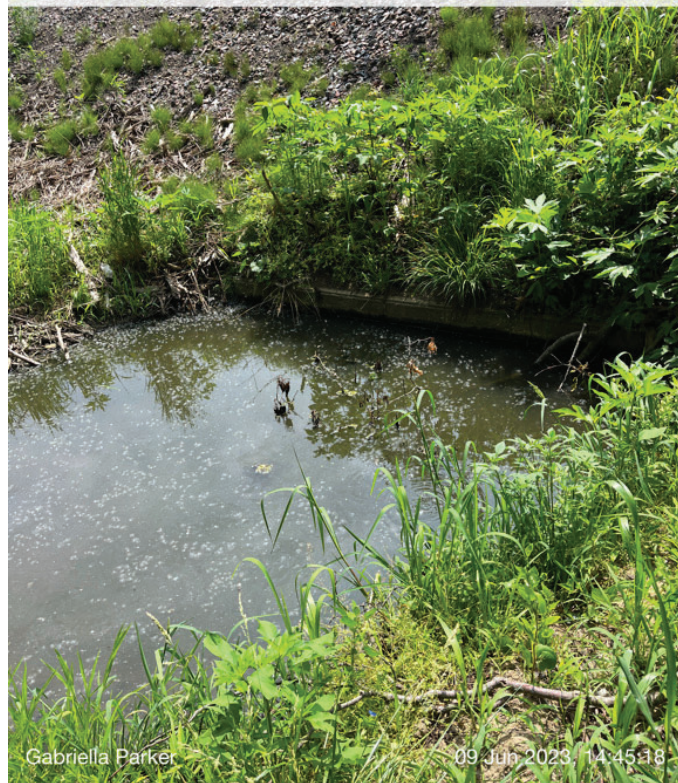
| <input checked="" type="checkbox"/> All crevices and cracks:<br><b>Bridges/culverts:</b> rough surfaces or imperfections in concrete<br><b>Other structures:</b> soffits, rafters, attic areas | | <input type="checkbox"/> Not present | | <input checked="" type="checkbox"/> Visual - live # 0 dead # 0<br><input type="checkbox"/> Guano<br><input type="checkbox"/> Staining<br><input type="checkbox"/> Audible<br><input type="checkbox"/> Odor<br><input type="checkbox"/> Photos<br><input type="checkbox"/> Species | | | |
| <input type="checkbox"/> Concrete surfaces (open roosting on concrete) | | <input checked="" type="checkbox"/> Not present | | <input checked="" type="checkbox"/> Visual - live # 0 dead # 0<br><input type="checkbox"/> Guano<br><input type="checkbox"/> Staining<br><input type="checkbox"/> Audible<br><input type="checkbox"/> Odor<br><input type="checkbox"/> Photos<br><input type="checkbox"/> Species | | | |
| <input type="checkbox"/> Spaces between concrete end walls and the bridge deck | | <input checked="" type="checkbox"/> Not present | | <input checked="" type="checkbox"/> Visual - live # 0 dead # 0<br><input type="checkbox"/> Guano<br><input type="checkbox"/> Staining<br><input type="checkbox"/> Audible<br><input type="checkbox"/> Odor<br><input type="checkbox"/> Photos<br><input type="checkbox"/> Species | | | |

The EM completed an inspection of the two culverts at MP 589.10 and Station 31170+00 prior to the culvert installation that occurred on 6/15/2023. At no time did the EM find evidence of bat use or nests present. Please see Appendix A for the Bat Inspection report.

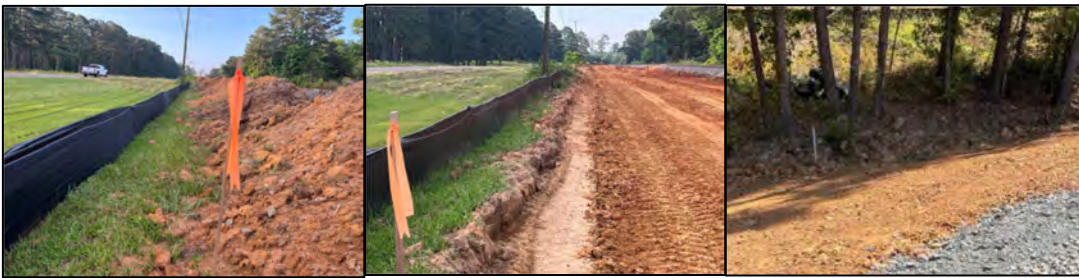
The Right of Way (ROW) limits are marked by wooden stakes with orange tape on the top of them. The temporary erosion control silt fence was installed approximately 3ft behind the surveyed wooden stakes, due to construction activities extending to the edge of ROW. The temporary erosion control silt fence was maintained through the completion of the project to contain all sediment and construction debris within the limits of the project site. Wooden stakes with orange ribbon were also placed along the ROW for offset to the centerline of new siding for construction purposes. These were used during the construction sequence allowing the contractor to measure from the surveyed stakes to the centerline of the new siding.

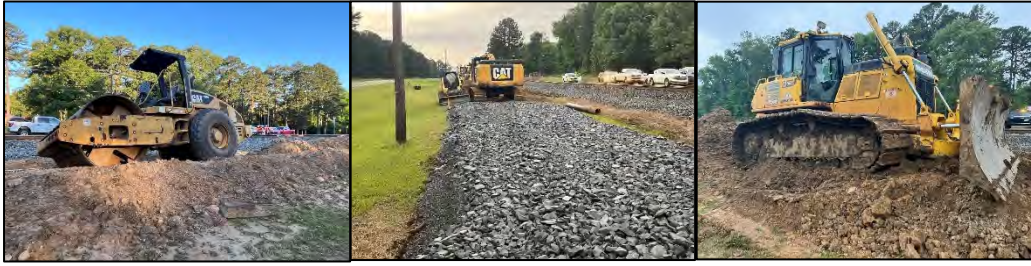
The anti-idling policy was discussed daily during the safety briefing completed at the project site. Contractors CW&W and Hollingsworth agreed not to leave any equipment idling while not in use. These briefings occurred during Safety/JSA meetings each day, and all new subcontractors were also briefed as they joined the project and began their work. The anti-Idling procedure was adhered to throughout the duration of the Mansfield capital improvement project.

The three photos below provide examples of some of the equipment that had to follow this policy during the project's duration. An equipment list used each day during the construction sequence was included within the daily environmental monitoring report prepared by the staff of Headwaters.

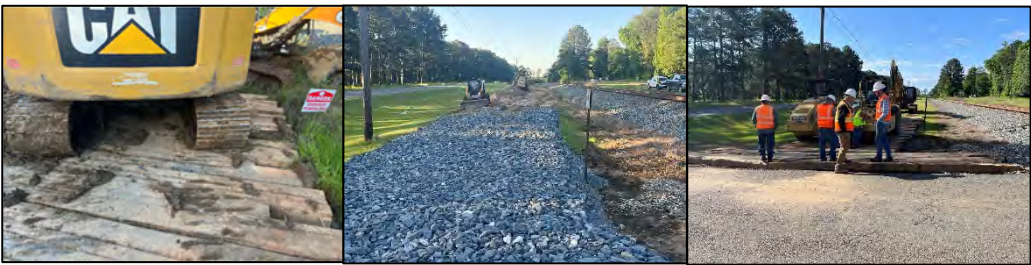
Dust suppression controls were put in place at various points throughout the project when it was determined that the work would potentially create significant dusting. The primary method of dust suppression was the use of rock that has been brought into place over removed vegetation (exposed soils) at construction entrance(s) in addition to wooden mats that were placed at low spots along the ROW. Review of each construction entrance occurred as part of the daily environmental monitoring by the environmental inspectors on the project. Additional top dressing or improvements to the construction entrances were completed as recommended to maintain the site and prevent the transport of sediment off site. See below photos of these controls on site.

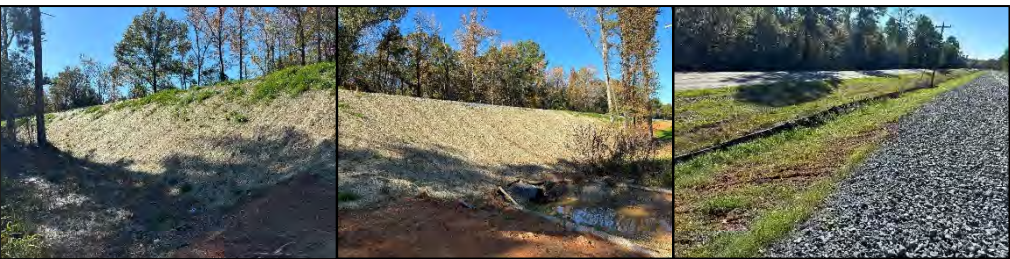
As part of the project completion, contractors were able to ensure that all site stabilization measures needed throughout the project were considered and completed within the 14-day window in accordance with the general permits completed for the project. The environmental inspectors supported the contractors with the use of temporary grassing as part of the construction sequence. As construction completed, permanent grassing was utilized to include the reutilization of topsoil and the hydroseeding and/or mulching covering final graded areas along the project ROW. At the end of the project, the EM returned to the site to ensure that revegetation had been maintained and was successful in its attempt to restore the ROW post-construction.

The photos below show some of the areas where revegetation measures were implemented along the construction site.

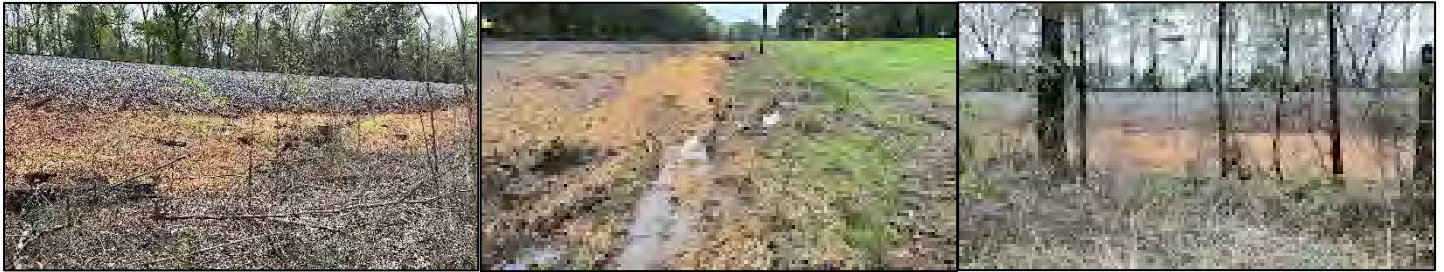
Tree clearing at Mansfield was completed before March 10, 2023. The individual occurrences of eagles, nest, or roosting trees were observed on or near the project site during the extent of the project construction activities. As part of the initial site clearing, no more trees were cleared than were necessary for the planned construction activities. The photos below show the ROW after the completion of tree clearing but before construction had begun.

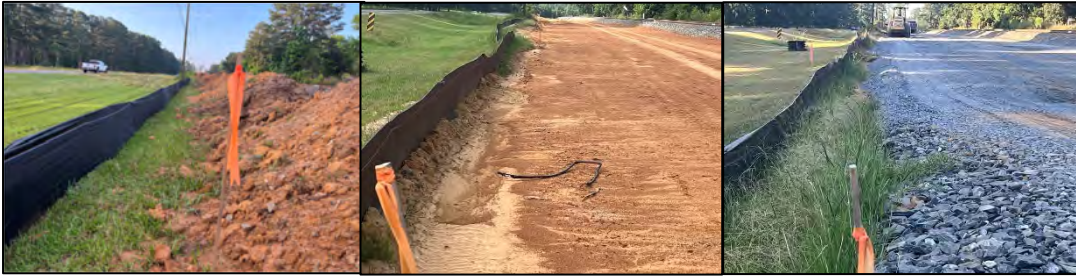
After tree clearing was complete, the limits of the project were clearly marked out to keep the contractor within the limits of the project with wooden stakes with orange tape on top of stakes. Silt fencing has also been installed along the perimeter of the project in accordance with the sediment and erosion control management plan.

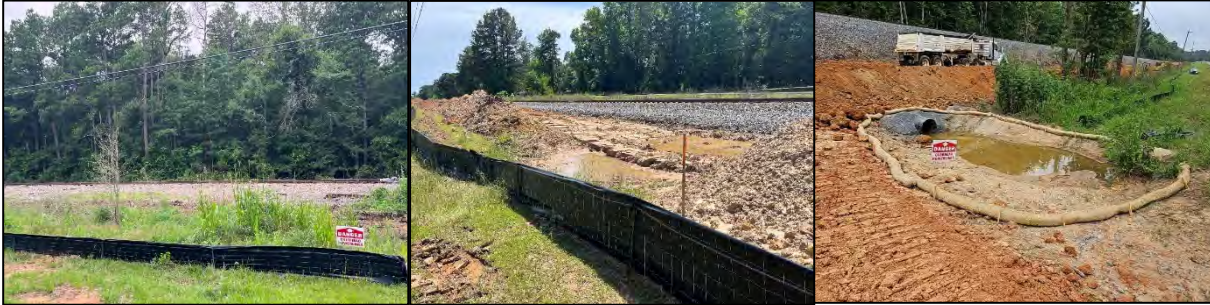
The contractor followed Best Management Practices by utilizing secondary containment while refueling, designated equipment cleaning areas, utilizing spill prevention measures, minimizing sediment on public roadways, and utilizing good waste management practices.

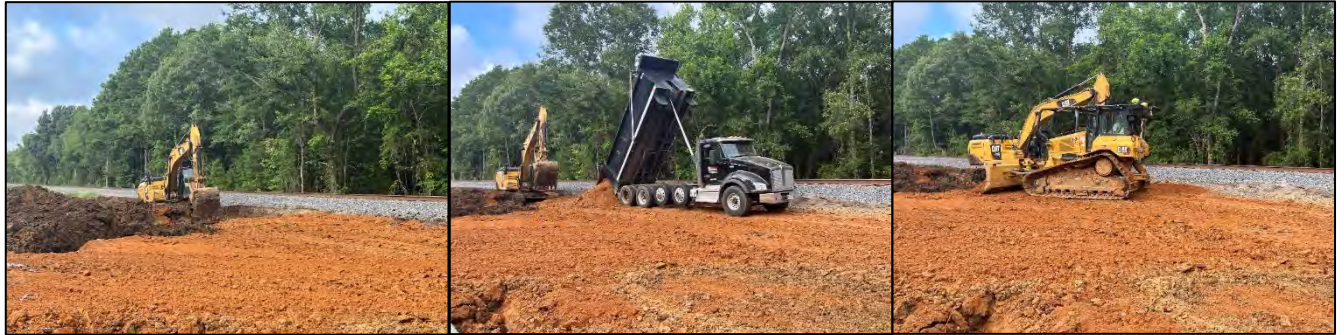
Suitable fill materials used within the Mansfield capital improvement project consisted of primary reused native soils, clean fill, and ballast material previously approved by project engineers and contractors and from state licensed local sources.

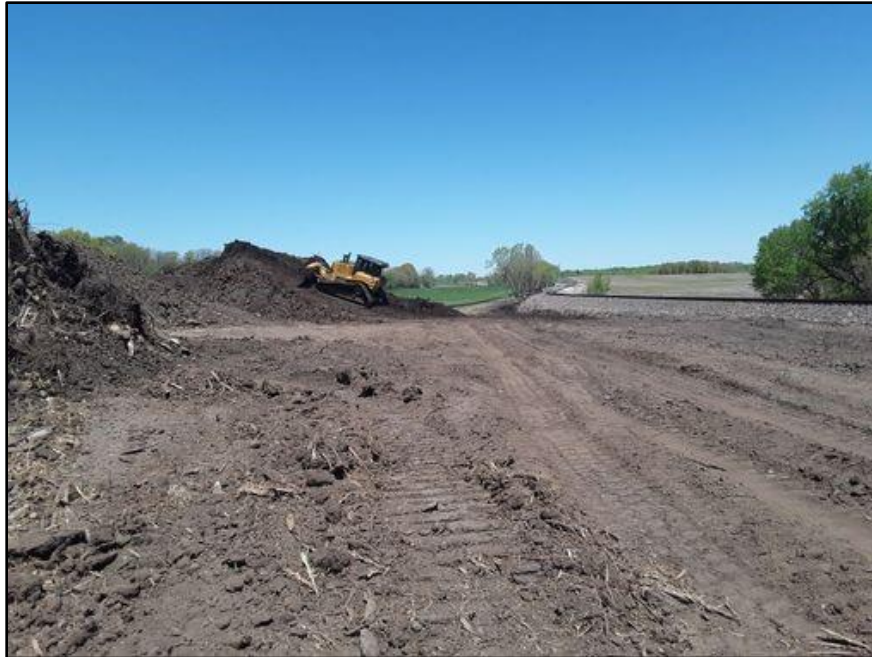
**Figure 1. Bulldozer stockpiling topsoil on the right-of-way; view facing north. (Photograph by S. Peterson 5/3/23.)**

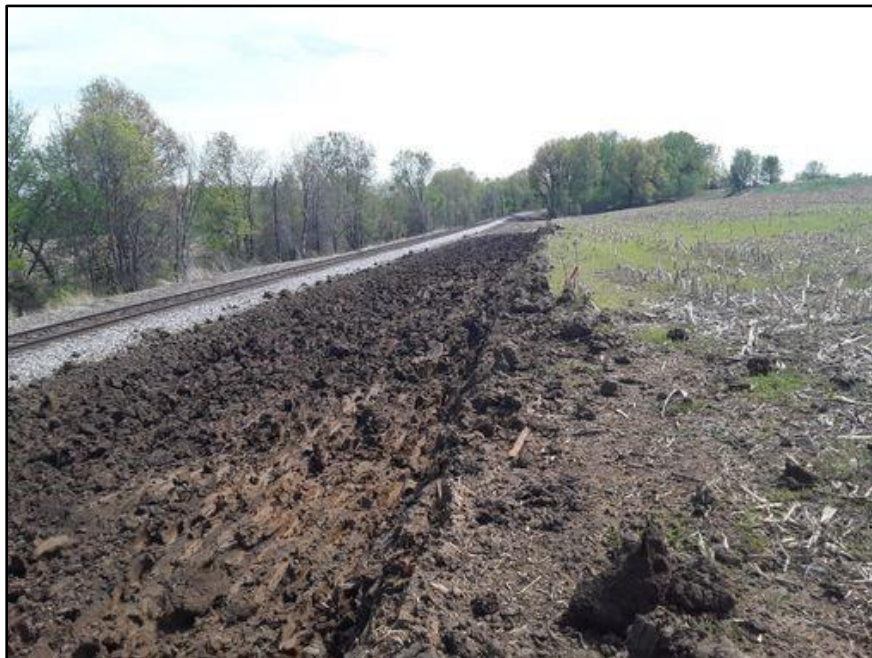
**Figure 2. Topsoil removal continues toward the south end of the right-of-way; view facing south. (Photograph by S. Peterson 5/4/23.)**

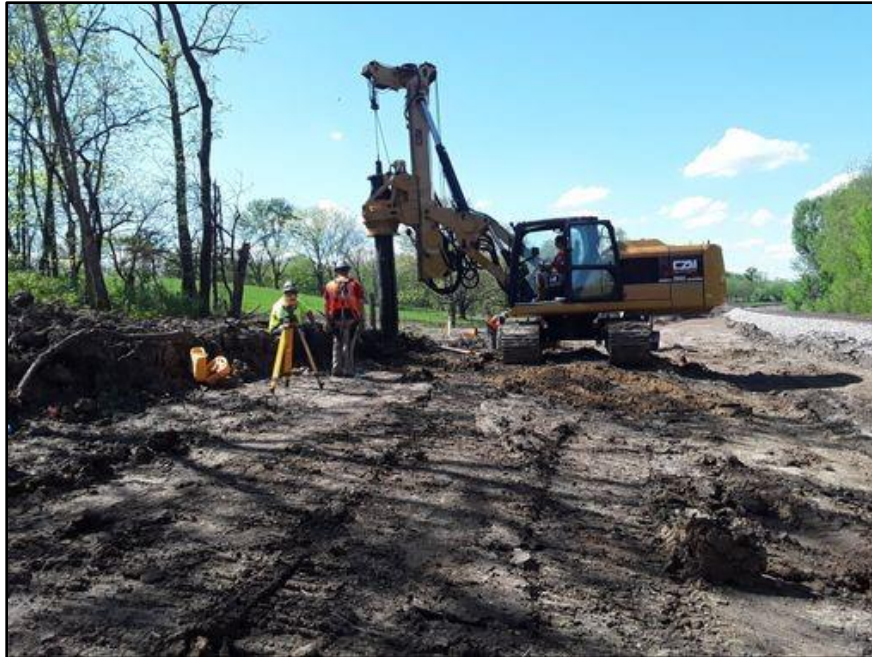
**Figure 3. Foundation crew drilling holes to set H-beams for the foundation walls; view facing north. (Photograph by S. Peterson 5/13/23.)**

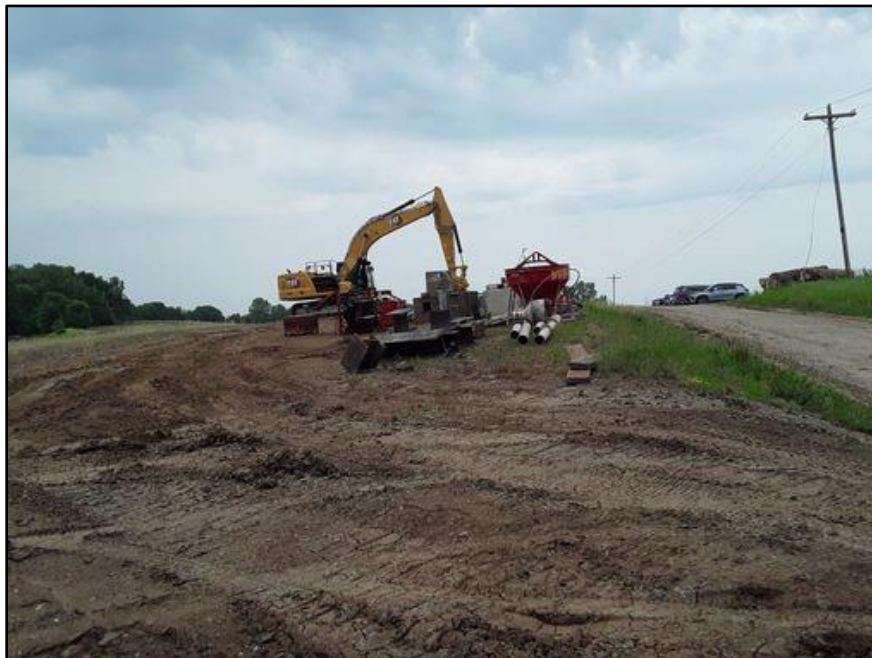
**Figure 4. Construction staging area on top of the hill; view facing south. (Photograph by S. Peterson 6/7/23.)**

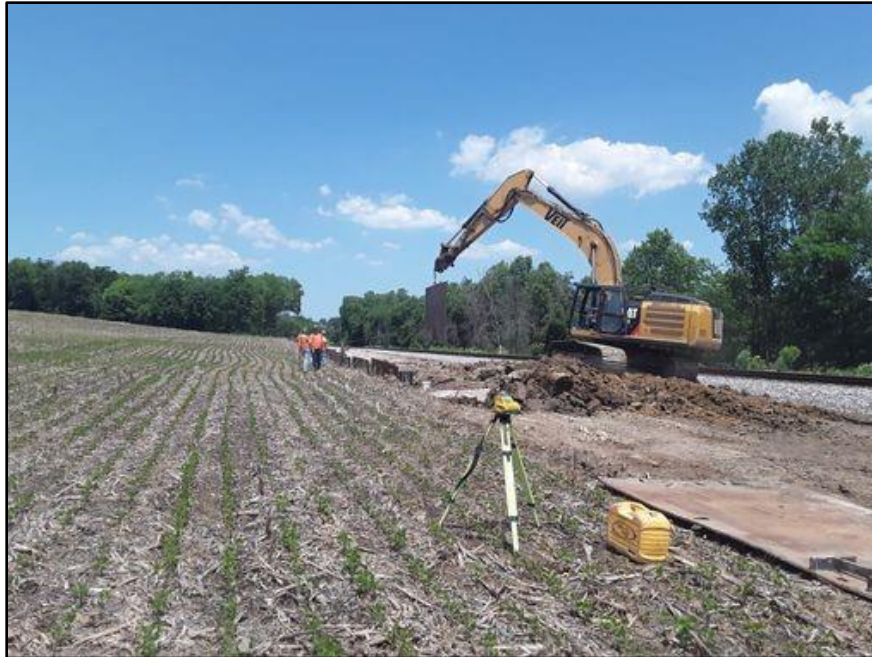
**Figure 5. Solar panels being set along the corridor; view facing northeast. (Photograph by S. Peterson 6/15/23.)**

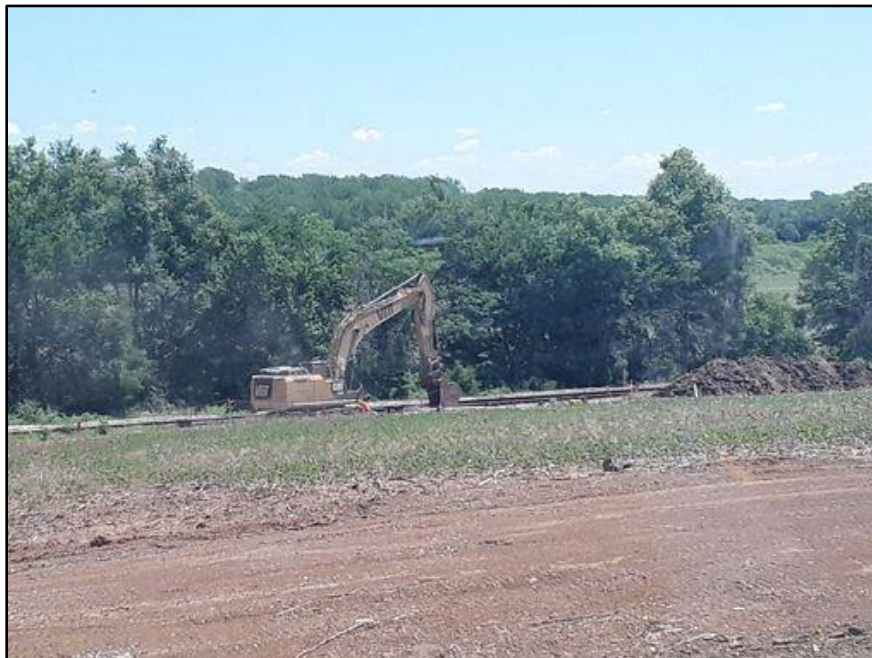
**Figure 6. Trenching along the corridor; view facing east. (Photograph by S. Peterson 6/19/23.)**

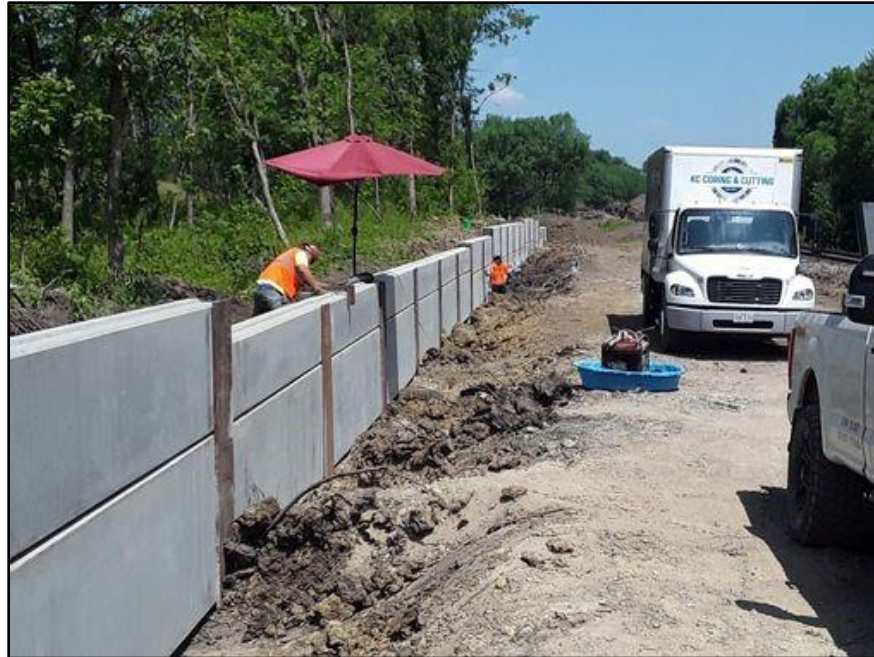
**Figure 7. Crew placing the northern portion of the retaining wall north of the rail crossing; view facing north. (Photograph by S. Peterson 6/22/23.)**

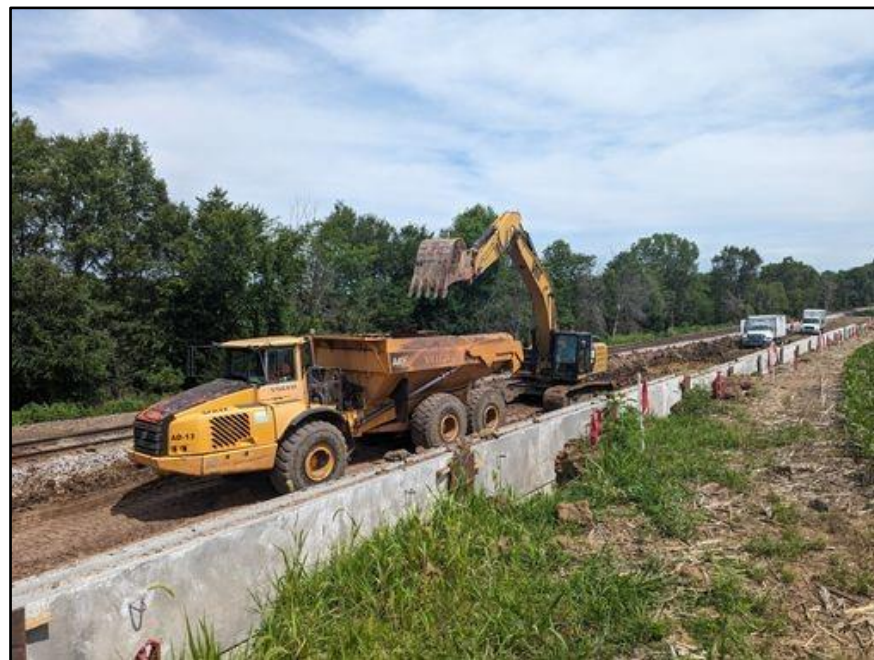
**Figure 8. Topsoil removal along the corridor; view facing southeast. (Photograph by S. Peterson 7/06/23.)**
