Re: Docket No. FD 36500, CPKC Quarterly Environmental Mitigation  
Measures Report for September 15 to December 14, 2023

# CPKC Quarterly Environmental Mitigation Measure Compliance Report Number 3

This report includes compliance activities completed between September 15, 2023, and December 14, 2023 (Quarter 3, Year 1 of the STBs oversight period following the acquisition of KCS by CP, STB Docket FD 36500)

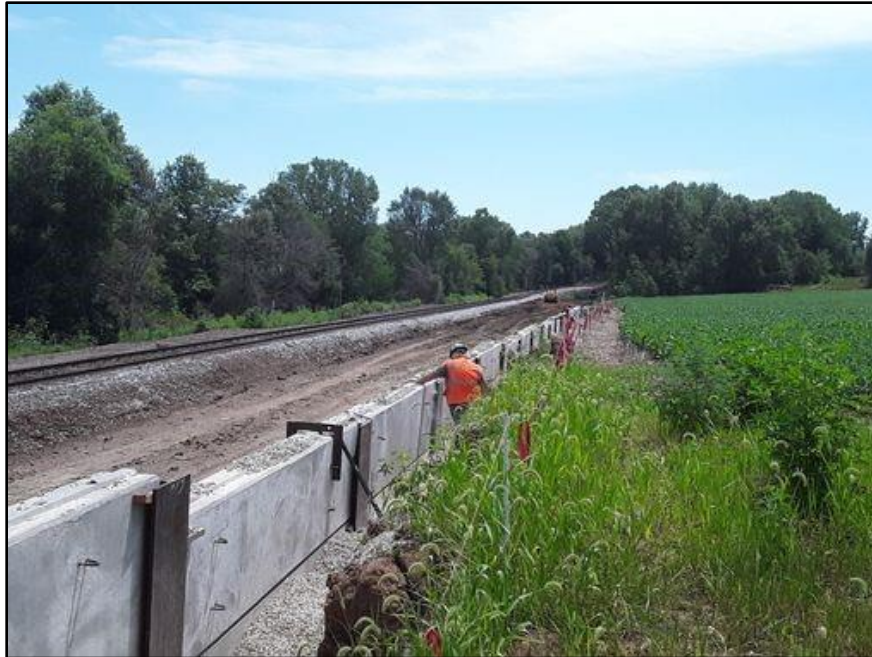
**Figure 9. Foundation crew working on the southern portion of the retaining wall; view facing southeast. (Photograph by S. Peterson 7/14/23.)**

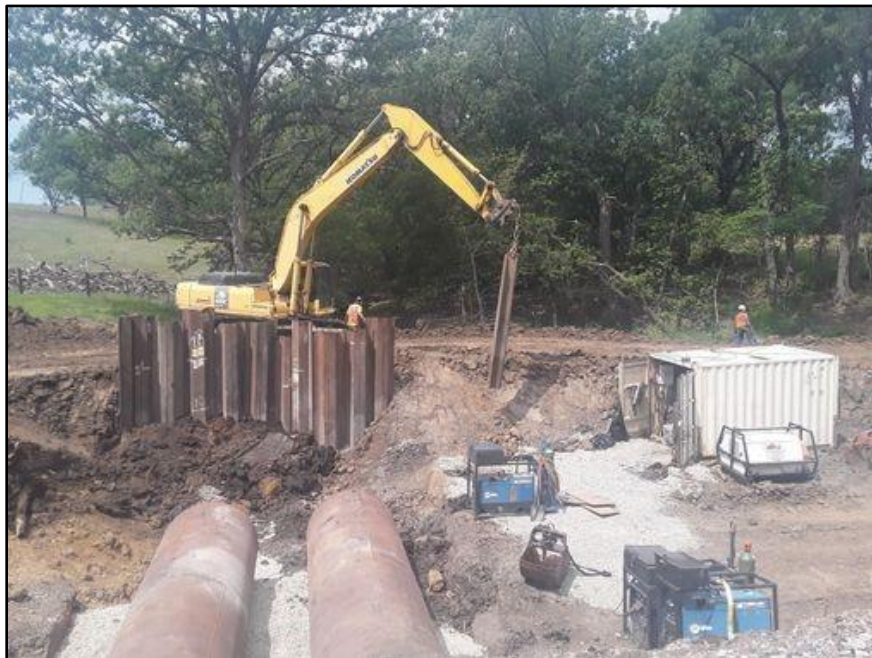
**Figure 10. Iowa Trenchless finishing activities at the first culvert site; view facing northwest. (Photograph by S. Peterson 7/20/23.)**

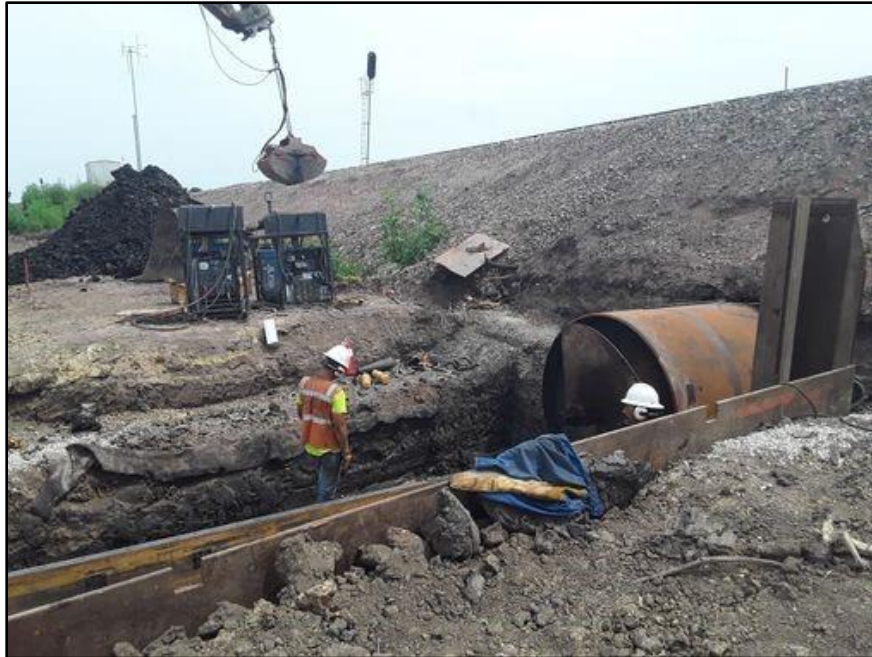
**Figure 11. Close-up of the trenching pit and the culvert; view facing northeast. (Photograph by S. Peterson 7/25/23.)**

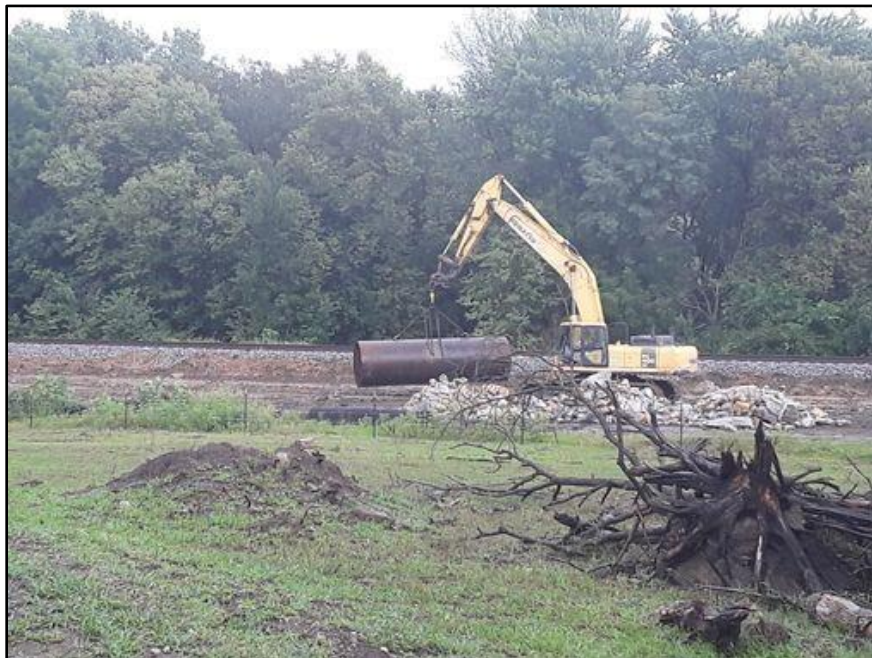
**Figure 12. Iowa Trenchless hauling pipe to the bore pit; view facing east. (Photograph by S. Peterson 8/2/23.)**

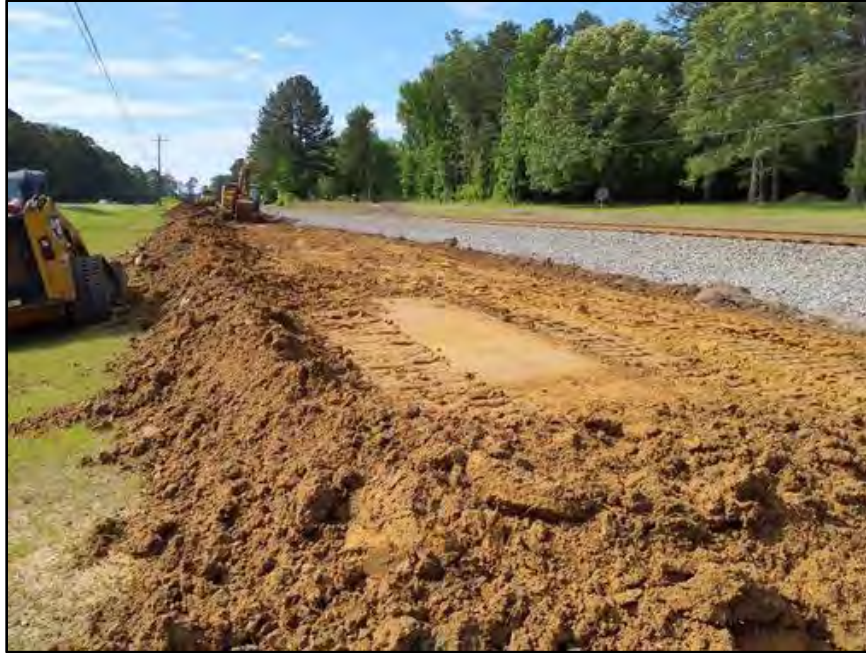
**Figure 1. Initial topsoil clearance by a bulldozer; view facing southwest. (Photograph by H. MacIsaac April 24, 2023.)**

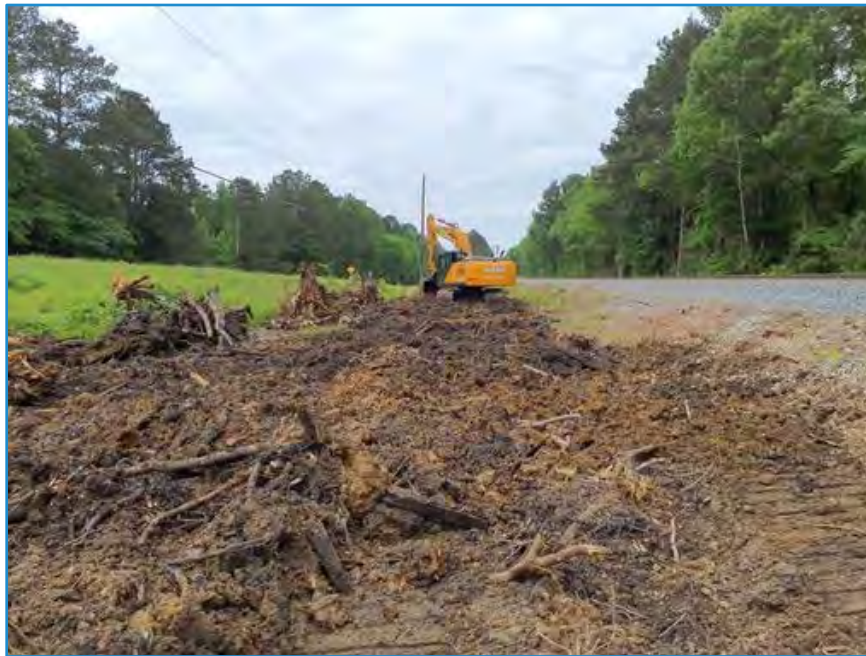
**Figure 2. Initial stump removal by an excavator; view facing southwest. (Photograph by H. MacIsaac April 24, 2023.)**

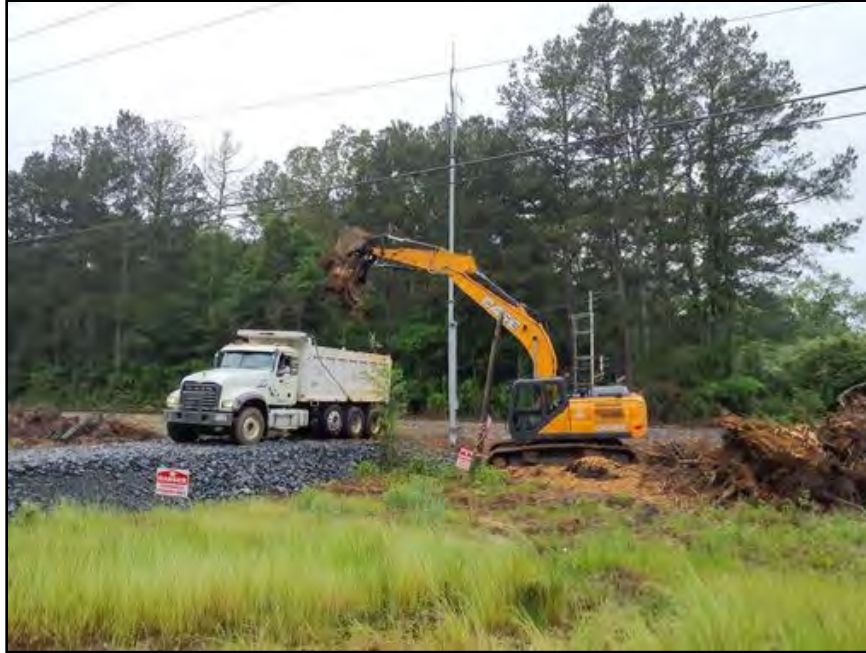
**Figure 3. Tree removal by excavator; view facing southwest. (Photograph by H. MacIsaac April 29, 2023.)**

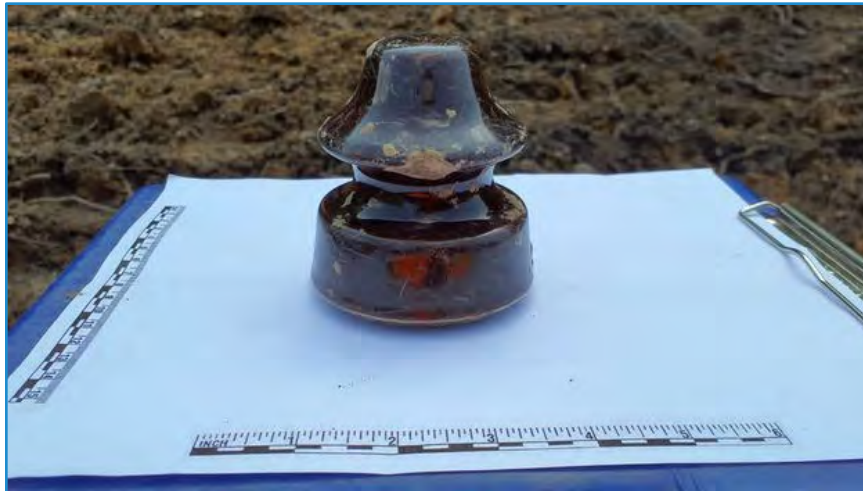
**Figure 4. Historic ceramic insulator found during monitoring; view facing south. (Photograph by H. MacIsaac May 5, 2023.)**

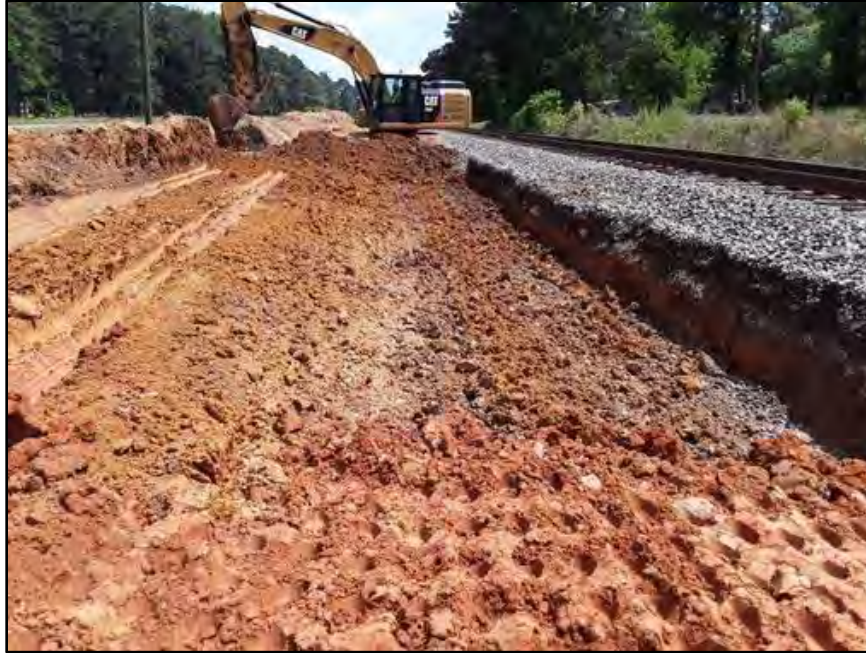
**Figure 5. Excavator digging a trench; view facing east. (Photograph by R. Jenson May 18, 2023.)**

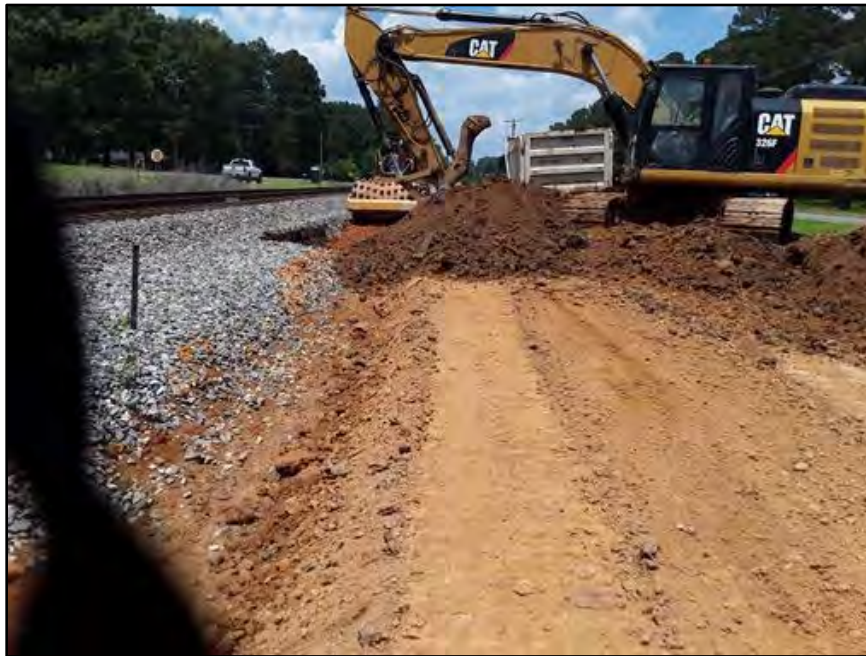
**Figure 6. Excavator digging a culvert installation trench; view facing east. (Photograph by R. Jenson May 18, 2023.)**

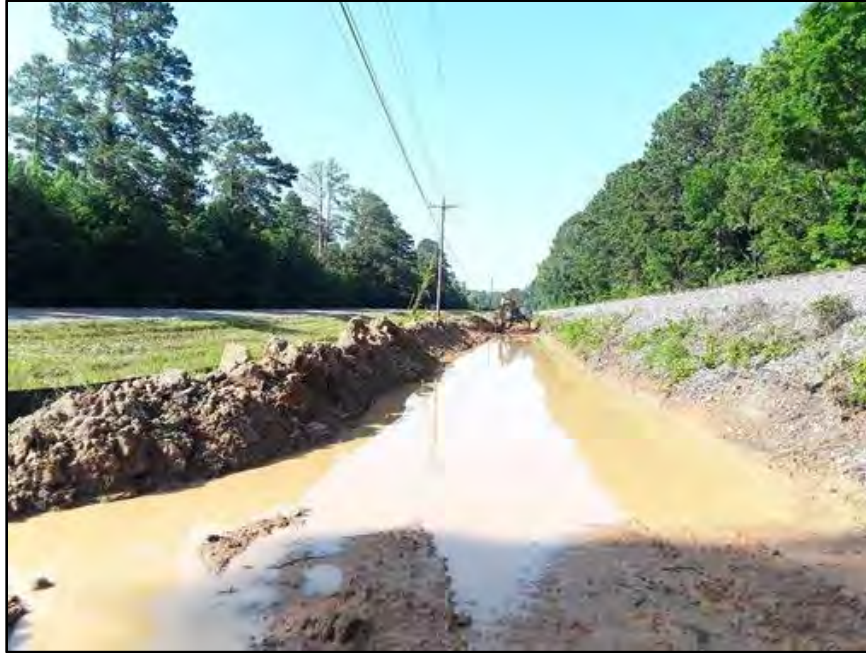
**Figure 7. Flooded ROW being drained by a bulldozer; view facing west. (Photograph by D. Holubar June 6, 2023.)**

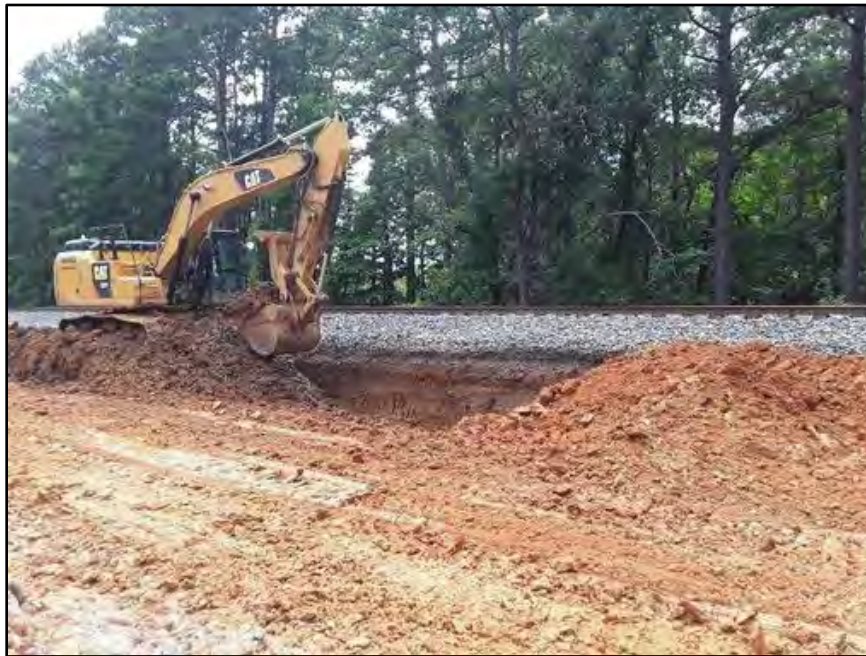
**Figure 8. Cut-and-fill grading using fill from the borrow pit; view facing southwest. (Photograph by D. Holubar June 13, 2023.)**

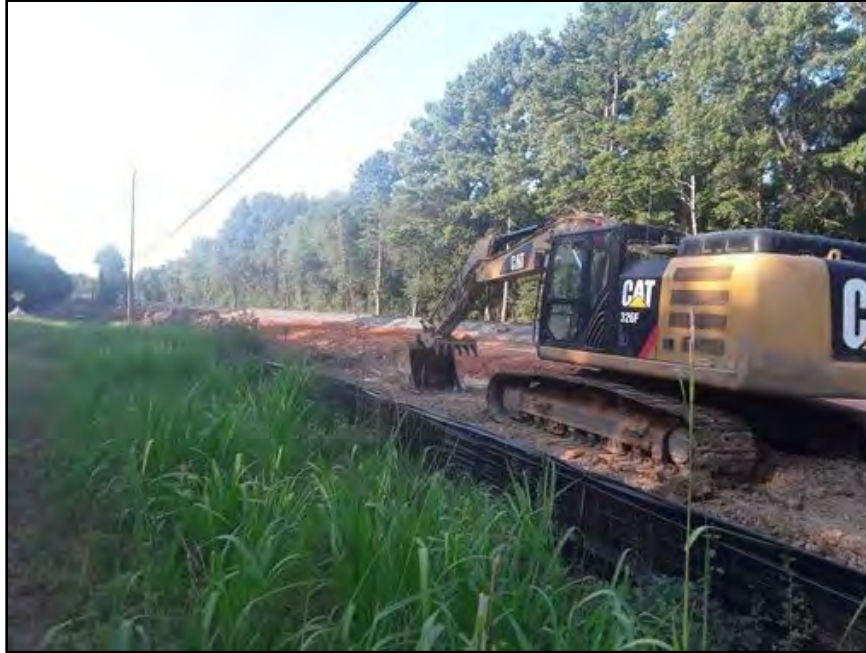
**Figure 9. Continued excavation of borrow pit; view facing southeast. (Photograph by H. Moore July 28, 2023.)**

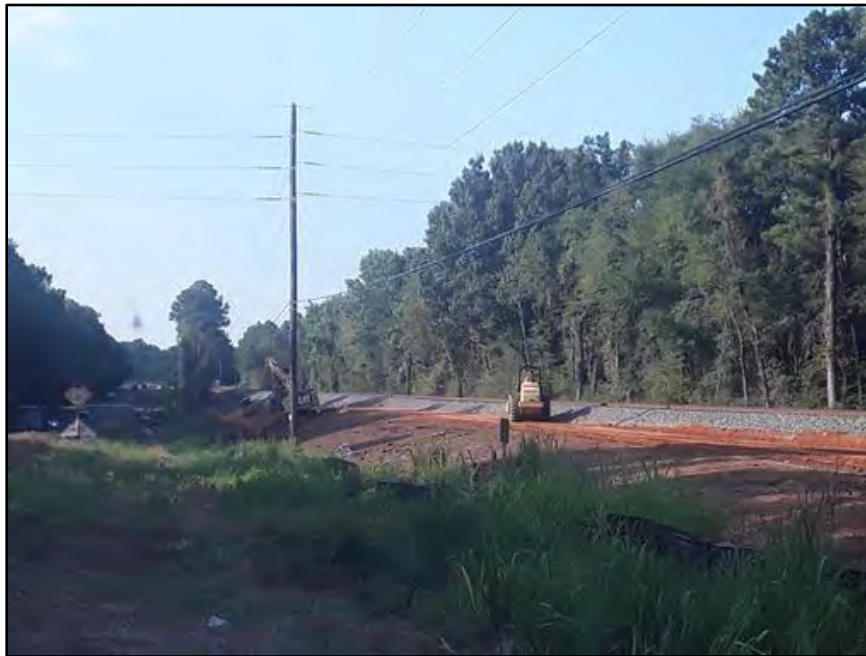
**Figure 10. Continued excavation of borrow pit; view facing southeast. (Photograph by H. Moore August 3, 2023.)**
