Re: Docket No. FD 36500, CPKC Quarterly Environmental Mitigation  
Measures Report for June 15 to September 14, 2024

# CPKC Quarterly Environmental Mitigation Measure Compliance Report Number 6

#### Bellevue, IA – New Siding

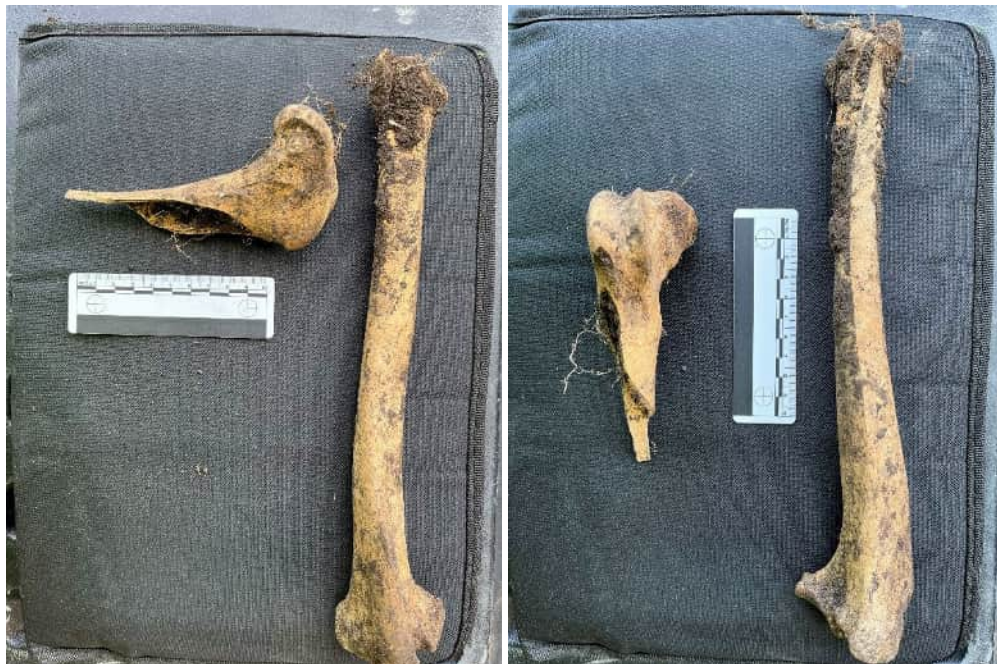
CPKC has an archaeological monitor on site full time during ground disturbing activities. On August 21<sup>st</sup>, the archaeological monitor observed two pieces of bone which were potentially human in origin, based on their size. They immediately halted construction activities in that area and followed the Archaeological Discovery procedures. The monitor contacted the lead archaeologist who quickly consulted with other experts, including HDR's osteologist. By that evening they had concluded the bones were relatively recent, non-human, and most likely from a white-tailed deer.

Once CPKC had confirmed the bones were recent and non-human, it resumed work.

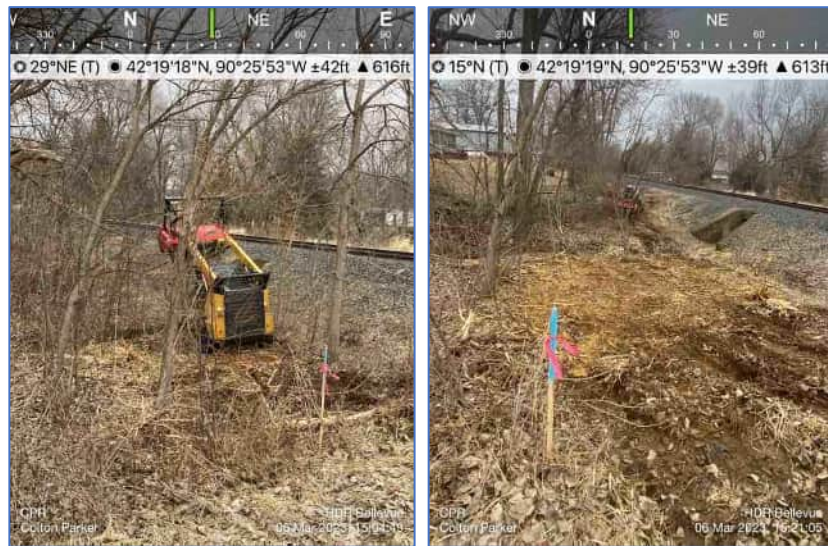
ROW boundary/limits are marked by blue survey stakes with pink ribbon. All wetlands are marked with green lath with yellow ribbon. All work was performed within the ROW limits.

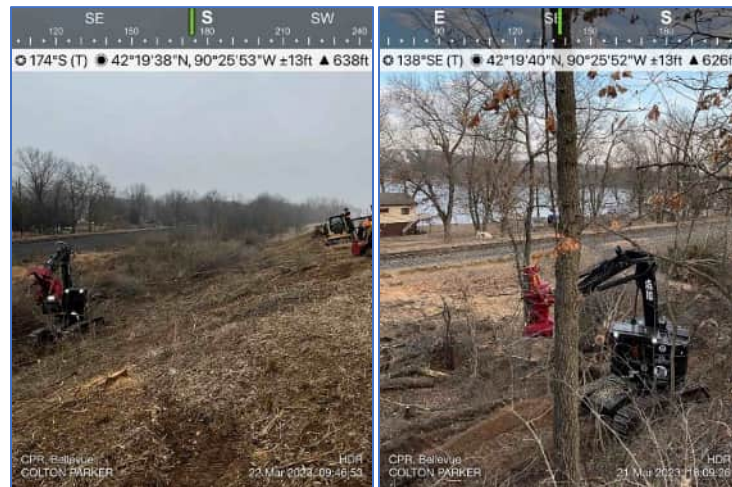
Tree clearing at Bellevue site was completed before April 1, 2023. No active bird nests were observed on site during clearing operations or construction.

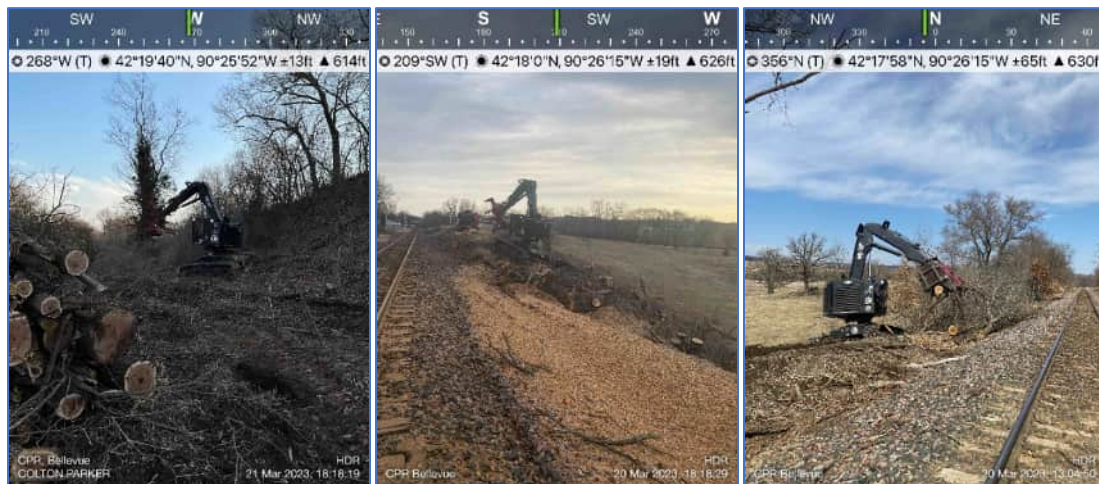
All clearing operations were completed outside of the above-listed dates. Environmental Monitor inspected area for any signs of bats or birds before clearing took place.

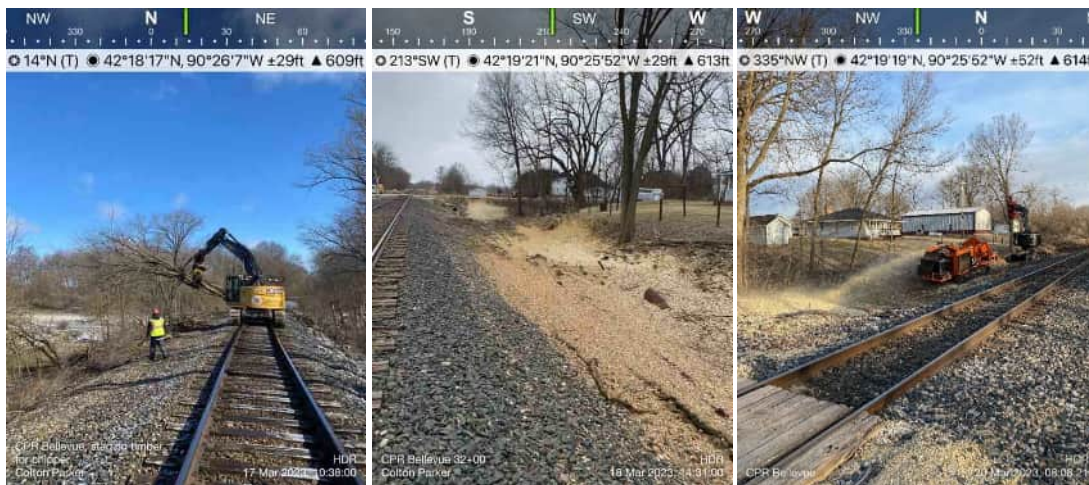
The clearing and construction boundaries were defined through survey stakes. Plan sets were provided to contractors outlining ROW boundaries. All contractors were made aware of any suitable bat habitats on ROW. No sign of bats was observed on site for the duration of the project.

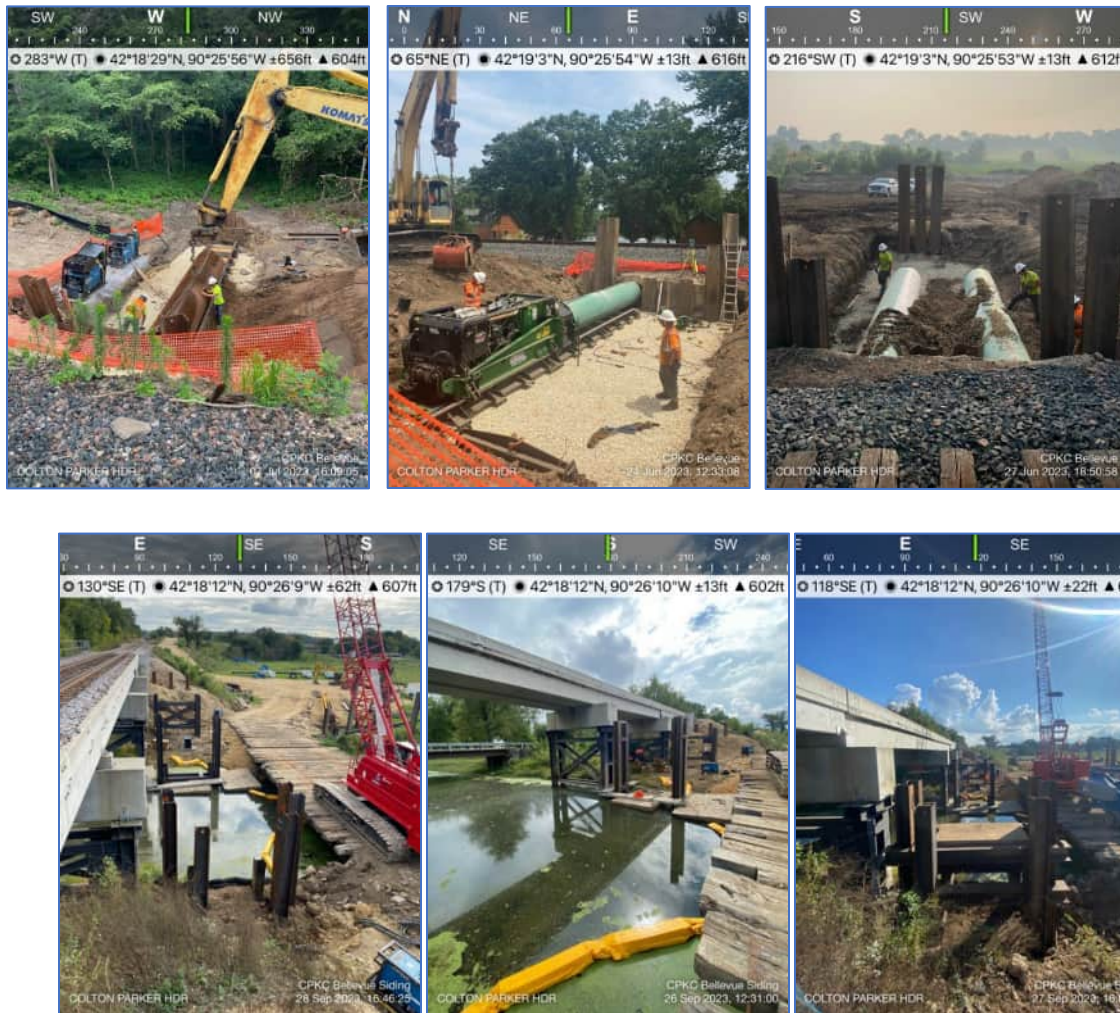
After it was determined that no bats or signs of bats were present in structures or onsite, culverts were worked on/replaced and bridge construction commenced during the bat active season. Continued inspection of bat presence was still conducted during the construction phase.

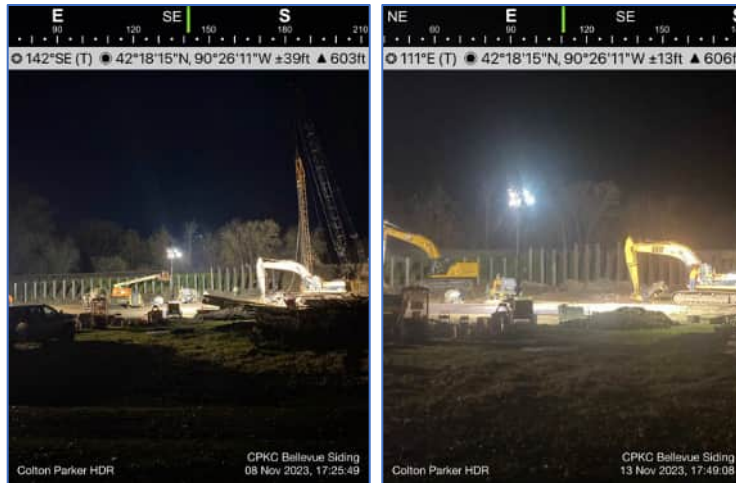
All temporary lighting was directed away from any suitable habitat for the northern long-eared bat and Indiana bat during their active season of April 1 to October 31. Full cut off lens were used and all night work was performed outside of the roosting season.

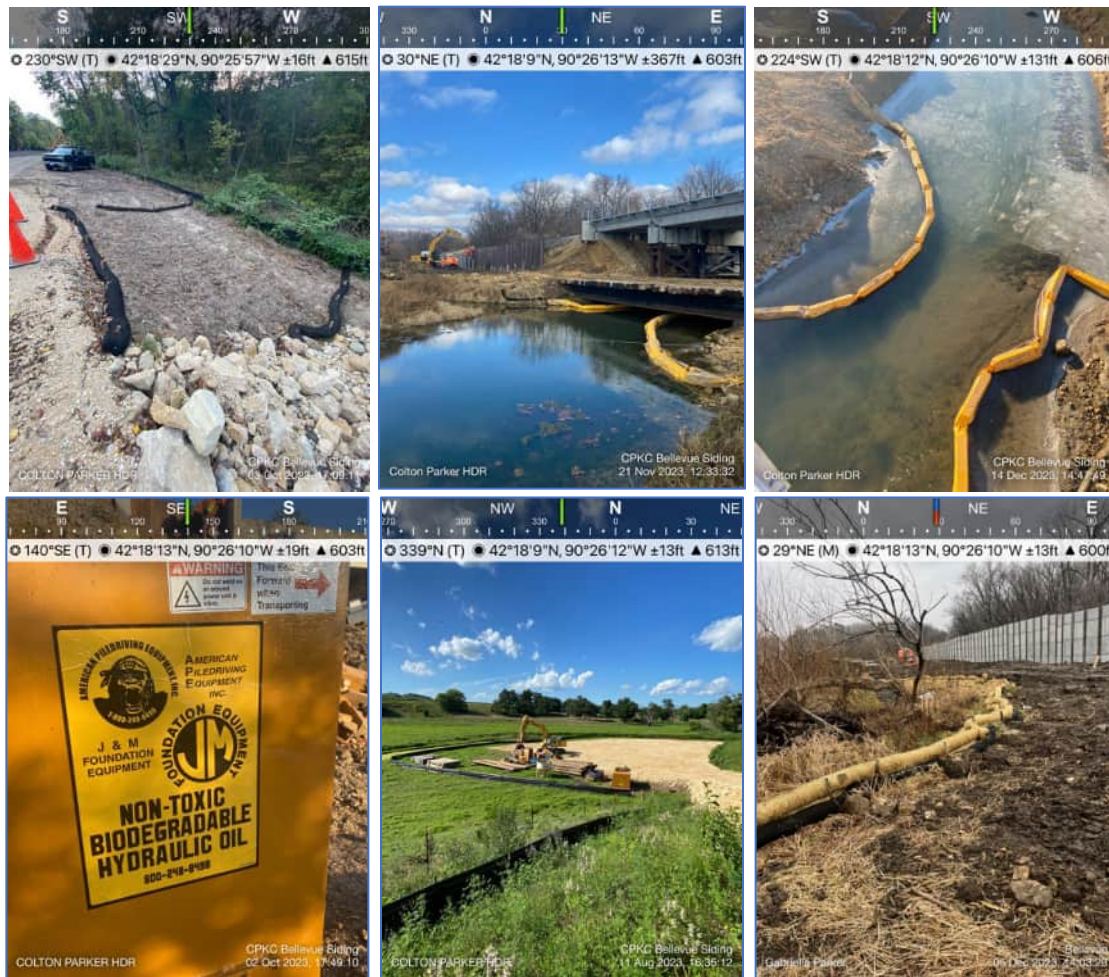
The contractor followed all water quality control conditions identified in all permits including the Water Quality Certification. A site-specific Stormwater Pollution Prevention Plan SWPPP was provided to all contractors onsite. Following the plan, Environmental Monitors and contractors worked together on the installation/maintenance of erosion control devices and best management practices minimizing the potential for erosion and sediment effecting the waterways. Routine SWPPP/rain event inspections were conducted appropriately until SWPPP close out.

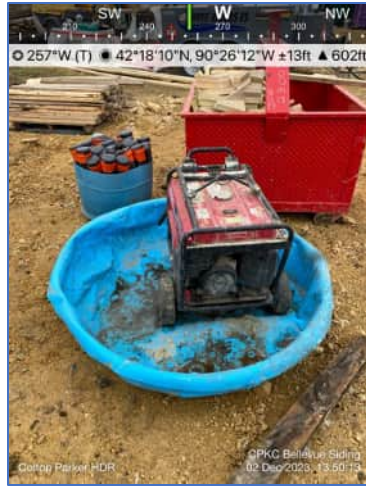
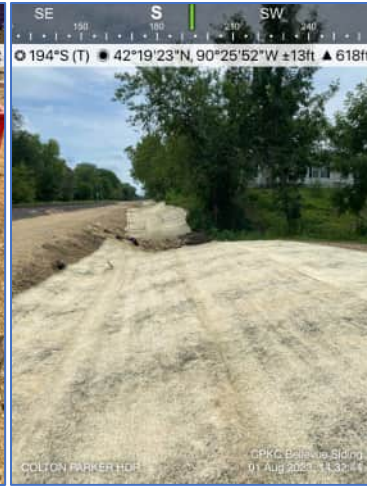
The contractor complied with the approved site-specific SWPPP plan. Following the plan, Environmental Monitors and contractors worked together on the installation of erosion control devices and best management practices near and around waterways including Spruce Creek, wetlands and culverts to reduce the amount of sediment and pollutants entering surface waters and ground waters. Implemented examples include silt curtains, erosion control blanket, silt fence, biologs/CFS, rip rap, secondary containment, filter bags and concrete washout areas.

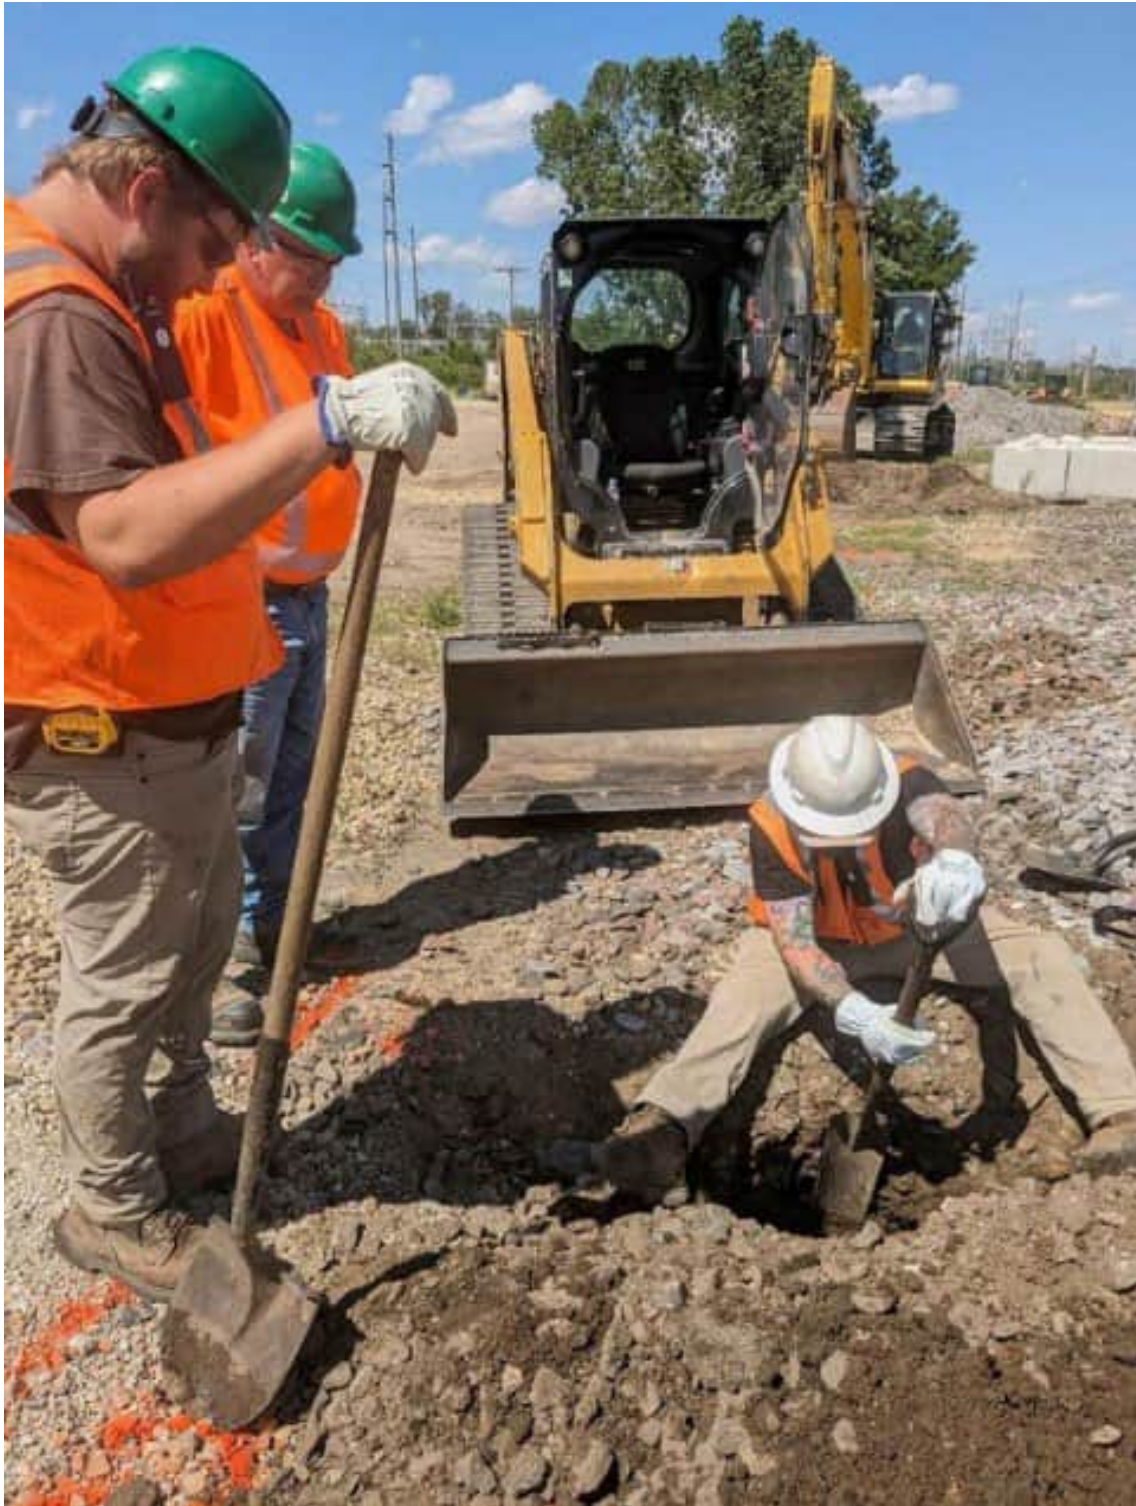
**Photo Date:** May 22, 2024

**Description of photo:** Pot-holing to locate electric lines.

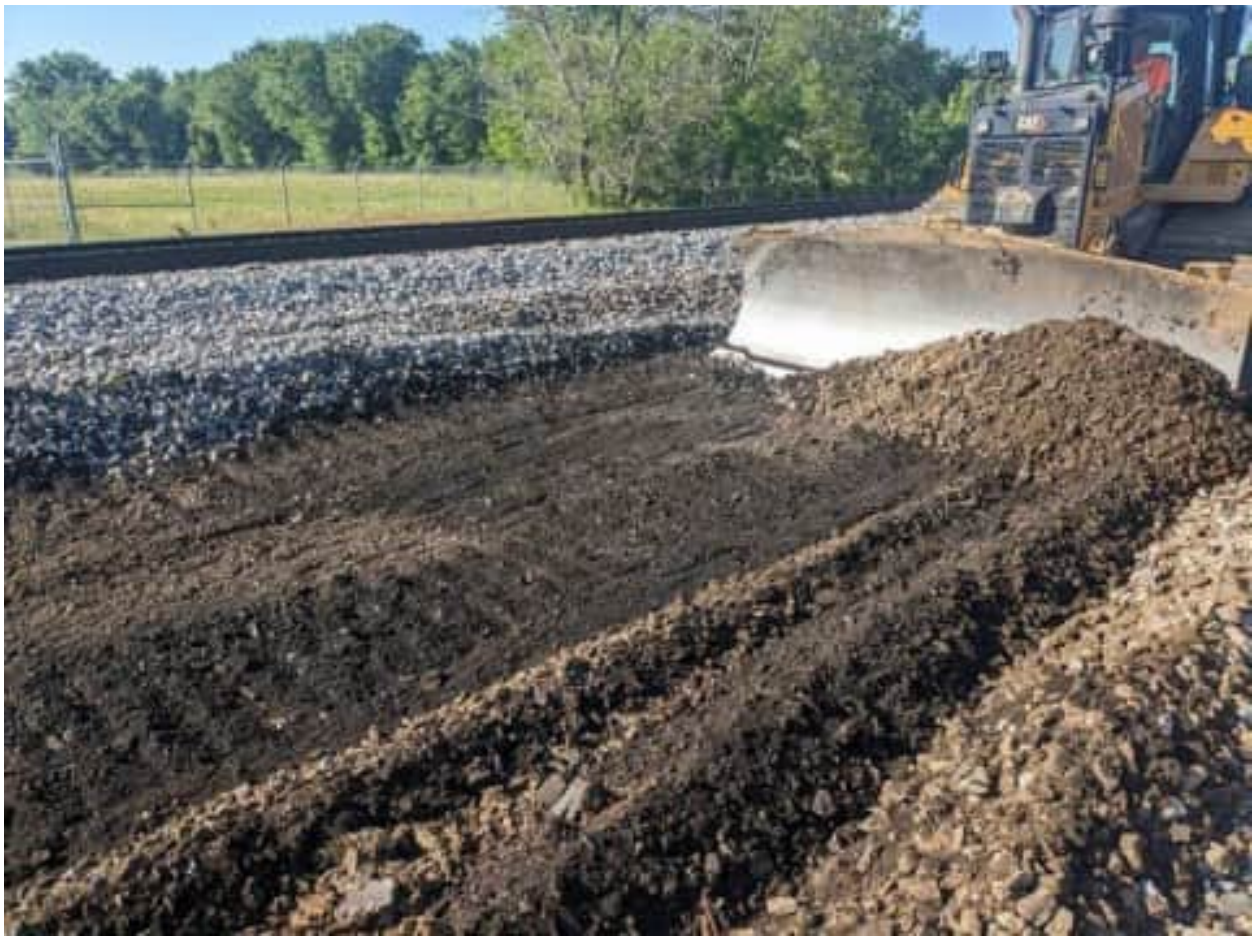
**Photo Date:** May 23, 2024

**Description of photo:** Blading ballast to desired grade.

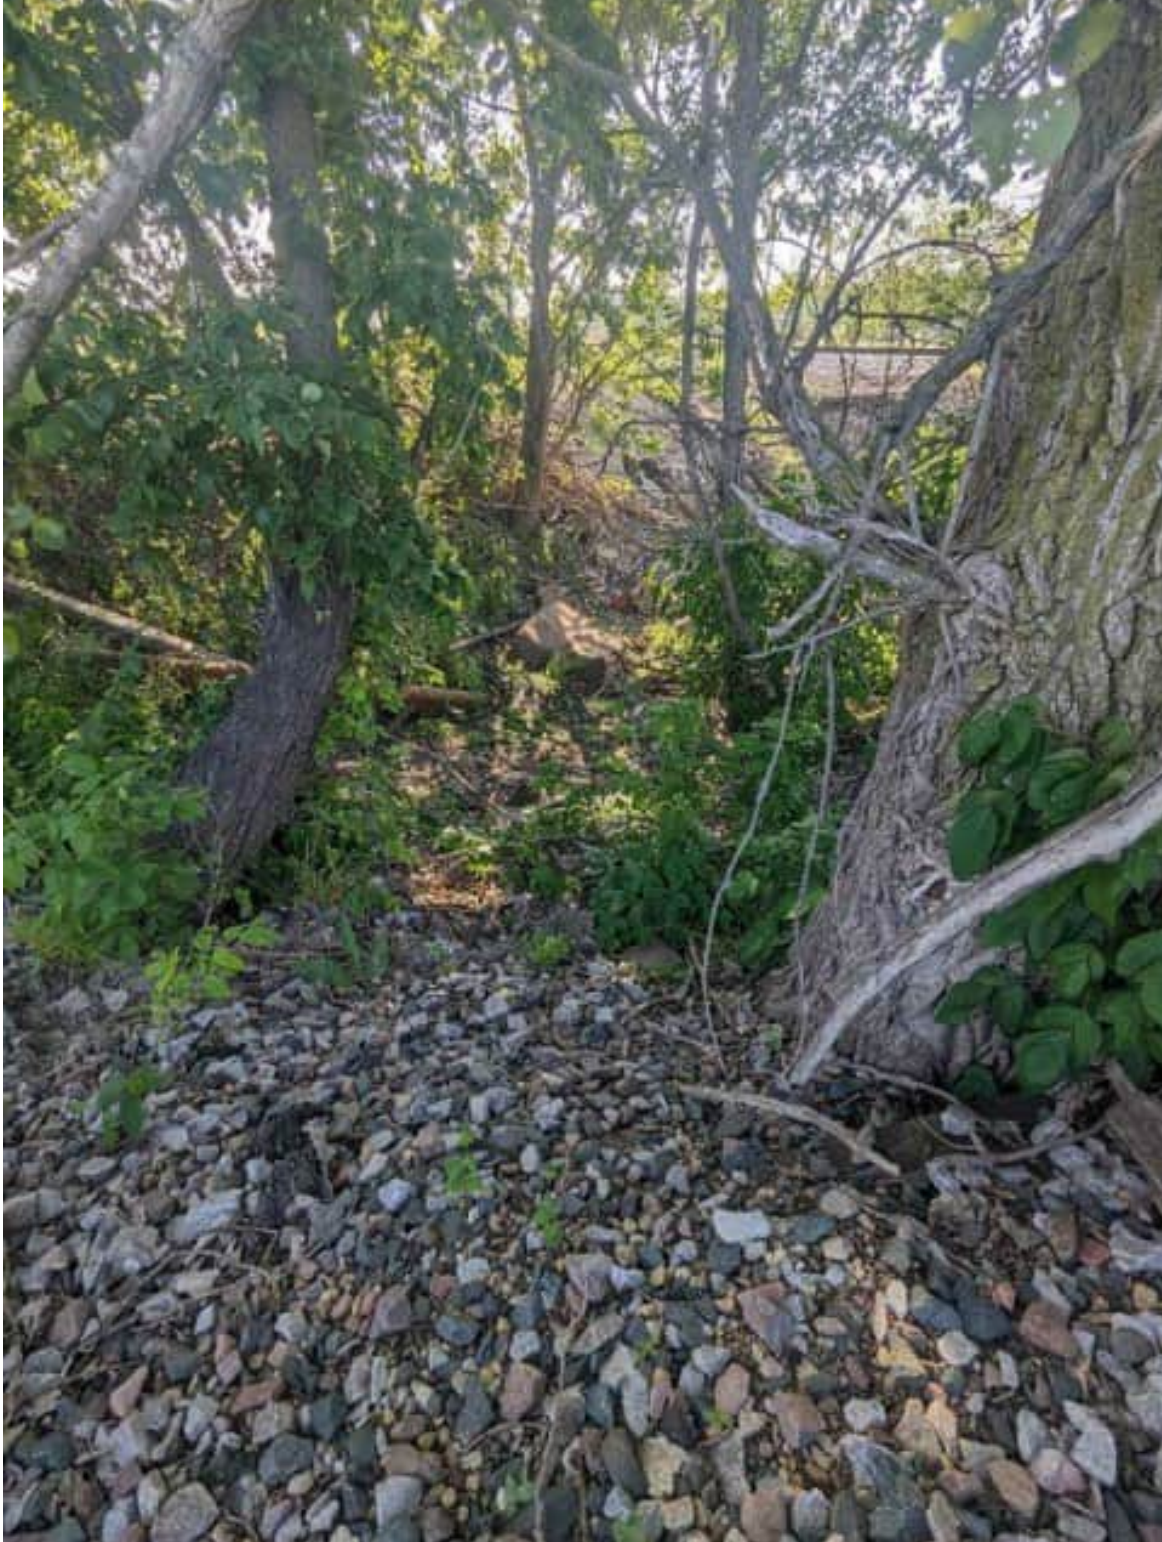
**Photo Date:** May 23, 2024

**Description of photo:** Tree base crowns 3-6 ft below ballast/site grade.

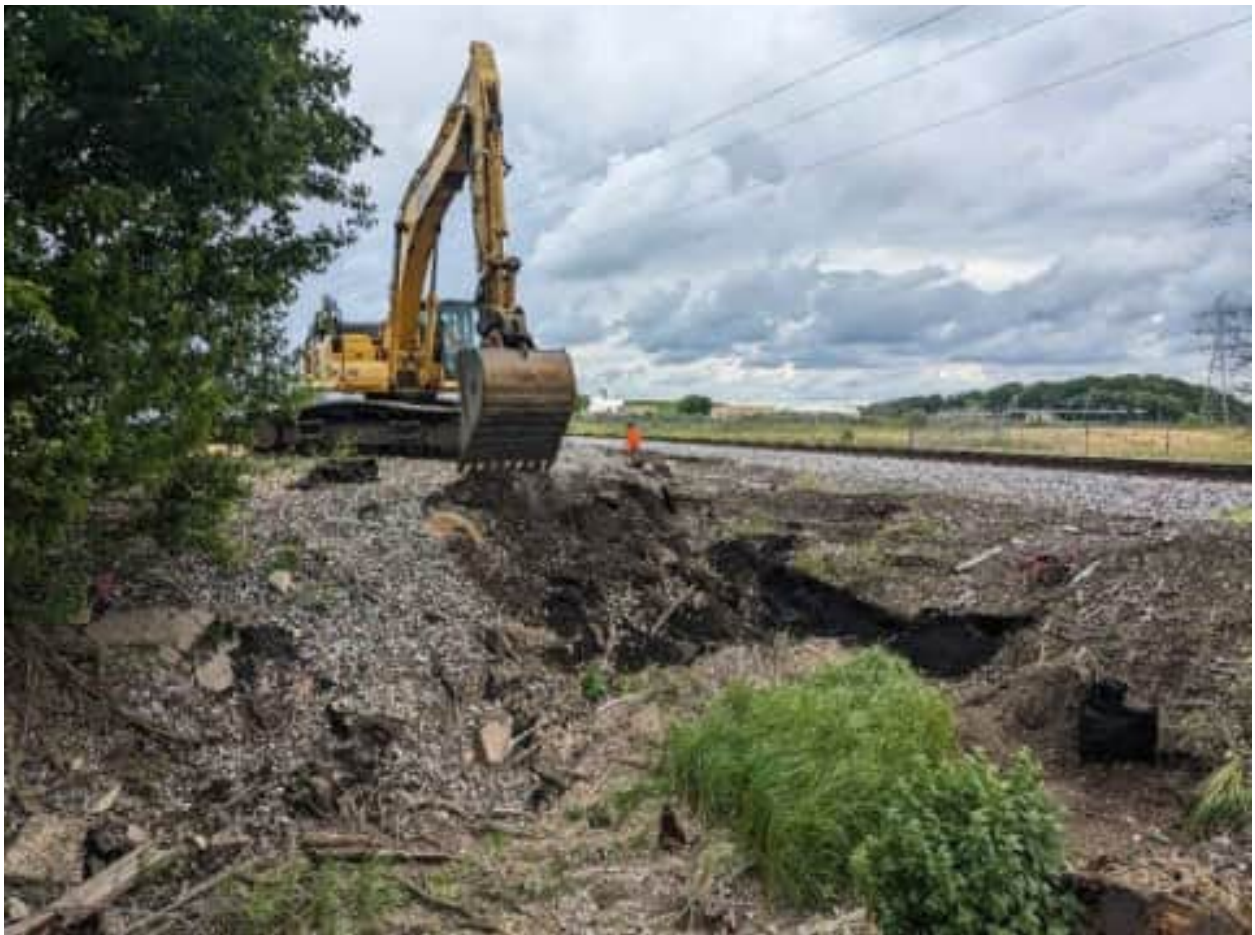
**Photo Date:** May 28, 2024

**Description of photo:** Commencing excavation/preparation of culvert bore pit.

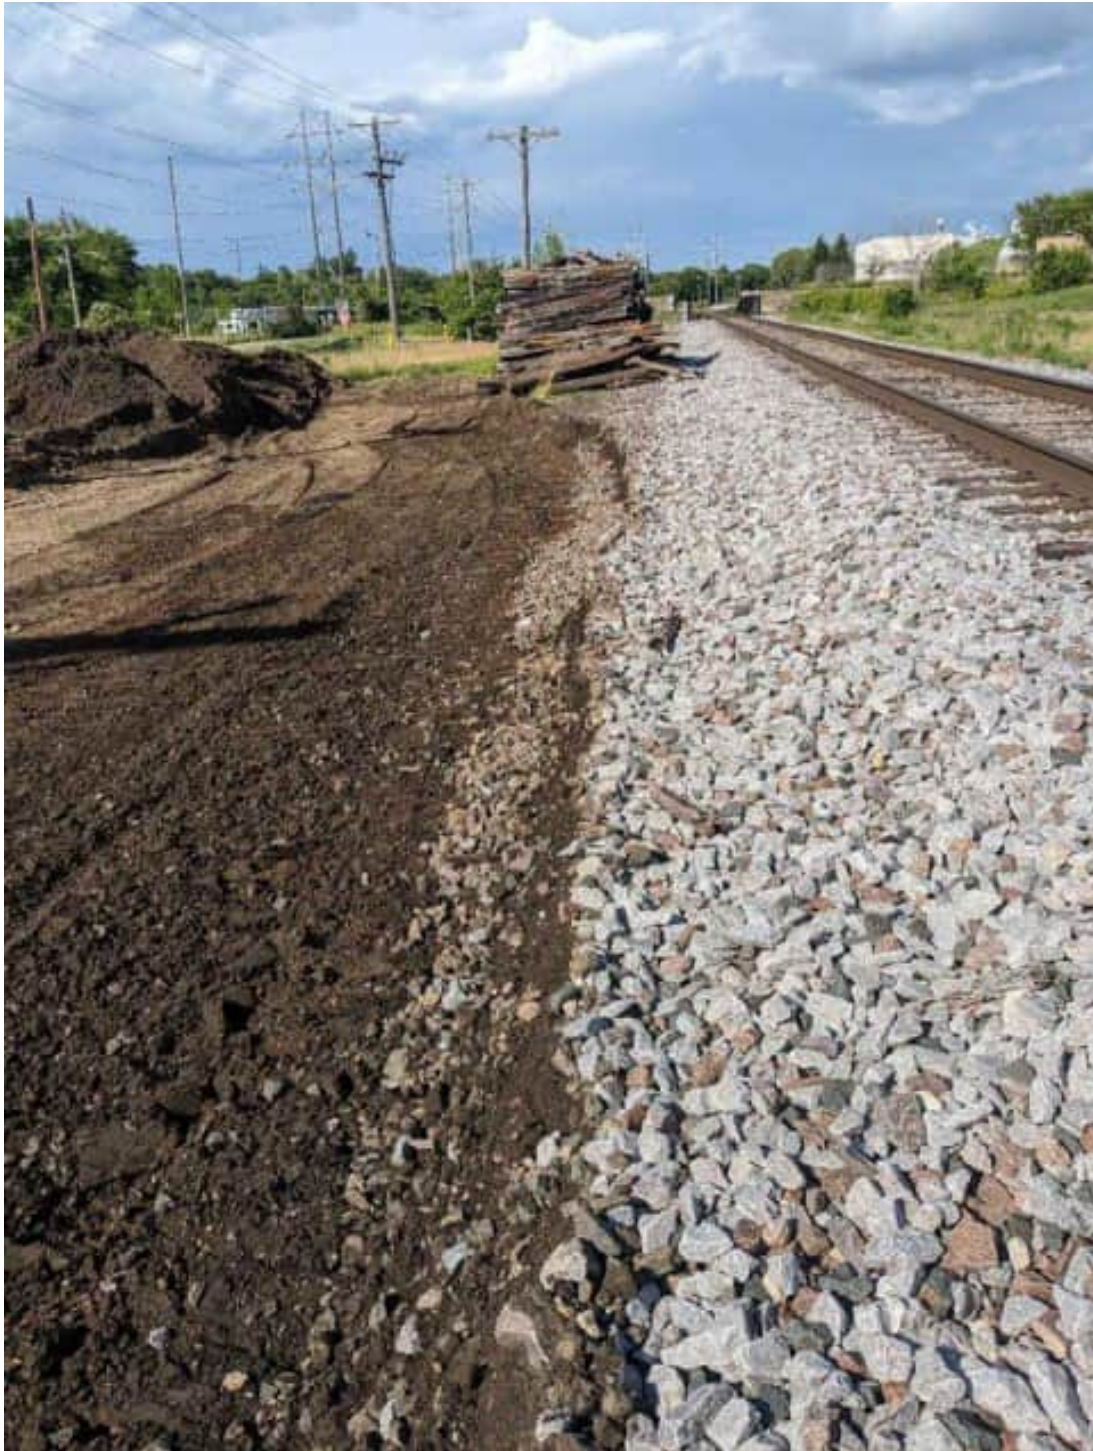
**Description of photo:** Disturbed clay deposits below ballast fill 4-5 ft. below grade in bore pit.

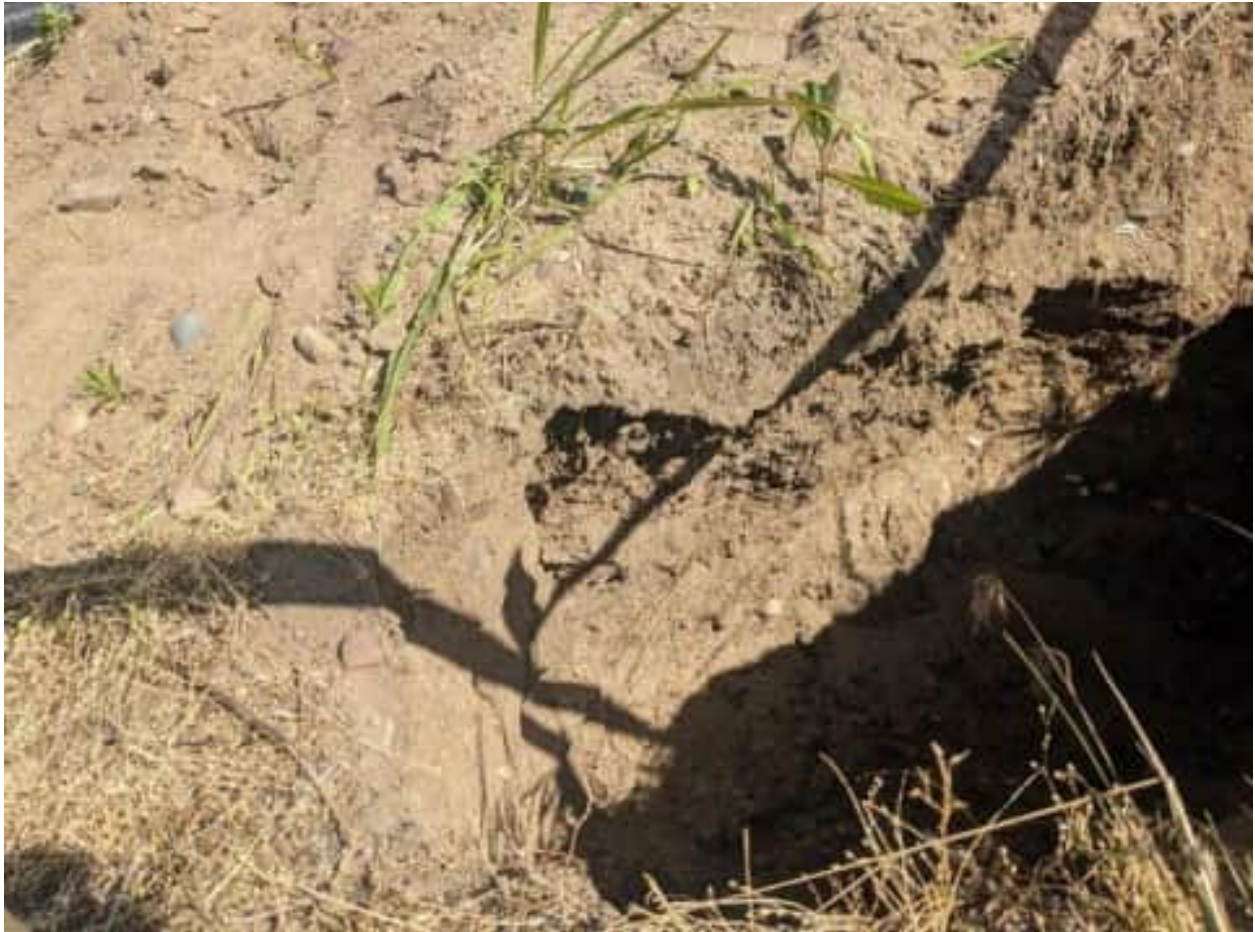
**Description of photo:** Grading north section south of bridge.

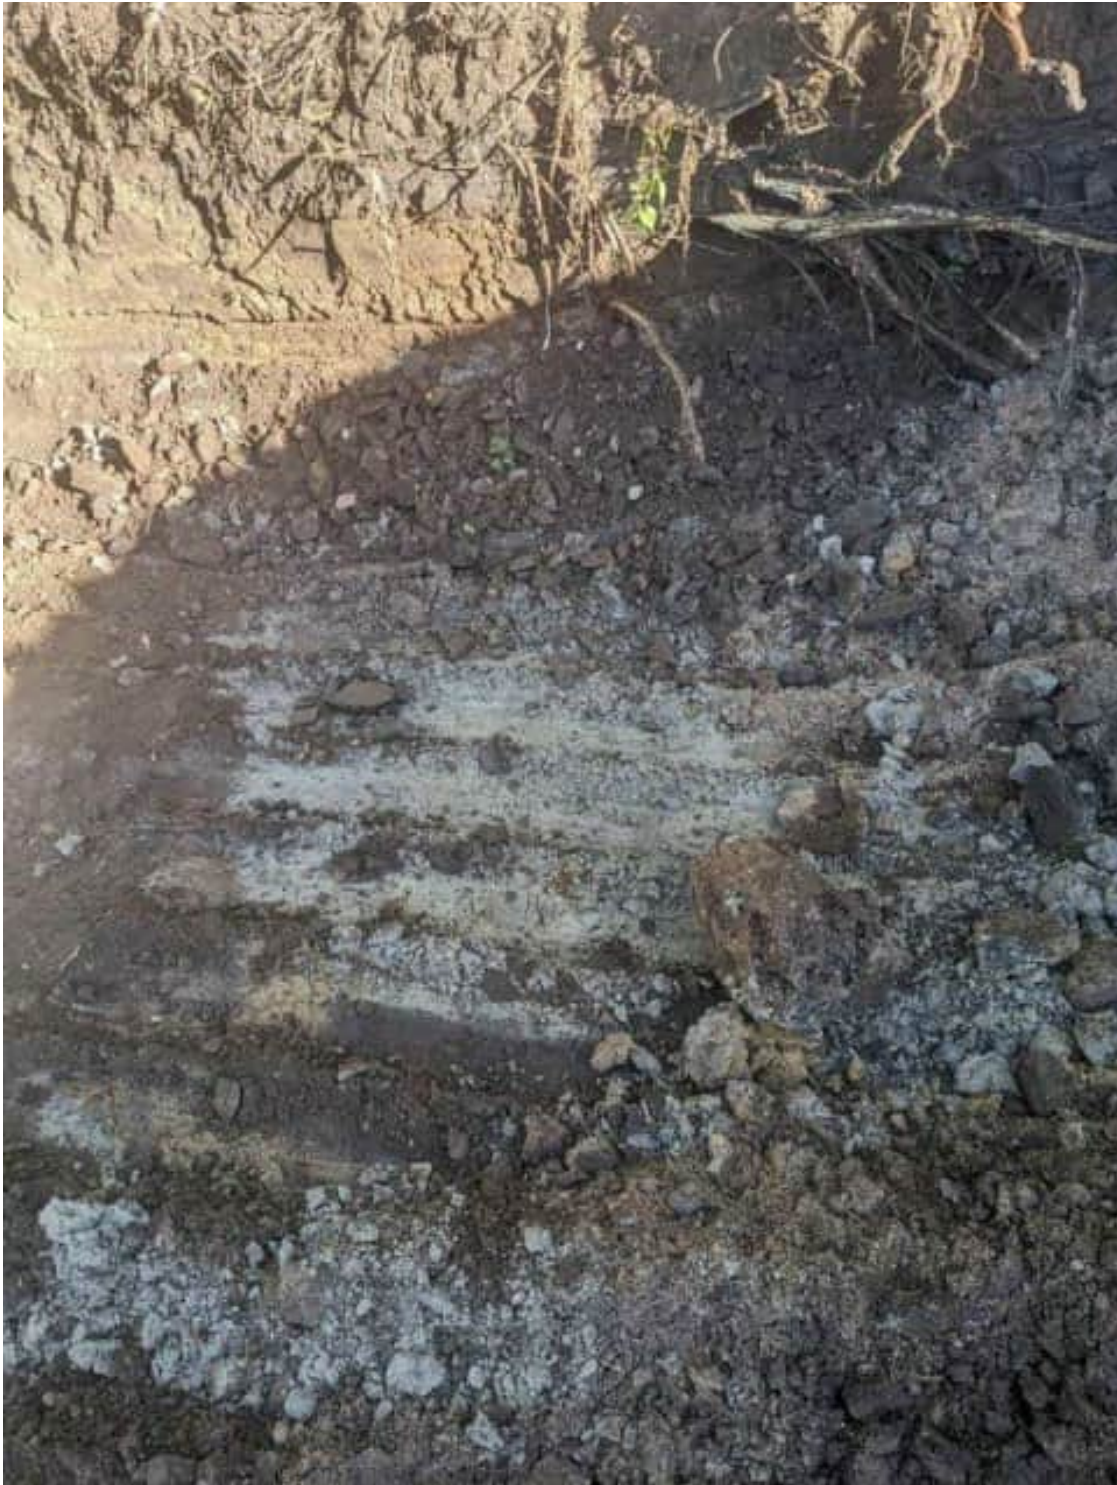
**Description of photo:** Pothole profile showing alluvial sand/gravel below disturbed topsoil.

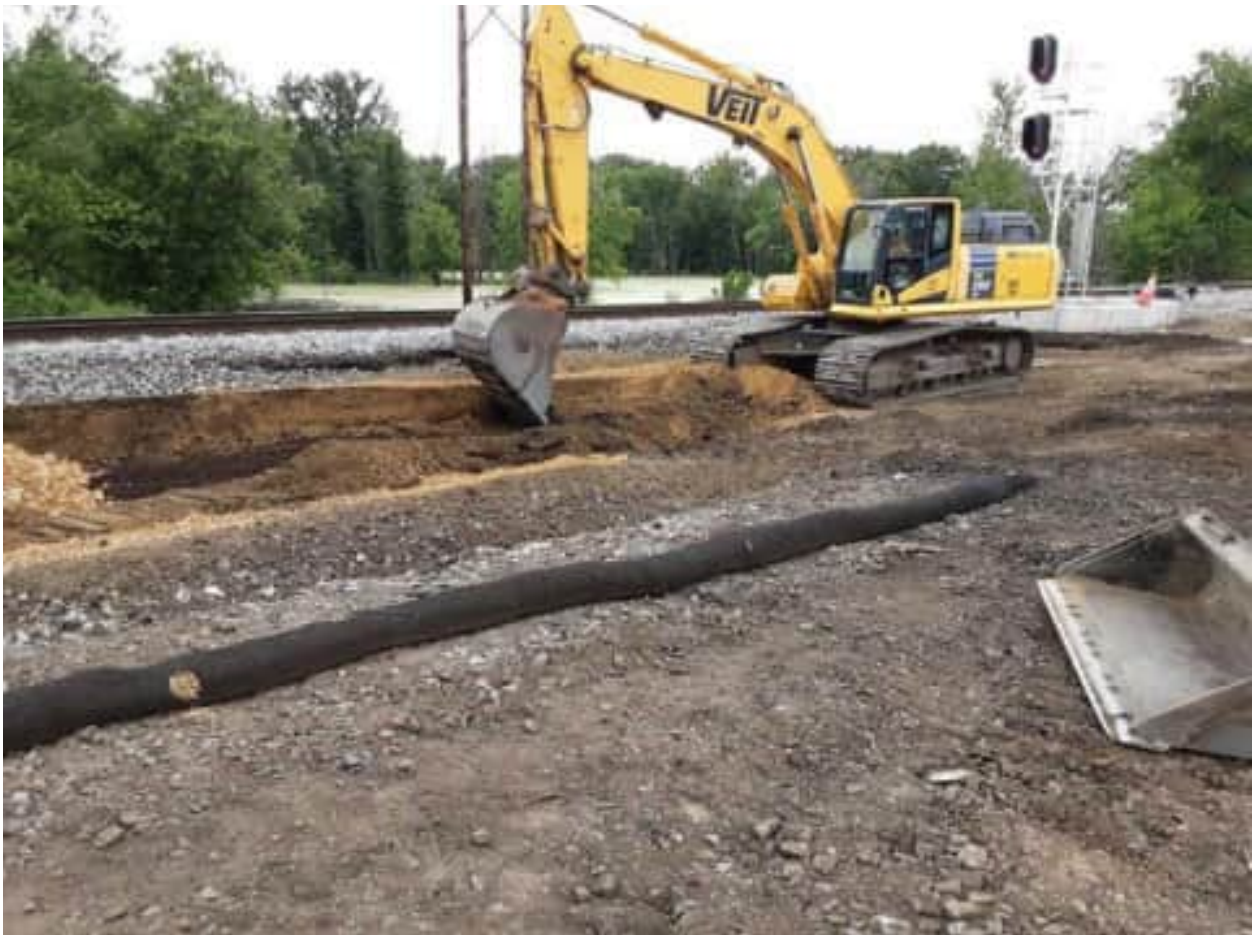
**Description of photo:** Excavation of rip-rap basin east side of drainage culvert showing deep alluvial sand deposits.

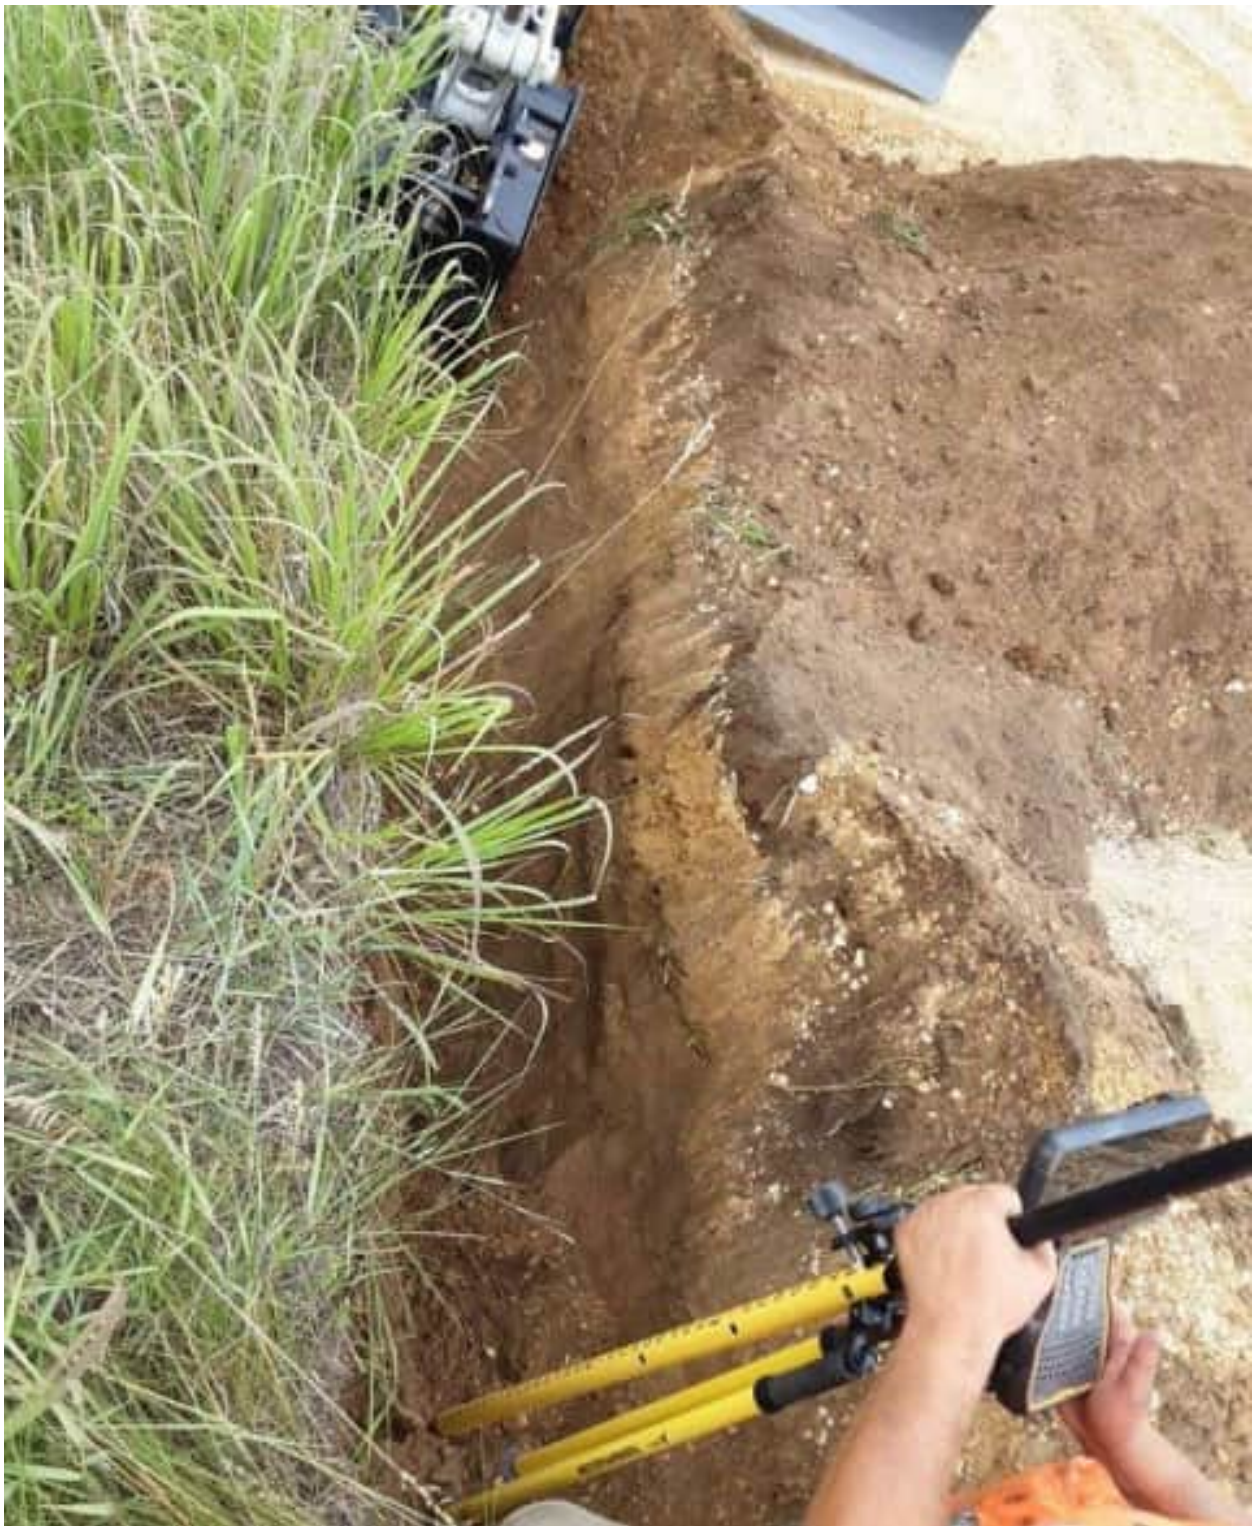
**Description of photo:** Remove & replace soft bed material to 1 ft depth. No cultural material noted.

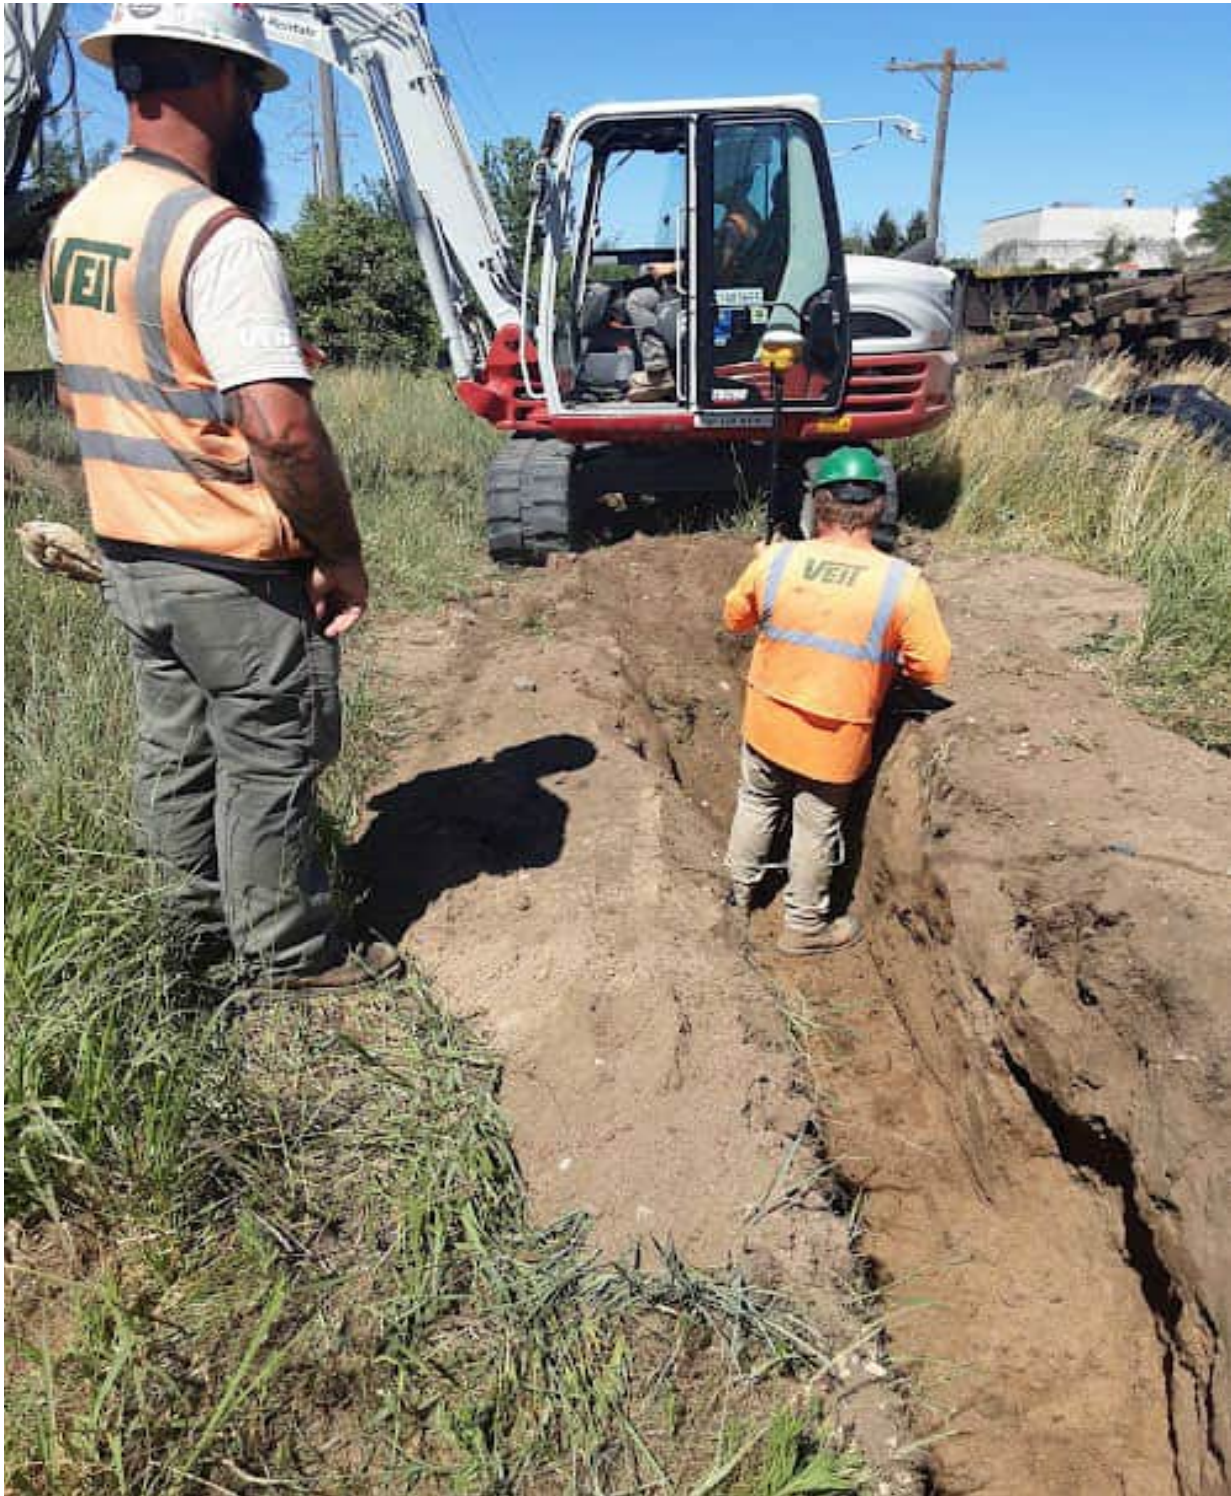
**Description of photo:** Trench in sub-ballast and clay sediments. No cultural material noted.

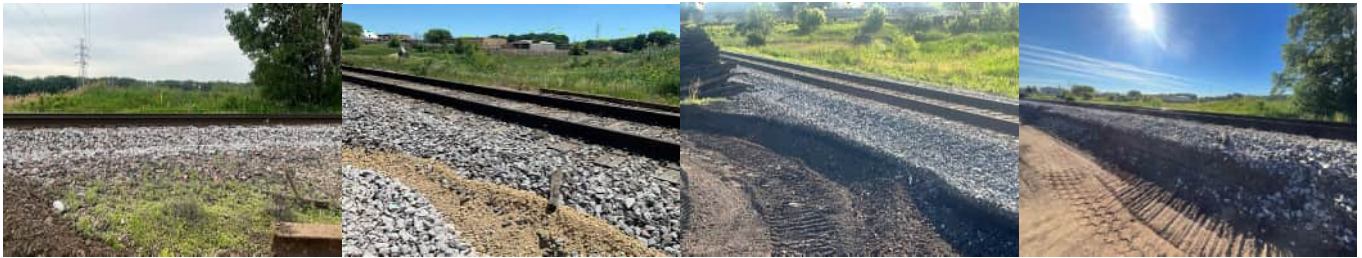
Right of Way (ROW) boundaries were marked with blue lath and wetlands were marked with green paint with yellow ribbon to indicate work limits. All workers on site were made aware that they were to keep work within the ROW. Work on the project was successfully kept within the ROW with minimal disturbance to wetland areas. The photos below show these color-coded boundaries.

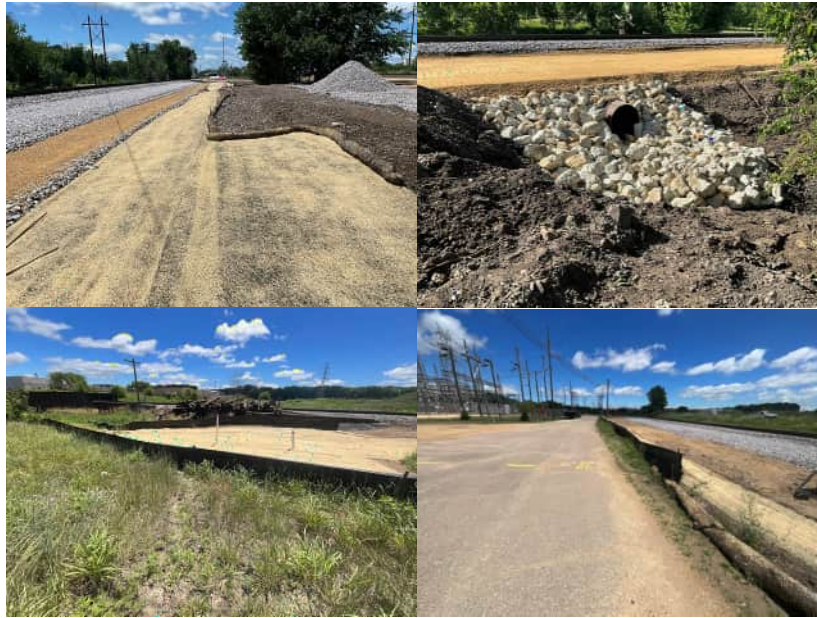
The project was able to ensure that all stabilization measures needed throughout the project were utilized within the 14-day window. This included the reutilization of topsoil material. At the end of the project, the EM returned to the site to ensure that revegetation had been maintained and was successful in its attempts to restabilize the land post-construction.

The photos below show some of the areas where revegetation measures were implemented along the construction site.
