Re: Docket No. FD 36500, CPKC Quarterly Environmental Mitigation  
Measures Report for June 15 to September 14, 2024

# CPKC Quarterly Environmental Mitigation Measure Compliance Report Number 6

#### Bellevue, IA – New Siding

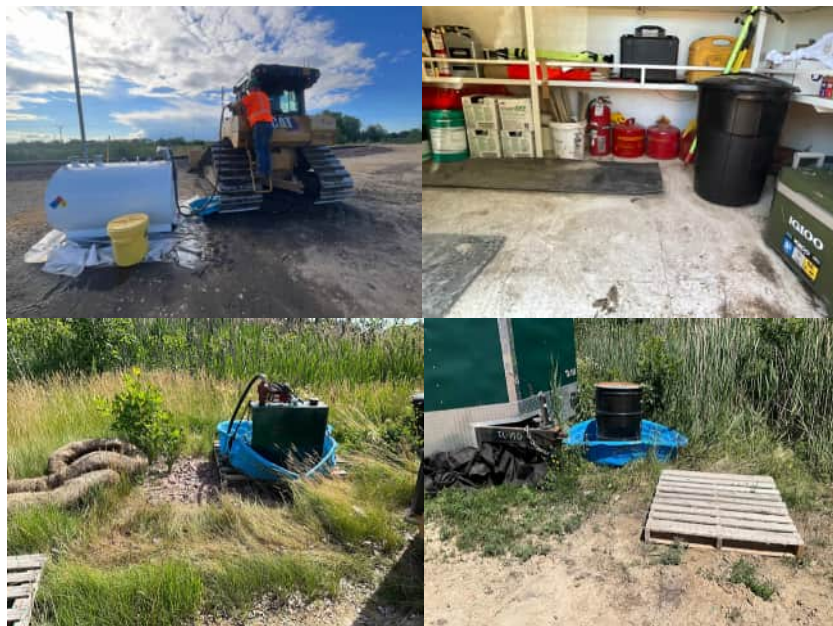
Petroleum products used during the Camanche capital improvement project were all handled properly with either a secondary containment method or storage within an enclosed job trailer. Each piece of equipment used on the project was also equipped with its own spill kit to manage containment immediately in case of a spill.

The photos below show these containment measures.

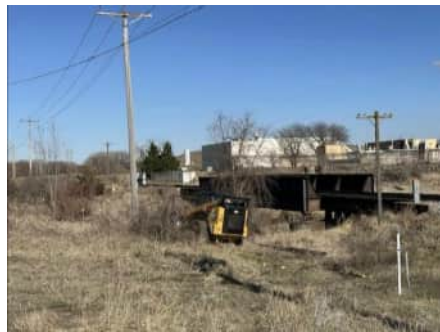
After tree clearing was complete, areas where trees had been cleared were marked with flagged survey limits so contractors could easily identify any area within ROW and near bridges where bat species could potentially be present. No bat habitat or nesting was identified throughout the Camanche capital improvement project. The photo below shows one of the areas that was inspected for bats.

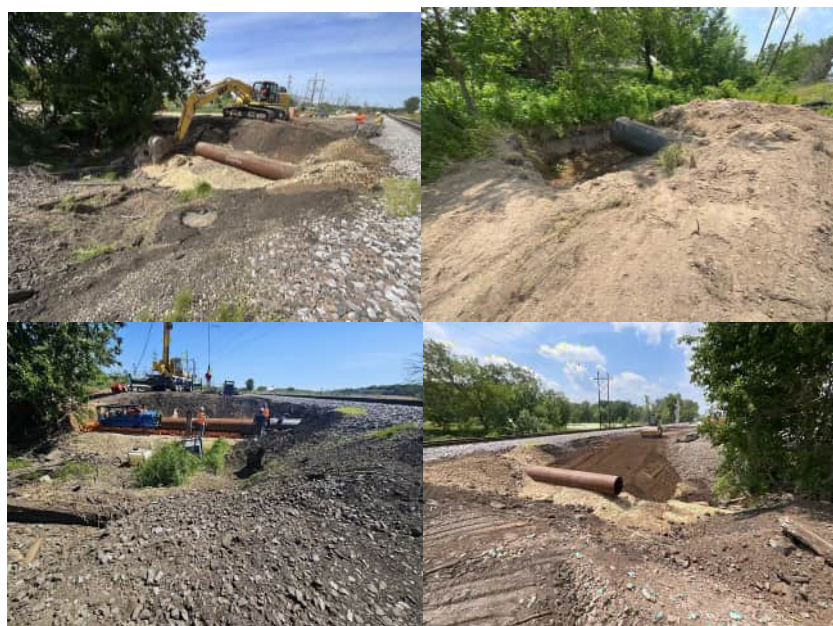
After an inspection determined that no bat species were present, the culvert installation at MP 160.24 was completed on 5/30/2024, during bat roosting period. Daily monitoring of bat species was completed by the EM, followed by a complete inspection by Gabriella Parker, biologist for HDR. No bat species was present before or during the installation process.

Photos below show the above culvert installation performed on 5/30/2024, demonstrating that no bats were present.

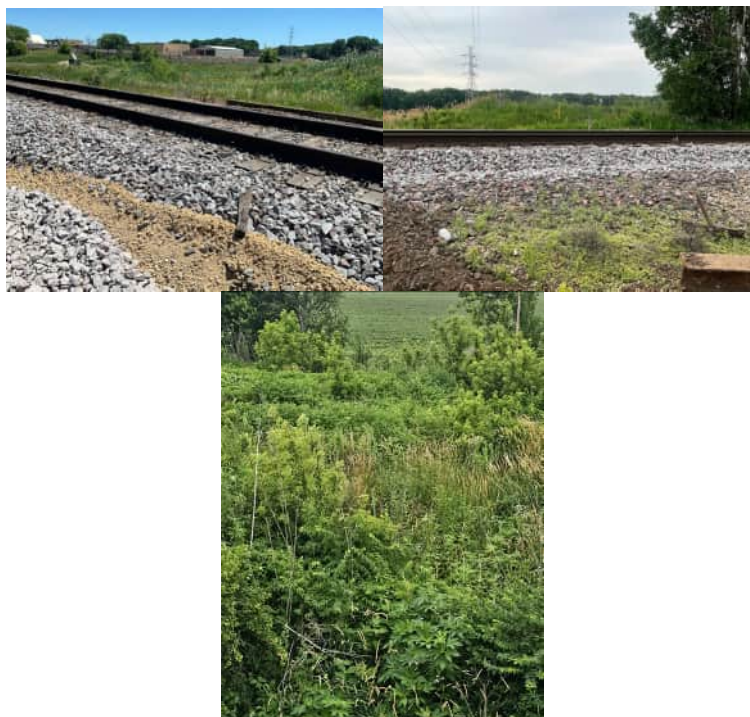
Wetlands were outlined in green lath to indicate sensitive habitats within the ROW. Blue lath was used to identify project ROW boundaries. Construction staging occurred within the ROW but outside of areas identified as sensitive habitats. No barricades or fencing was used.

Photos below show green and blue lath in various locations along the project.

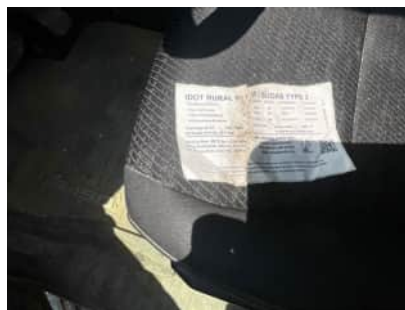
Seed mixes used within the Camanche capital improvement project for the minimization of the introduction and spread of noxious weeds were verified by the EM prior to use. The seed tag shown in the photo below as provided by the seeing contractor specifies No Noxious Weeds found and the IDOT Seeding type Requirements in Section 2.02 of the Iowa Standard Specifications for Highway Construction. No herbicide spray methods were used on the project.

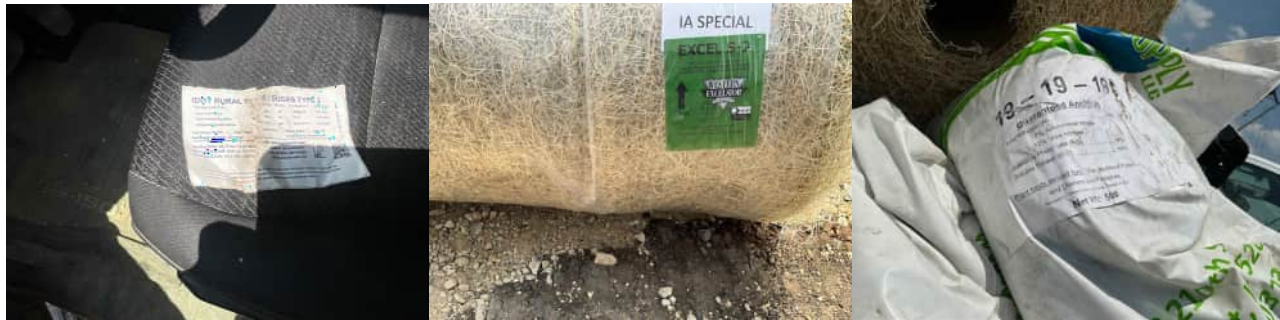
Seed mixes used for revegetative efforts on the Camanche capital improvement project were verified according to seed tags and the IDOT Seeding Type Requirements in Section 2.02 of Iowa Standard Specifications for Highway Construction.

See below photos for various seed mix types used on the project for revegetation.

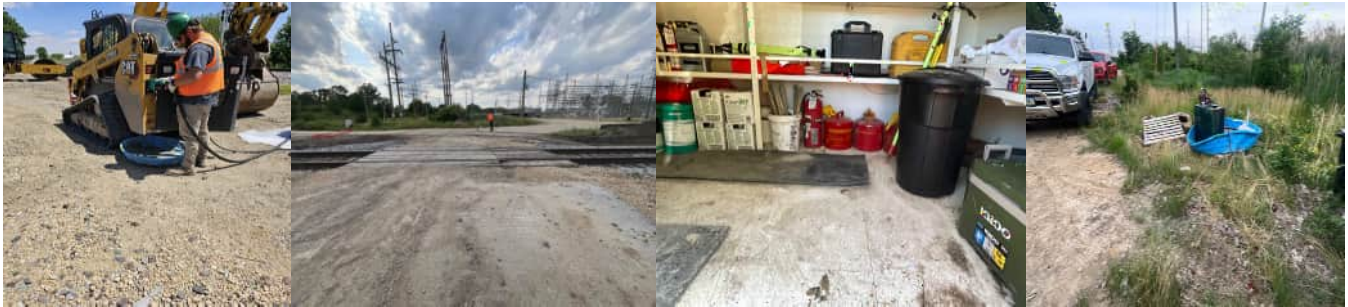
The contractor followed Best Management Practices by utilizing secondary containment while refueling, designated equipment cleaning areas, utilizing spill prevention measures, minimizing sediment on public roadways and utilizing good waste management practices.

Weekly and post rain event SWPPP inspections were completed throughout the construction phase of the project and continued through 70% post-construction revegetation.

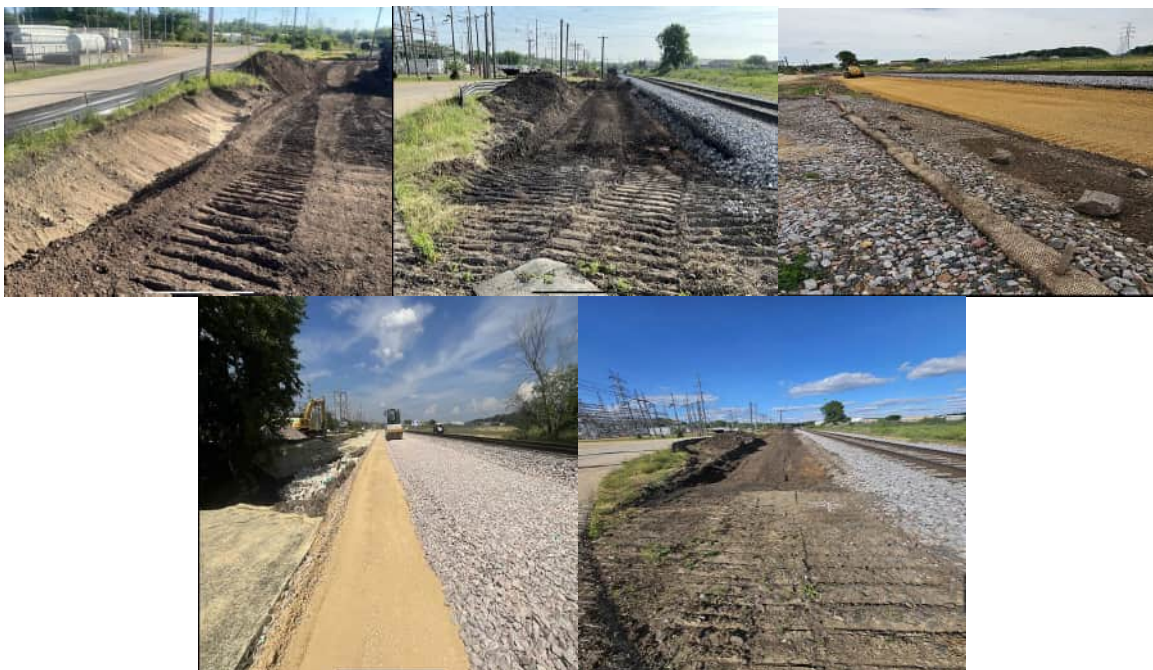
Suitable fill materials used within the Camanche capital improvement project consisted of primary reused Native soils, Clean Fill and ballast material previously approved by project engineers and contractors and from state licensed local sources.
