# Phase I Historic Resources Survey for the Green Eagle Railroad Project

## Maverick County, Texas

## Technical Report of Findings

December 2024

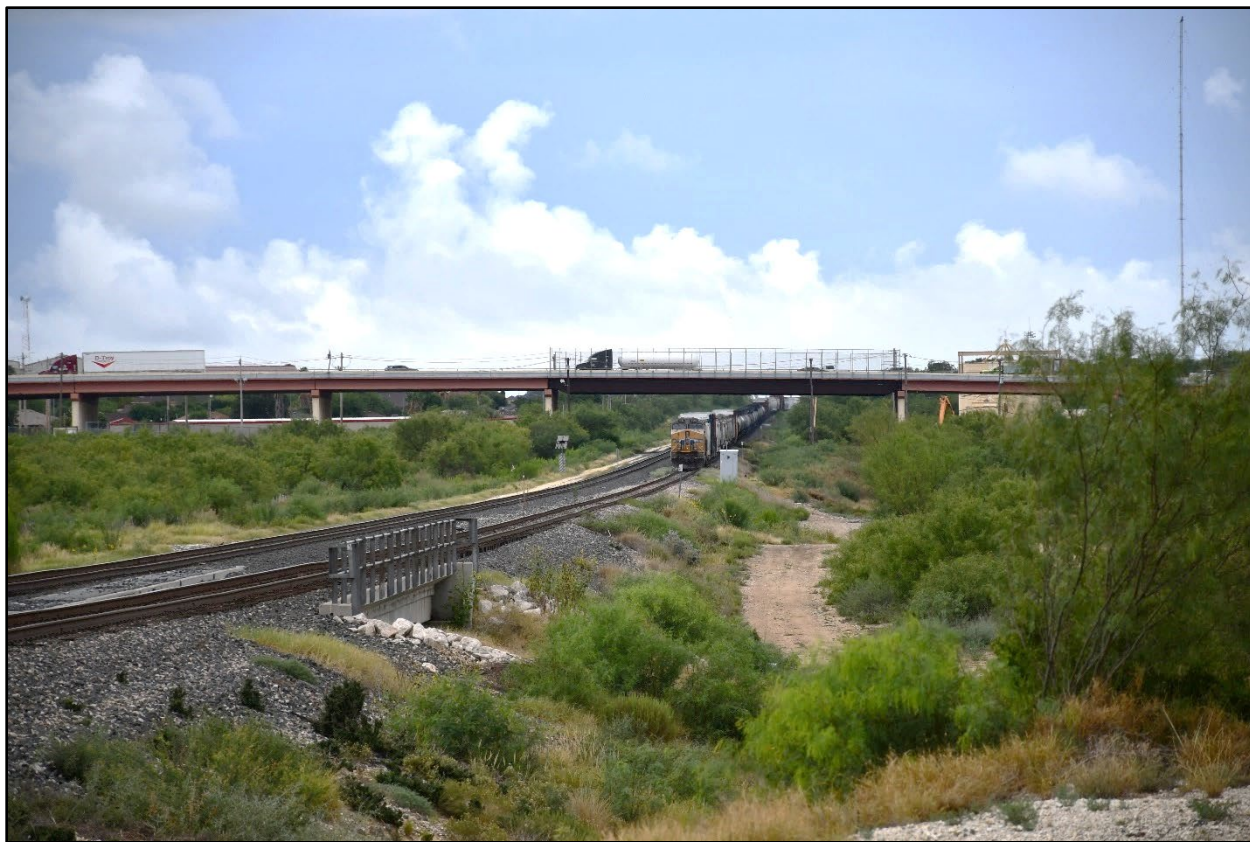
**Figure 3. View of SM-01, Facing South into the Project Area, towards Seco Creek, from Dr. Gates Drive.**

SM-01 is a segment of the current Union Pacific Railroad that was constructed beginning in 1882 as the branch of the Galveston, Harrisburg and San Antonio (GHSA) railway, the first railroad to reach Eagle Pass, from Spofford, Texas. The section is still used for rail traffic with some resulting upgrades (Figure 3). According to aerial imagery, a second, non-historic track was laid on the east side of the historic track, within the APE, between 2012 (Google Earth 2012) and 2013 (Google Earth 2013). This expansion between 2012 and 2013 resulted in the replacement of the historic single track bridge crossing Seco Creek with a non-historic double track bridge, and the replacement of the at-grade crossing of Dr. Gates Drive with non-historic concrete infill (Google Earth 2012, Google Earth 2013).

SM-01 is associated with the transportation history of Eagle Pass, Texas. However, numerous non-historic alterations to the track and its setting, both within and outside of the APE, have resulted in a loss of historic integrity. Within the APE, the line was widened to a double track between 2012 and 2013, necessitating the replacement of the historic bridge over Seco Creek with a non-historic double track bridge (Figure 3), and the replacement of the at-grade crossing at Dr. Gates Drive with a non-historic concrete infill crossing- these alterations have resulted in the loss of material and design integrity.

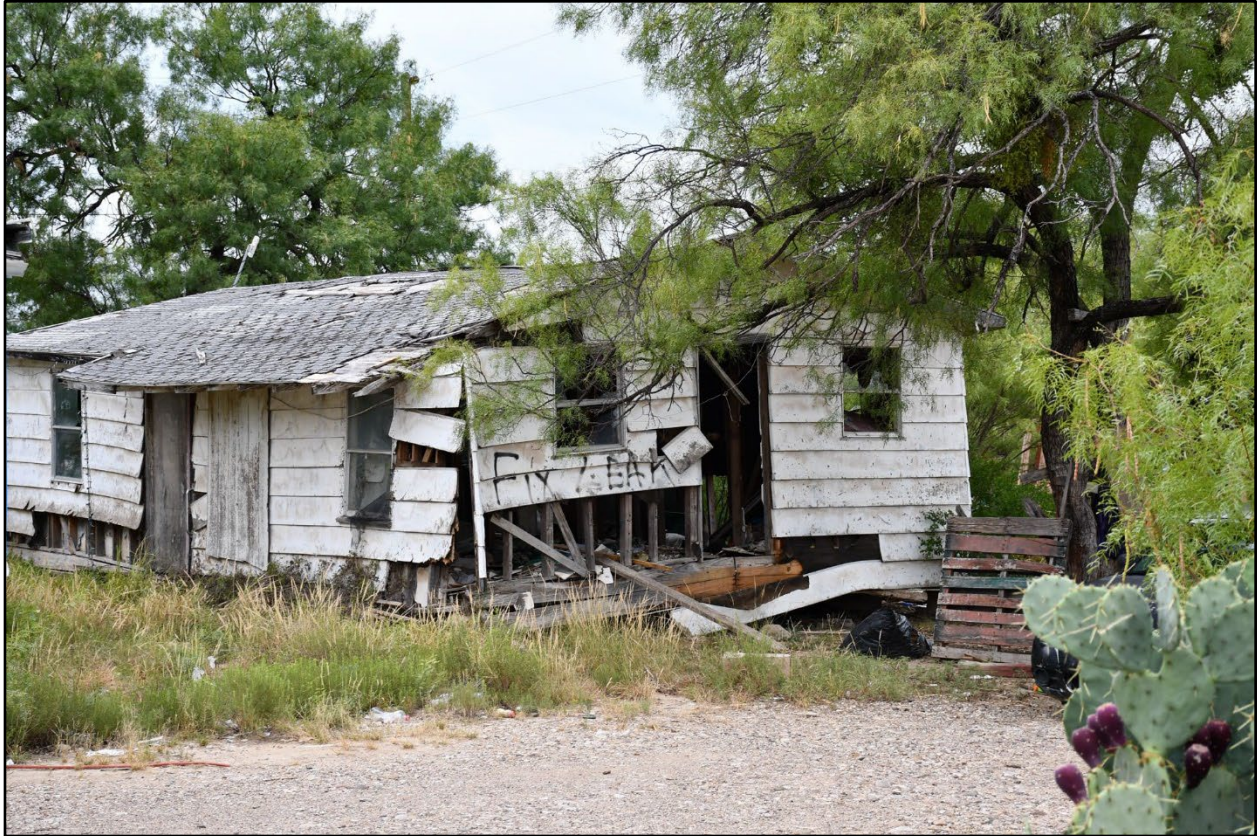
**Figure 4. Oblique view of SM-02, Facing southeast towards west (side) and north (front) elevations from Dr. Gates Drive.**

SM-02 is a side-gabled structure is partially clad in wood clapboard siding, which is missing in some areas exposing the studs (Figure 4). Additionally, the joists or foundation appear to have collapsed as the building has a significant slant. It is fenestrated with 1/1 wood sash windows, is missing its doors, and has the remnants of an asphalt shingle roof on plywood decking. There are multiple non-historic mobile homes on the property which appear to be in use. The Maverick County Appraisal District does not provide a date of construction for SM-02. SM-02 appears in aerial photographs between 1967 (IBWC 1967) and 1972 (USGS 1972). Therefore, SM-02 was constructed in the late 1960s or early 1970s.

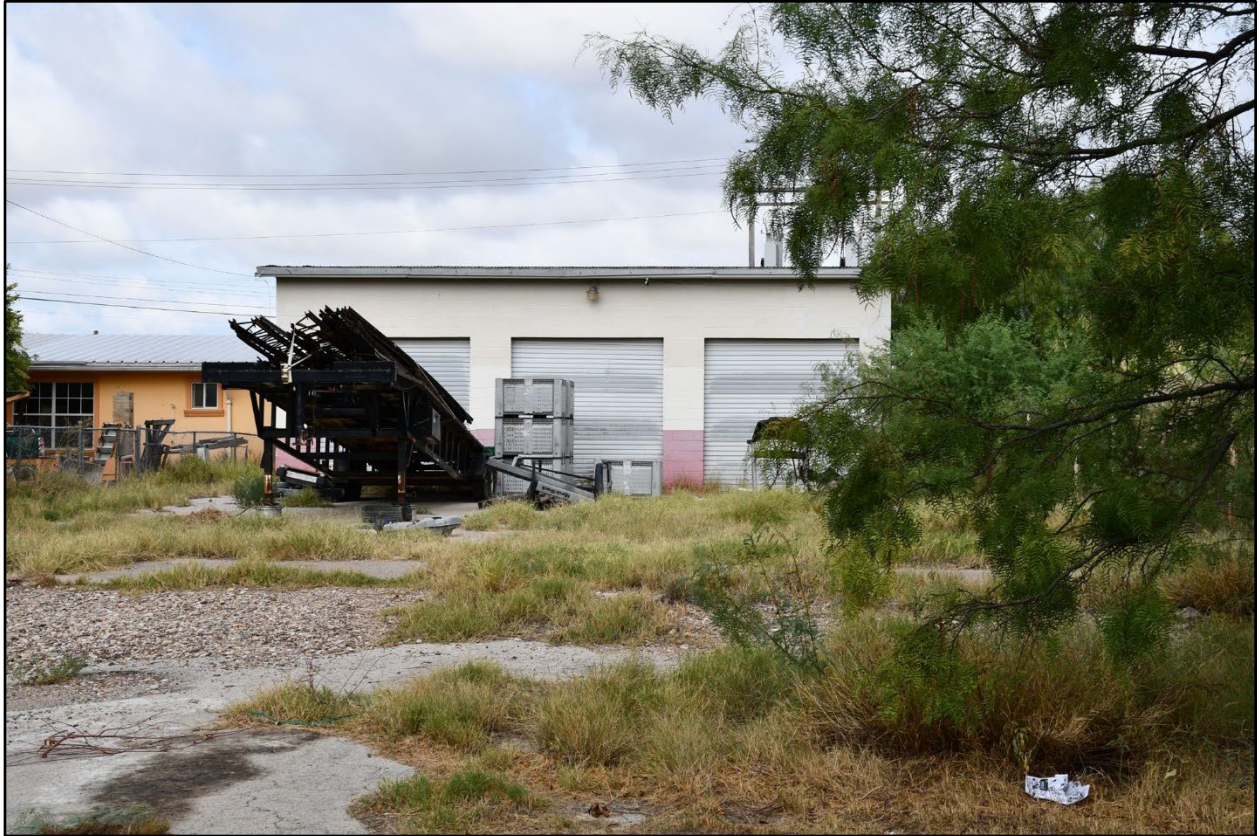
**Figure 5. View of SM-03, Facing west towards east (front) elevation from Barrera Street.**

SM-03 is a three bay, concrete block garage with a metal roof and rolling metal garage doors (Figure 5). The building has a shallow pitch shed roof with minimal overhangs. According to the Maverick County Appraisal District, the garage was built in 1980, which is corroborated by historic aerial imagery (TxDOT 1976, NASA 1980). Therefore, SM-03 was constructed in 1980.

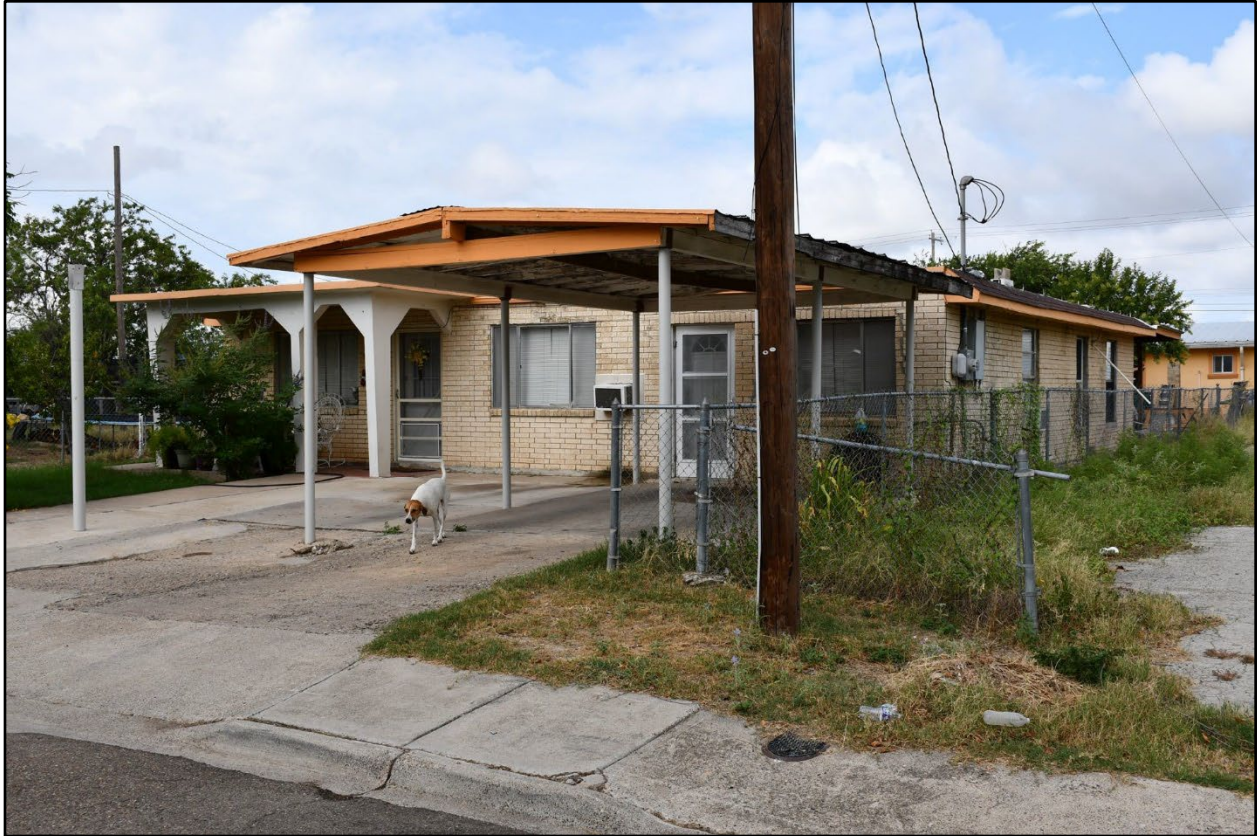
**Figure 6. Oblique view of SM-04, Facing southwest towards east (front) and north (side) elevations from Barrera Street.**

SM-04 has a rectangular form and a flat roof with slight mansards on its side elevations clad in asphalt shingles (Figure 6). The house is fenestrated with both metal sash windows and metal framed picture windows. A non-historic replacement front door with a fanlight, and non-historic 9-light door provide access on the façade. There is a flat roofed porch with concrete supports over the entry, and a detached front gabled carport in the driveway. The Maverick County Appraisal District does not provide a date of construction for SM-04. SM-04 appears in aerial photographs between 1967 (IBWC 1967) and 1972 (USGS 1972). Therefore, SM-04 was constructed in the late 1960s or early 1970s.

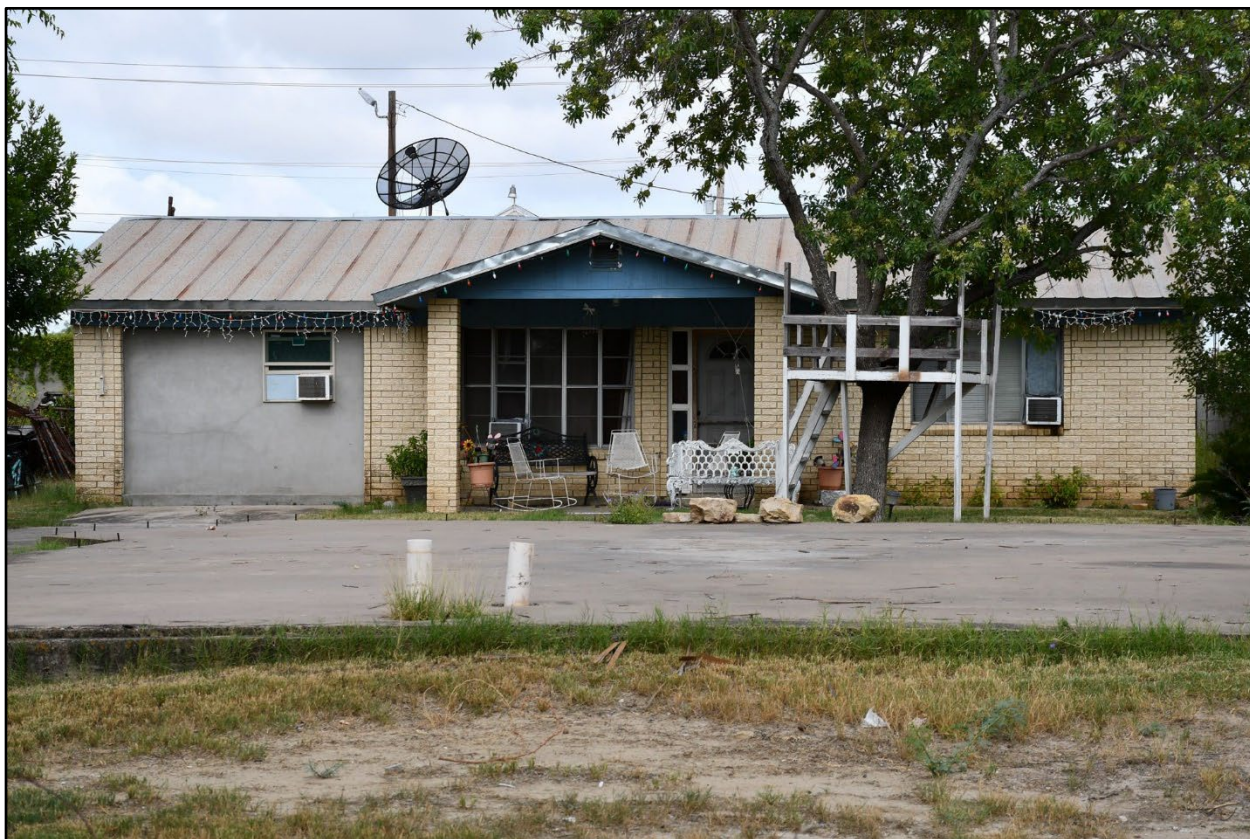
**Figure 7. View of SM-05, Facing west towards east (front) elevation from Barrera Street.**

SM-05 is a compact Ranch House with a side gabled roof clad in standing-seam metal. The exterior is clad in a running bond brick veneer, with two multipaned picture windows and a front gabled porch centered on the façade. The historic carport has been infilled and a window placed within the non-historic wall (Figure 7). According to the Maverick County Appraisal District, SM-05 was constructed in 1980, which is corroborated by aerial photography (TxDOT 1976, NASA 1980). Therefore, SM-05 was constructed in 1980.

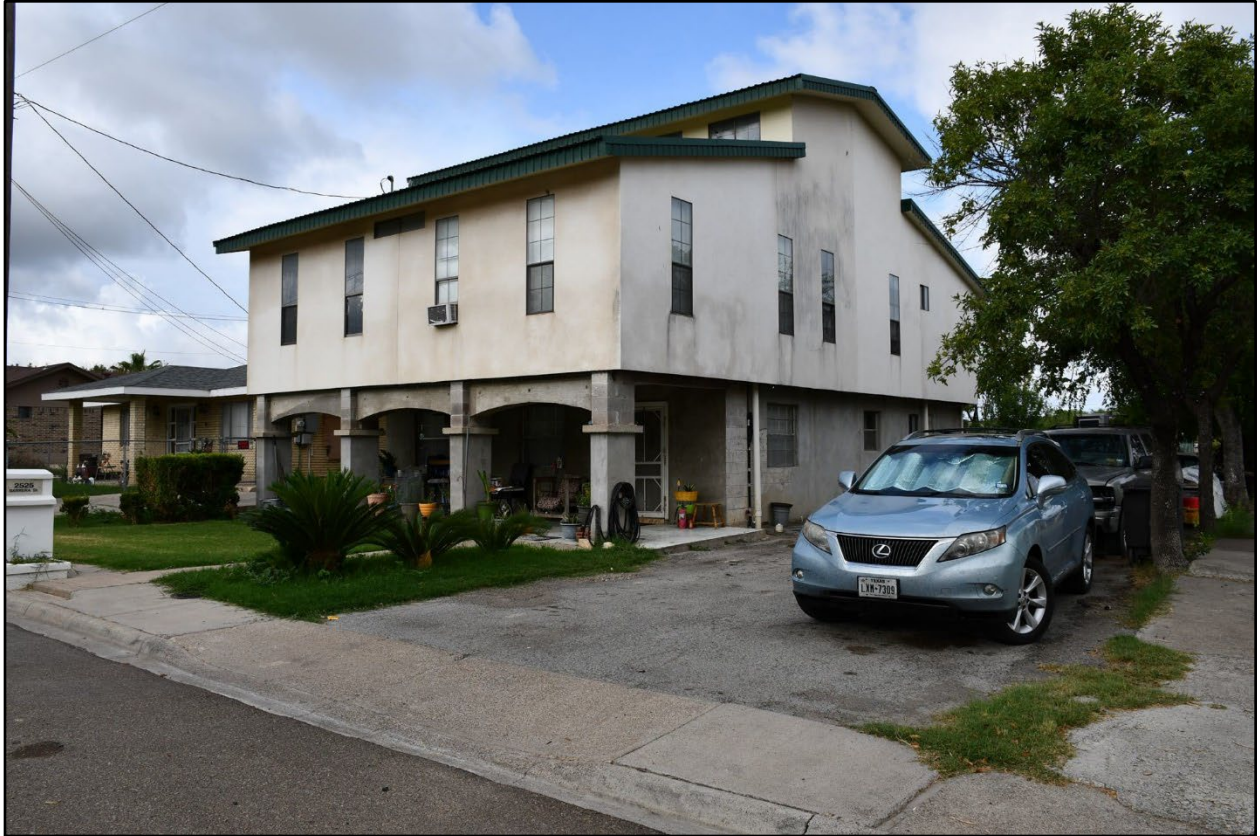
**Figure 8. Oblique view of SM-06, Facing southwest towards east (front) and north (side) elevations from Barrera Street.**

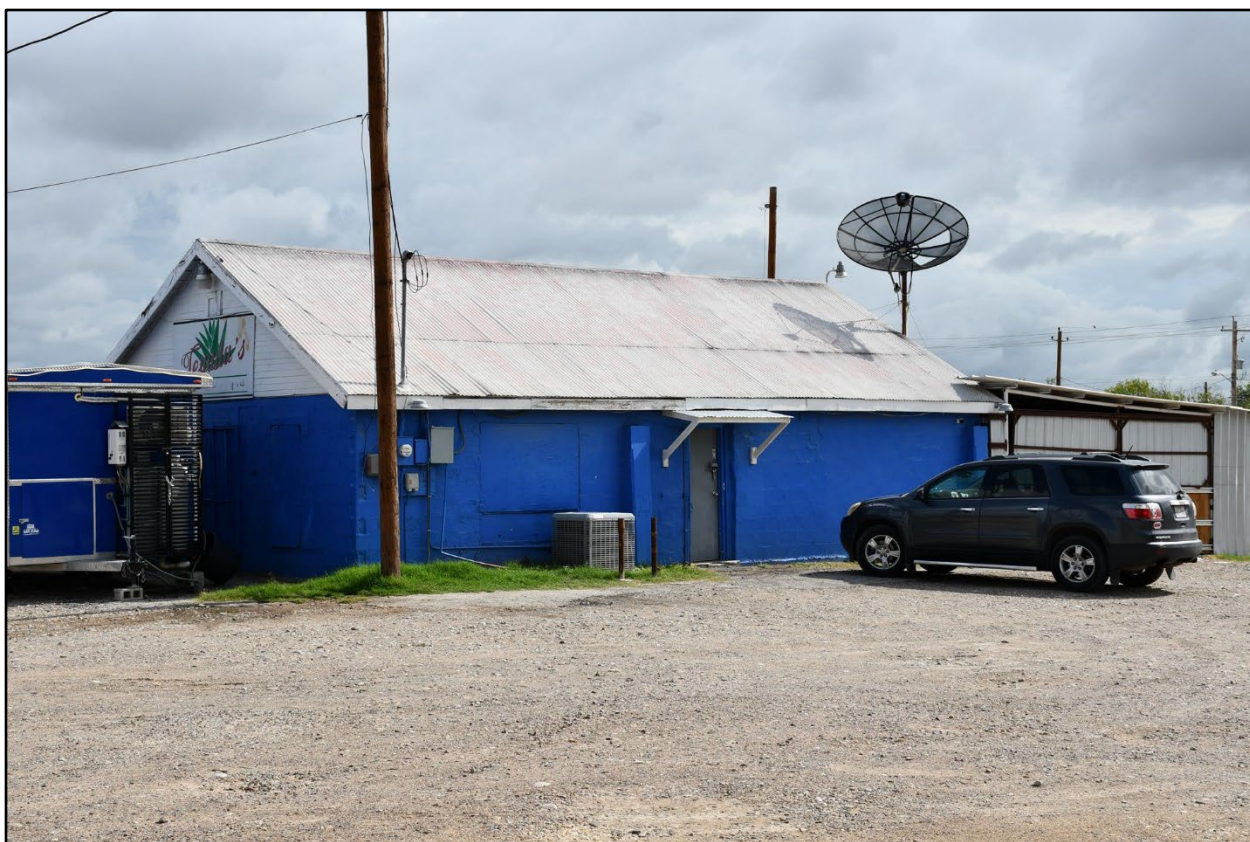
**Figure 9. View of SM-07, Facing northeast towards west (front) and south (side) elevations from US 277.**

the lack of a recognized architectural type or style, combined with the alterations including infilled windows and doors and non-historic vinyl siding in the gable ends, that have resulted in the loss of material integrity, result in the resource being recommended not eligible under Criterion C. Lastly there are no indications that the resource is likely to yield information on important research questions in history or prehistory. Therefore, there was no basis for evaluating the property under Criterion D. SM-07 is recommended not eligible for the NRHP.

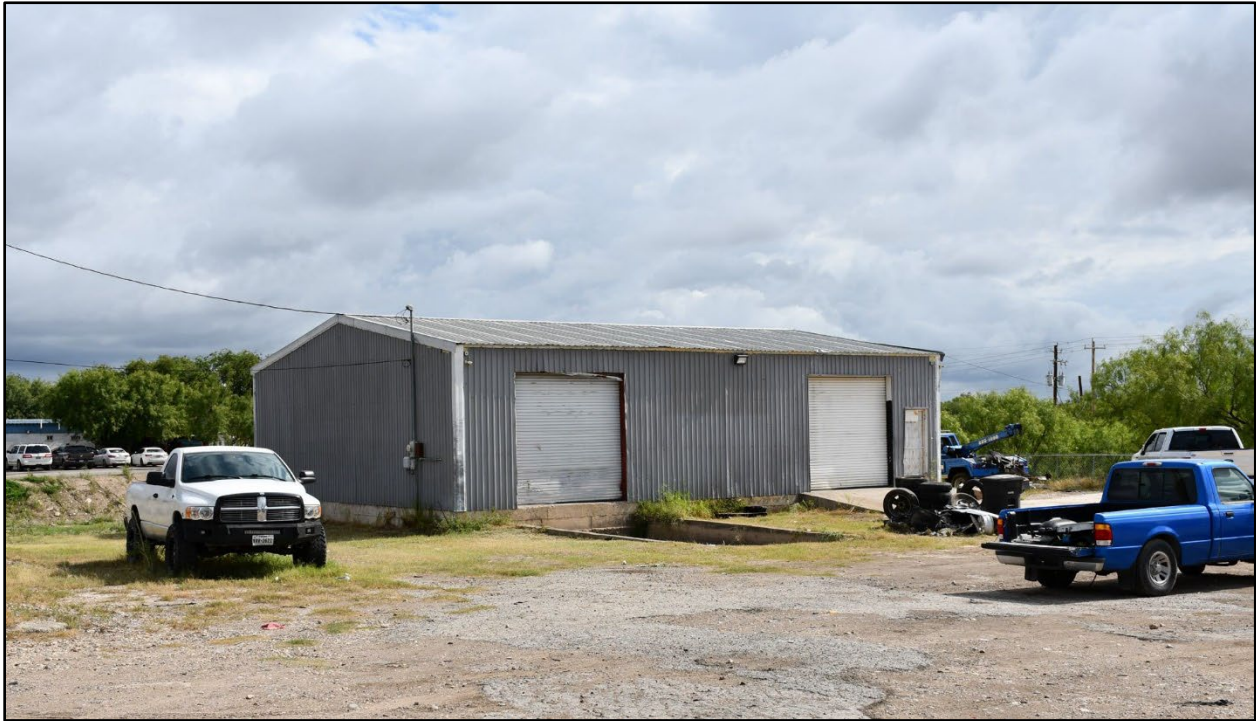
**Figure 10. View of SM-08, Facing northeast towards west (side) and south (front) elevations from US 277.**

SM-08 is a side-gabled, two-bay garage with metal siding, a metal roof, and two rolling metal garage doors (Figure 10). Ramps lead downward towards the entry bays, forming two loading docks. According to the Maverick County Appraisal District, the building was constructed in 1980, which is corroborated by aerial photographs (TxDOT 1976, NASA 1980). Therefore, SM-08 was constructed in 1980.

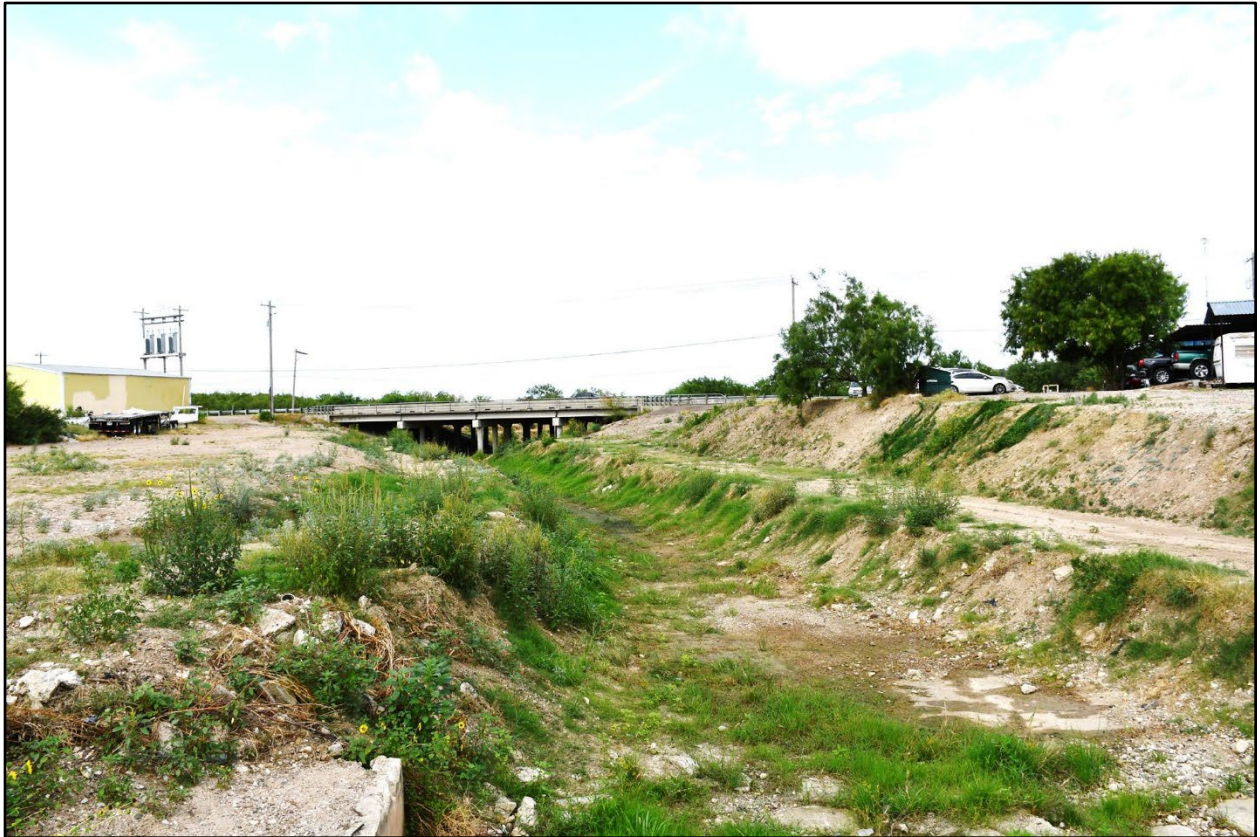
**Figure 11. View of SM-09, Facing west toward US 277 from the Barrera Street culvert.**

Seco Creek had any unique or innovative engineering qualities compared to other, more clearly marked, lateral branches of the Maverick Irrigation Canal; therefore, SM-09 is recommended not eligible for listing under Criterion C. Lastly there are no indications that the resource is likely to yield information on important research questions in history or prehistory. Therefore, there was no basis for evaluating the property under Criterion D. SM-09 is recommended not eligible for the NRHP.

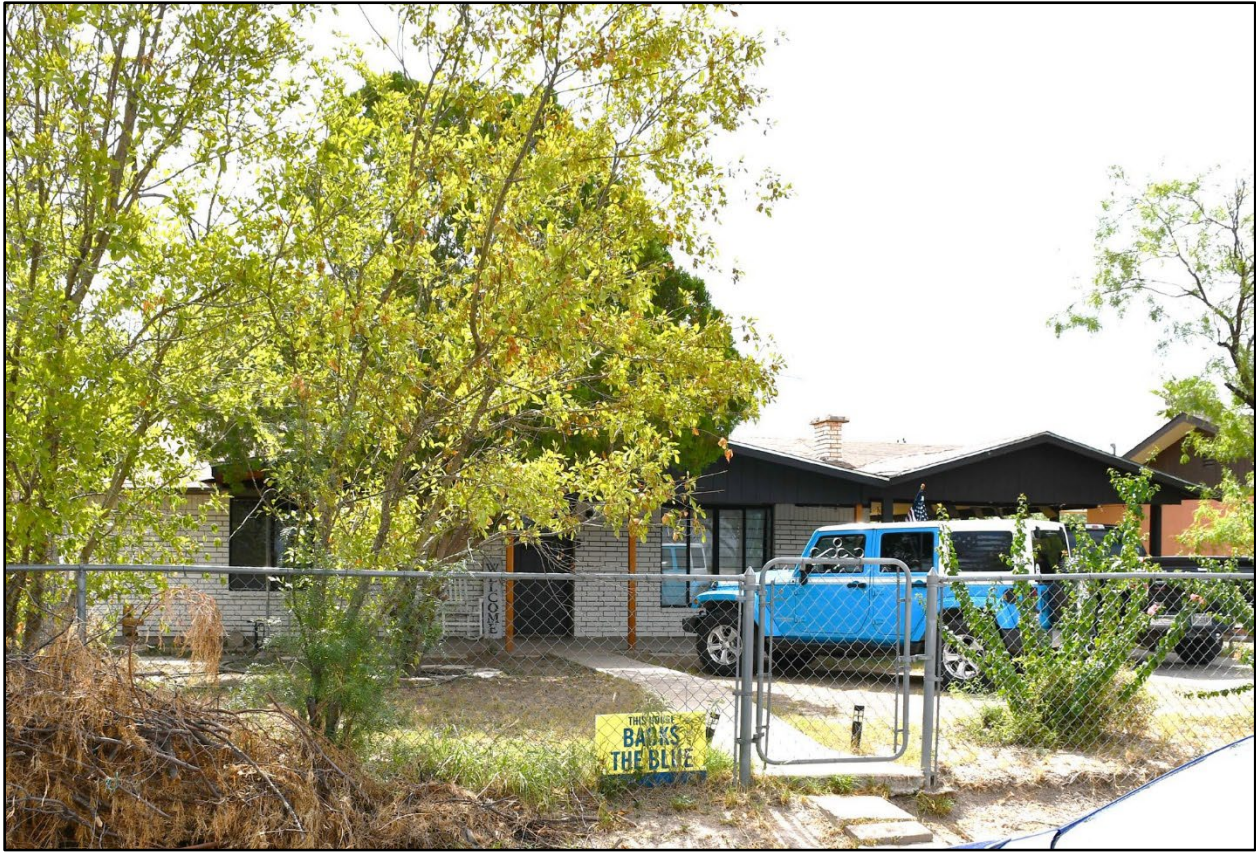
**Figure 12. View of SM-10, facing east towards west (front) elevations from Commissary Avenue.**

SM-10 has a side-gabled roof clad with asphalt shingles, with a front-gabled porch and front-gabled carport on the façade, both of which have channeled plywood in their gable ends (Figure 12). The exterior of the building is clad in a running bond brick veneer and is fenestrated with a variety of sash windows on the elevations and a paneled picture window on the façade. The house is accessed by a replacement front door with a fanlight, and there are non-historic dimensional lumber porch supports as well. A shed was added in 2008. The Maverick County Appraisal District does not provide a date of construction for SM-10. SM-10 appears in aerial photographs between 1980 (NASA 1980) and 1981 (NHAP 1981). Therefore, SM-10 was constructed between 1980 and 1981.

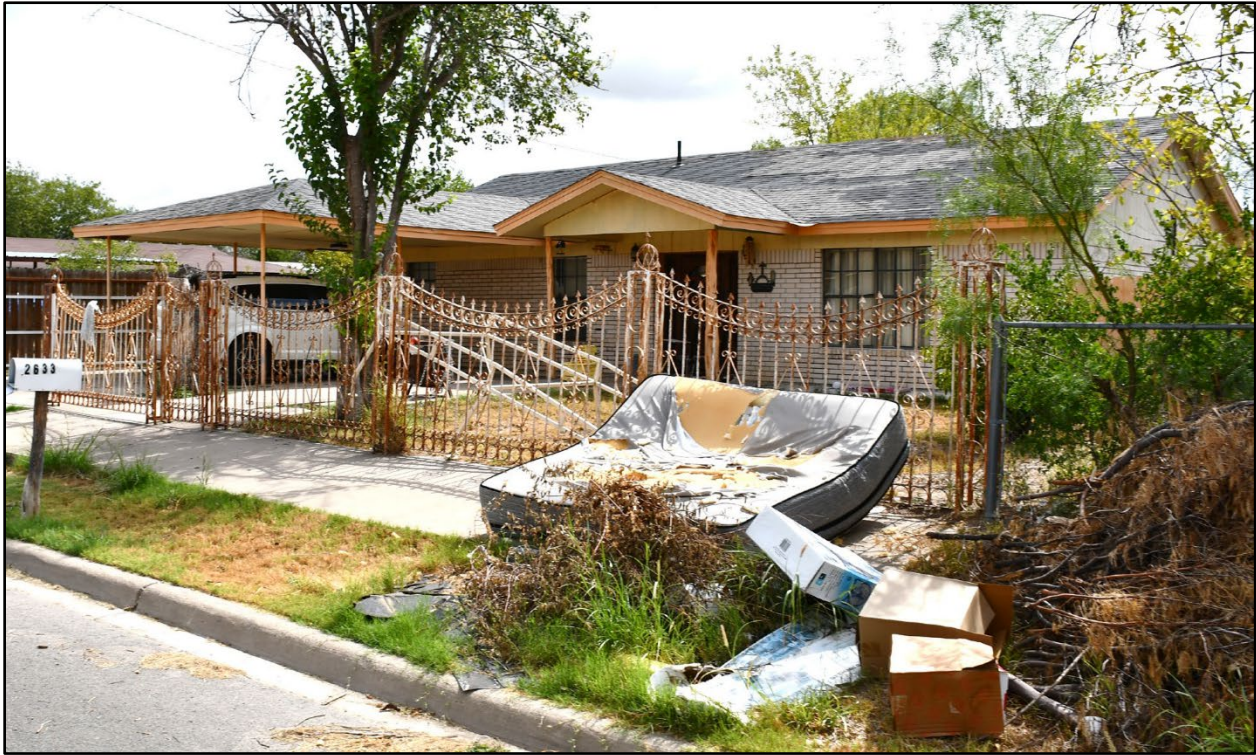
**Figure 13. Oblique view of SM-11, Facing northeast towards west (front) elevation and south (side) elevations from Commissary Avenue.**

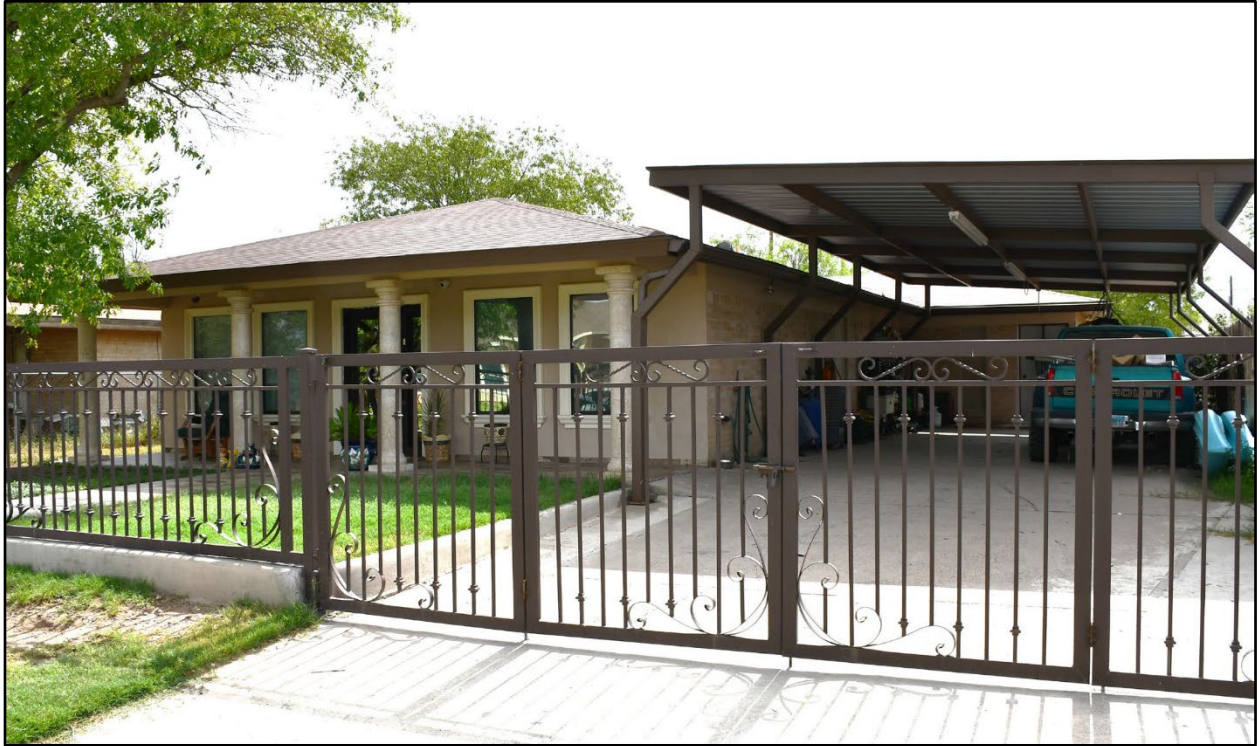
**Figure 14. Oblique view of SM-12, Facing northeast towards west (front) elevation and south (side) elevations from Commissary Avenue.**

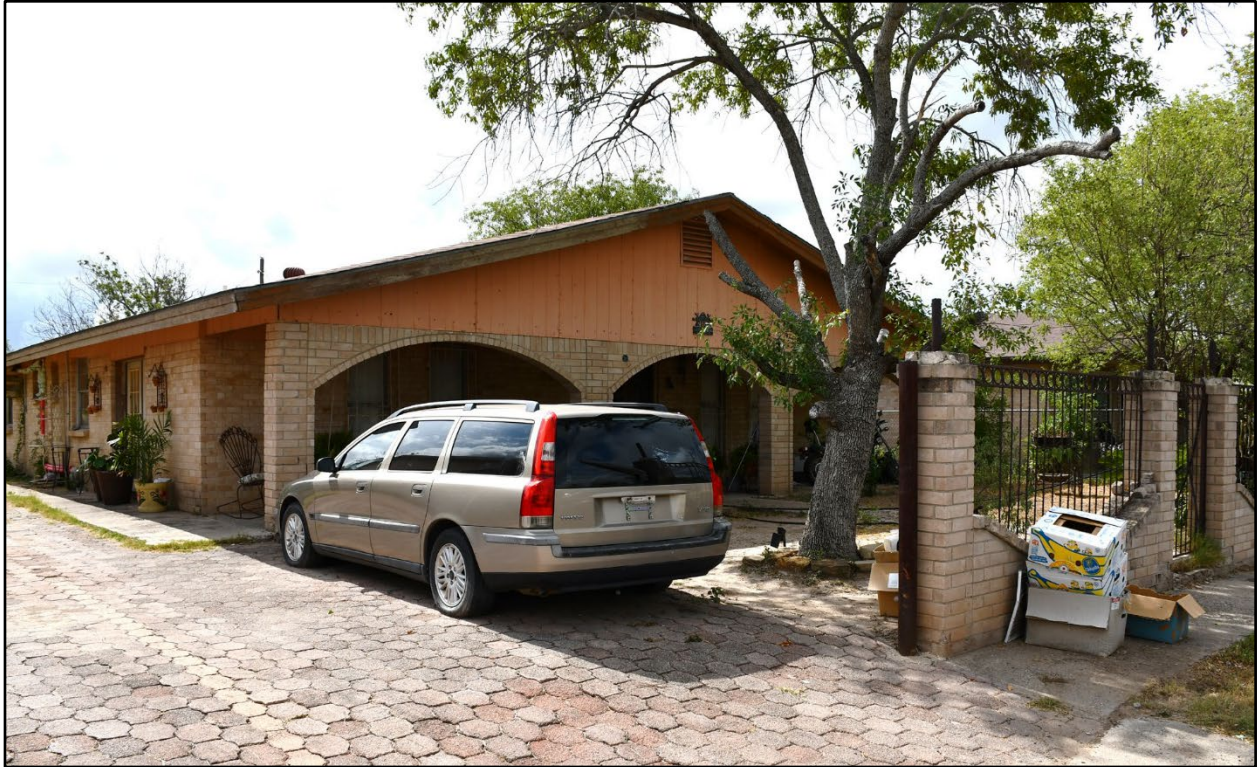
**Figure 15. Oblique view of SM-13, Facing southeast towards west (front) elevation and north (side) elevations from Commissary Avenue.**

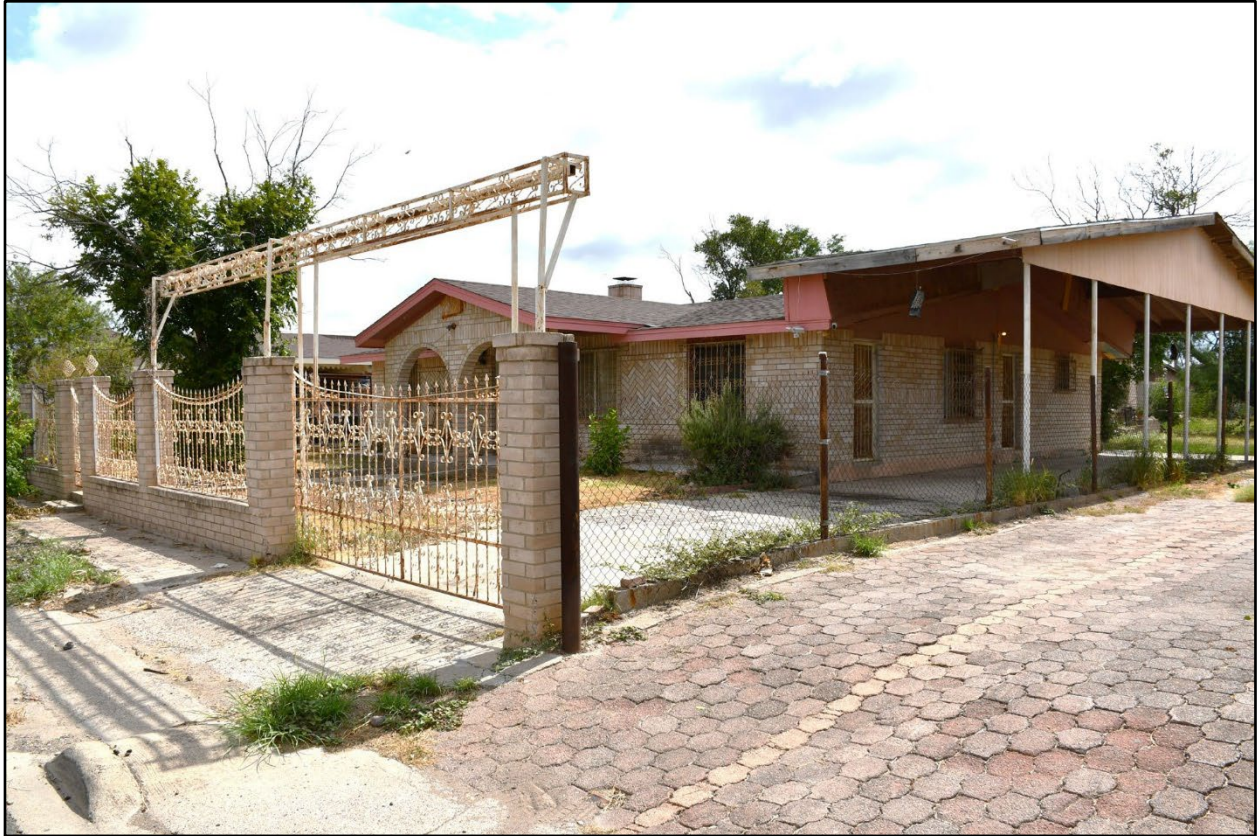
**Figure 16. Oblique view of SM-14, Facing northeast towards west (front) elevation and south (side) elevations from Commissary Avenue.**

B. Further, the resource lacks a recognized architectural type or style and the attached carport has resulted in the loss of material and design integrity; thus SM-14 is recommended not eligible under Criterion C. Lastly there are no indications that the resource is likely to yield information on important research questions in history or prehistory. Therefore, there was no basis for evaluating the property under Criterion D. SM-14 is recommended not eligible for the NRHP.

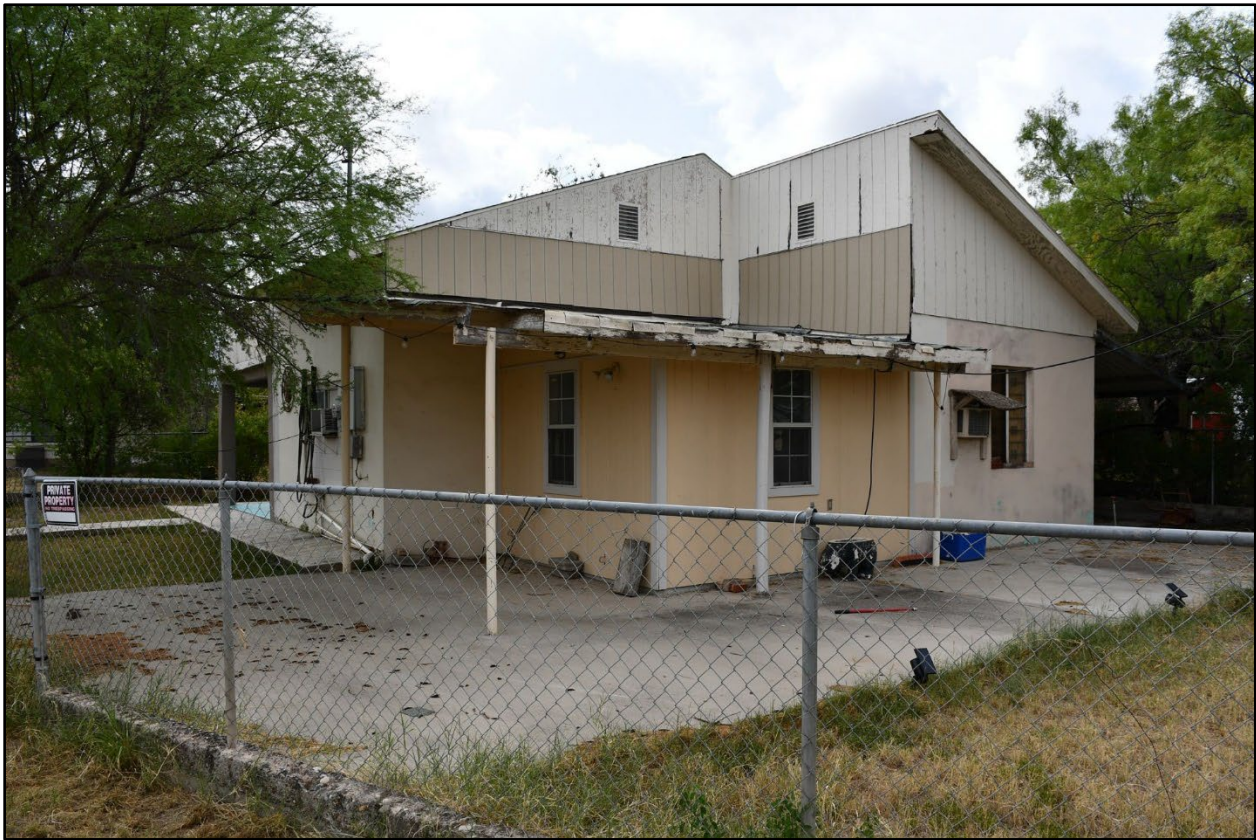
**Figure 17. Oblique view of SM-15, Facing southeast towards west (side) elevation and north (front) elevations from Ritchie Road.**

SM-15 appears to have operated solely in a residential capacity since its construction, and background research did not reveal any association with events or trends that have contributed to the history of the area. Consequently, SM-15 is recommended not eligible for listing under Criterion A. Background research did not reveal an association with any significant individuals; thus, SM-15 is recommended not eligible for listing under Criterion B. Further, the resource lacks a recognized architectural type or style and the deck addition and vinyl sash replacement windows have resulted in the loss of material and design

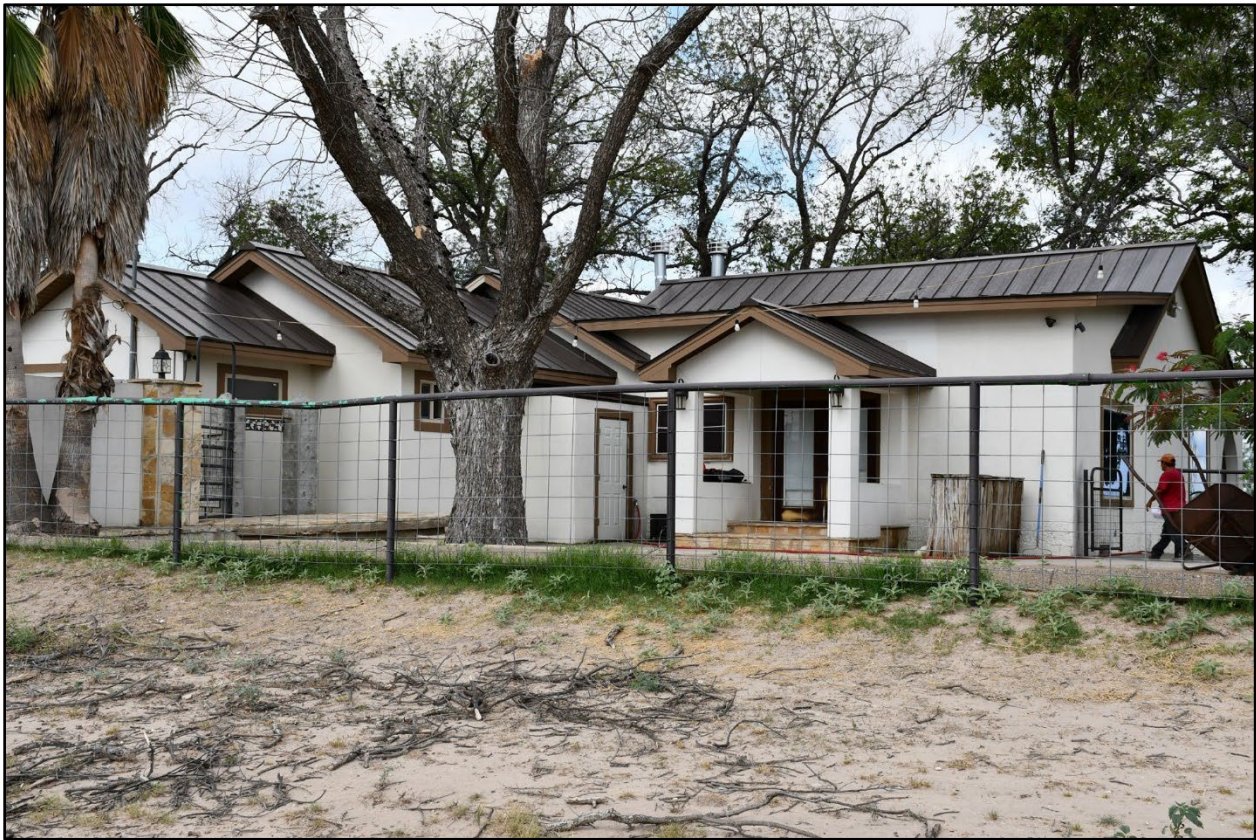
**Figure 18. Oblique view of SM-16, Facing southwest towards east(front) elevation and north (sides) elevations from Ritchie Road.**

owned by the same entity; further, the house has been so extensively altered that the property no longer can convey an association with historic agricultural practices. Therefore, SM-16 is recommended not eligible for listing on the NRHP under Criterion A. Background research did not reveal an association with any significant individuals; thus, SM-16 is recommended not eligible for listing under Criterion B. Further, the resource lacks a recognized architectural type or style and the 2015 additions and replacement doors and windows throughout the building have resulted in the loss of material and design integrity; thus SM-16 is recommended not eligible under Criterion C. Lastly there are no indications that the resource is likely to yield information on important research questions in history or prehistory. Therefore, there was no basis for evaluating the property under Criterion D. SM-16 is recommended not eligible for the NRHP.
