# Four Southern Tribes Cultural Working Group Meeting

**Pecos Industrial Rail Access  
and Train Extension (PIRATE)**

**Docket No. FD 36501  
Union Pacific Railroad Company  
Construction and Operation Exemption  
in Maricopa County, Arizona**

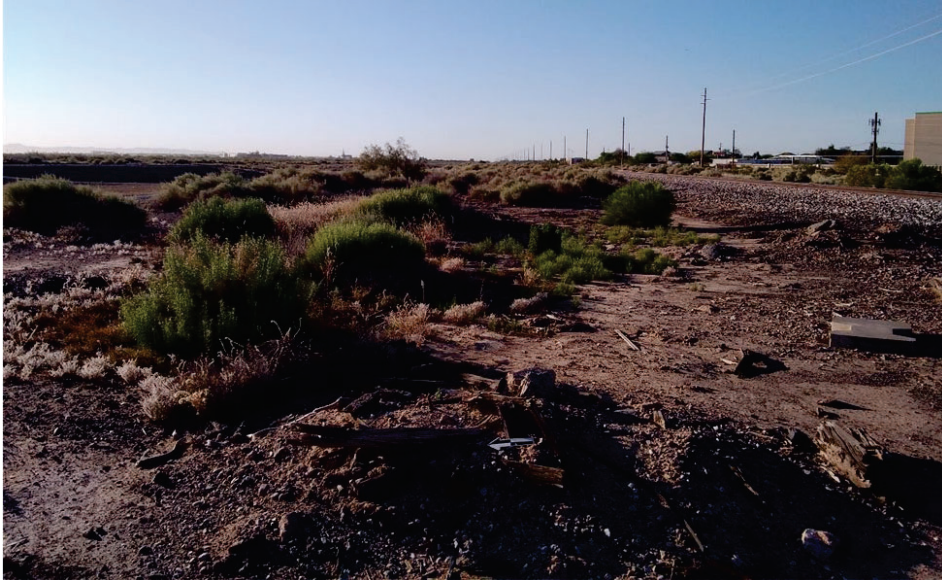
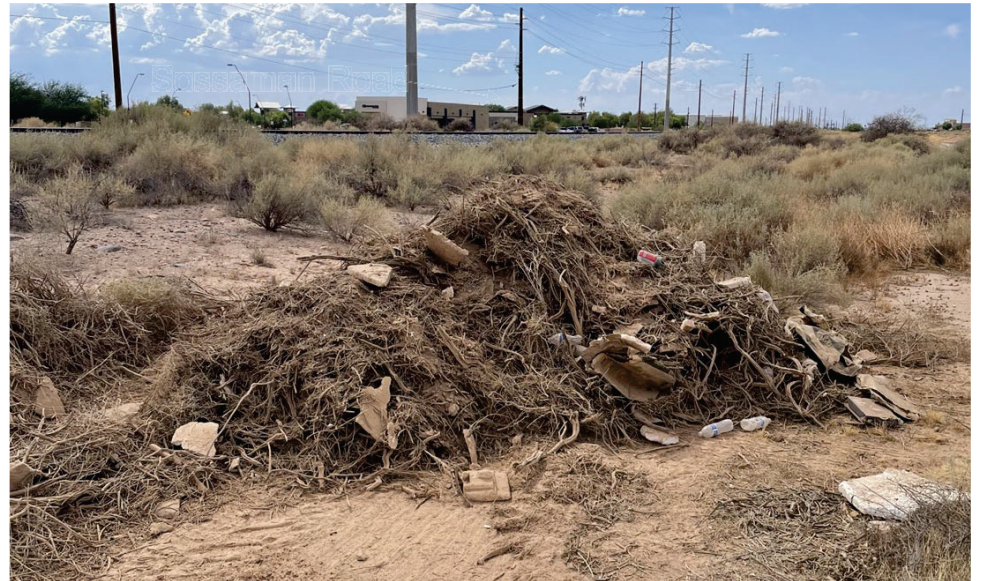
## Damage Area 5 at [REDACTED] – Pre- and Post-Damage Conditions

May 2022: Pre-damage conditions at

[REDACTED] in the APE [REDACTED]  
[REDACTED].

August 2023: Post-damage conditions at  
[REDACTED] following vegetation  
removal in the APE [REDACTED]  
[REDACTED].

| Damage Class | Definition | Damage Area | Invasive Fieldwork Recommendations |
|---|---|---|---|
| <b>Minor</b> Damage | Surface disturbance is less than 1 foot (30.49 cm) deep <u>and does not</u> intersect any previously recorded ACs or features | Damage Areas 3 and 5 | Removal of vegetative material at Damage Area 5 with qualified archaeological monitor |
