Re: Docket No. FD 36500, CPKC Quarterly Environmental Mitigation  
Measures Report for December 15, 2025 to March 14, 2026

# CPKC Quarterly Environmental Mitigation Measure Compliance Report Number 12

This report includes compliance activities completed between December 15, 2025 and March 14, 2026 (Quarter 4, Year 3 of the STBs oversight period following the acquisition of KCS by CP, STB Docket FD 36500).

BLUE VALLEY SOUTH SIDING EXTENSION  
CPKC Final Environmental Monitoring Report

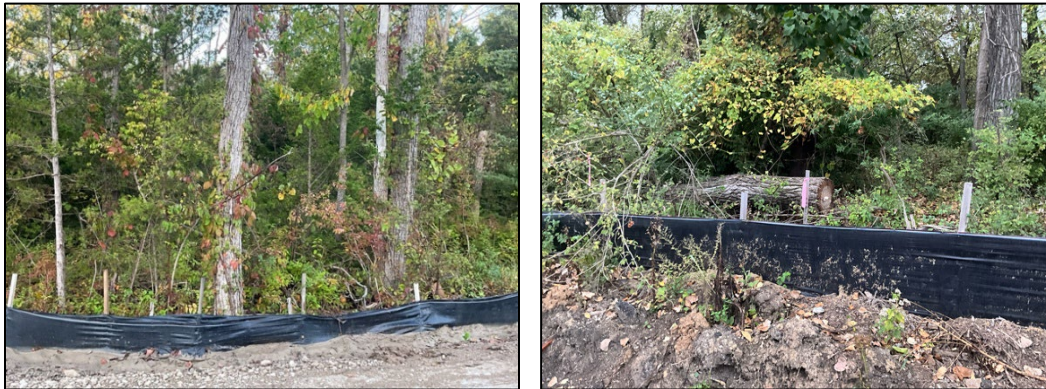
Right of Way (ROW) boundaries were marked with orange ribbon on wood lath and wetlands were marked with pink ribbon to indicate work limits. All workers on site were made aware that they were to keep work within the ROW. Work on the project was successfully kept within the ROW with minimal disturbance to wetland areas. The photos below show these color-coded boundaries.

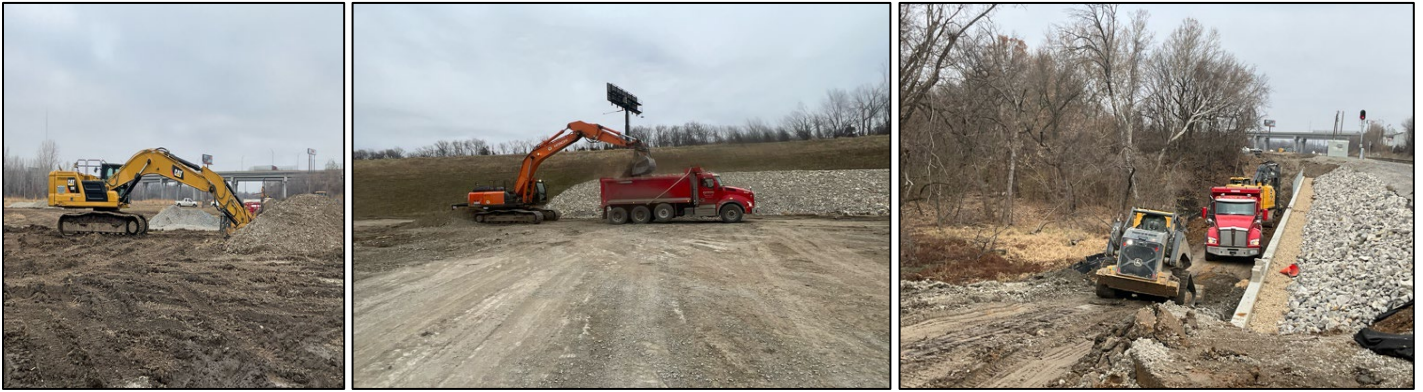
The Environmental Monitor (EM) held weekly briefings with crew members regarding equipment noise throughout the duration of the Blue Valley South capital improvement project. From July 22<sup>nd</sup> to September 10<sup>th</sup>, to increase worker safety, due to excessive heat, work at Blue Valley Siding started at 0600. From November 10th to 21st, to minimize impacts to railroad operations, work at Blue Valley double track started at 0500. The work area was bordered by industrial and commercial operations and there was no disturbance to residential areas. All other work was performed between the hours of 0700 and 2100 throughout construction. Noise was kept within acceptable limits of the project permits at all times.

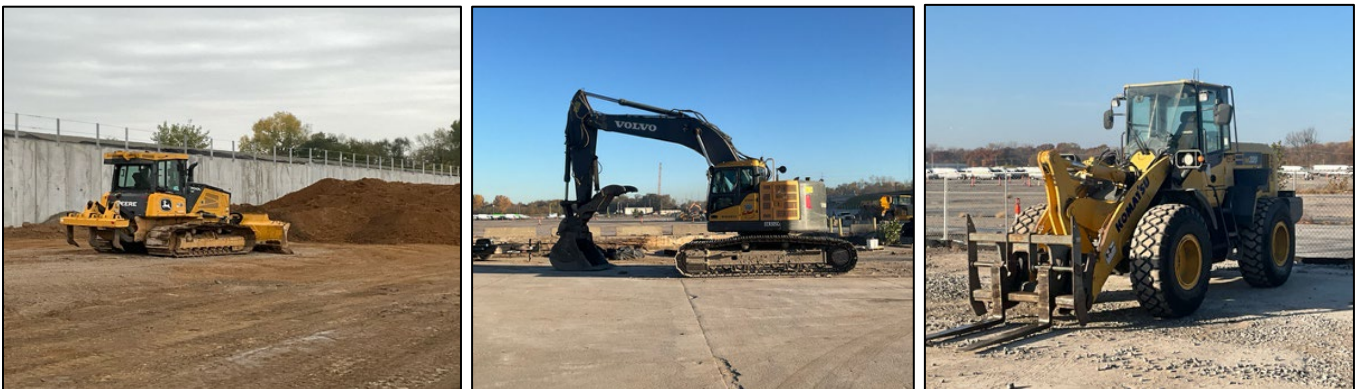
The Anti-Idling procedure was discussed during the initial and weekly briefings held by the Flagger. These briefings occurred during Safety/JSA meetings, and all new subcontractors were also briefed as they joined the project and began their work. The Anti-Idling procedure was adhered to throughout the duration of the Blue Valley South capital improvement project.

The photos below provide examples of some equipment that had to follow this policy during the project's construction period.

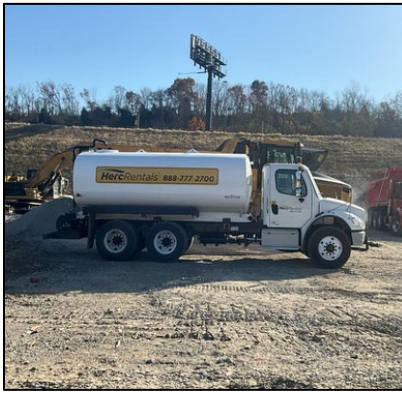
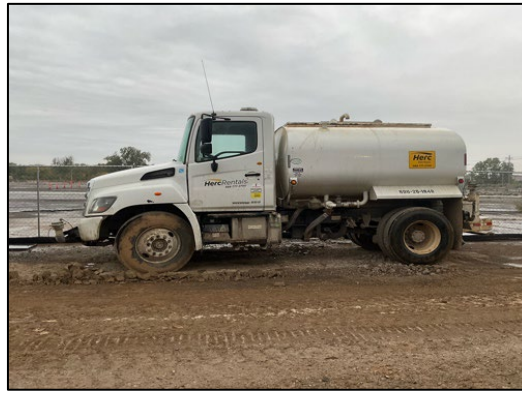
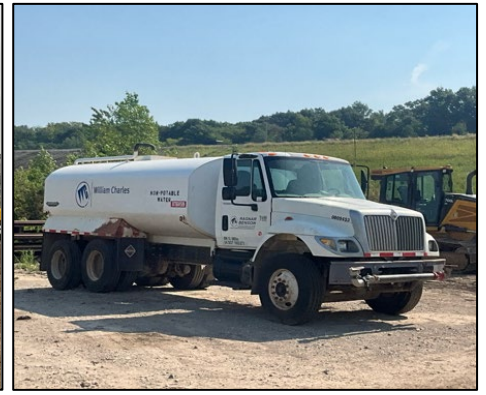
The primary method of dust control suppression was an available water truck. Dust suppression was needed throughout the capital improvement project.

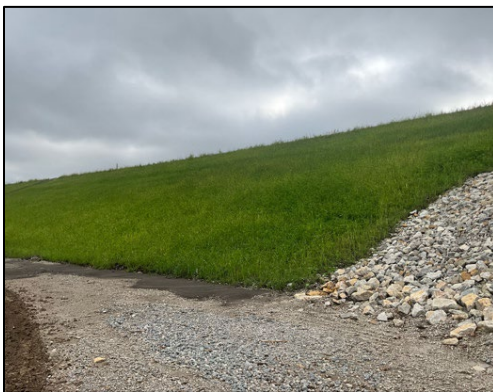
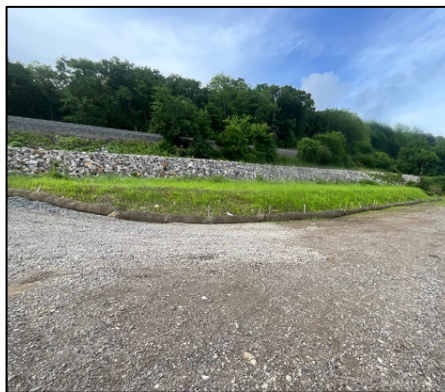
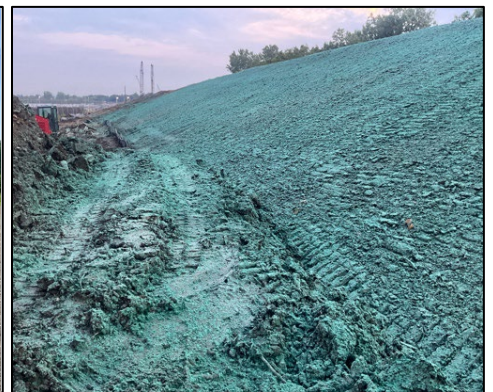
The project was able to ensure that all stabilization measures needed throughout the project were utilized within the 14-day window. This included the reutilization of topsoil material. At the end of the project, the EM returned to the site to ensure that revegetation had been maintained and was successful in its attempts to restabilize the land post-construction.

The photos below show some of the areas where revegetation measures were implemented along the construction site.

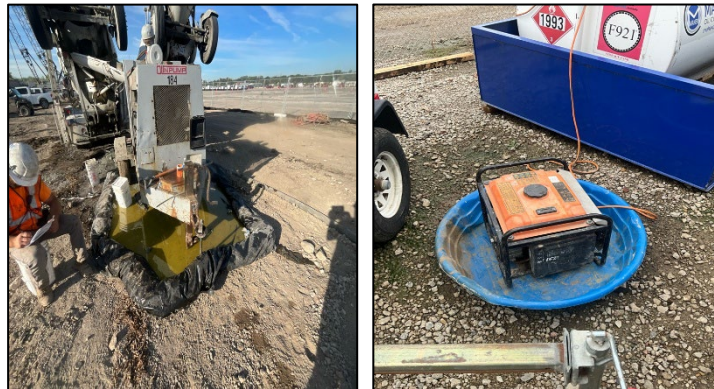
No spills occurred during the construction period of the Blue Valley South capital improvement project. All equipment on site was equipped with spill kits with additional kits available within the contractor trailer.

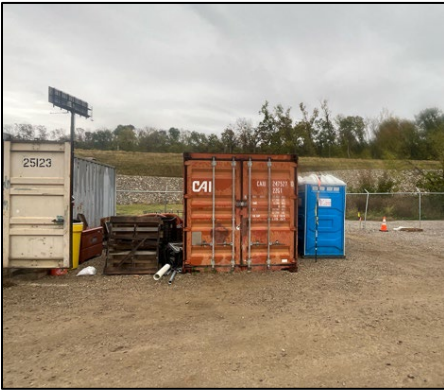
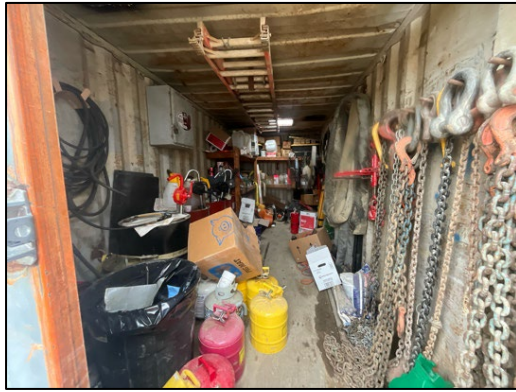
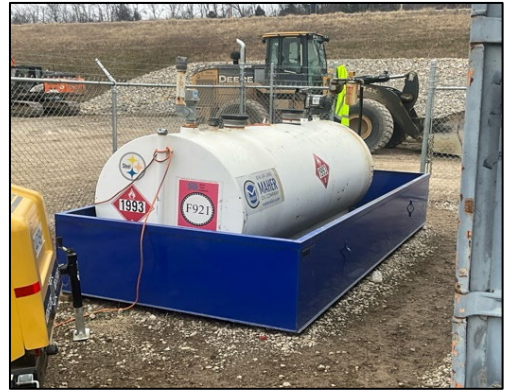
Petroleum products used during the Blue Valley South improvement project were all handled properly with either a secondary containment method or storage within an enclosed job trailer. Each piece of equipment used on the project was also equipped with its own spill kit to manage containment immediately in case of a spill.

The photos below show these containment measures.

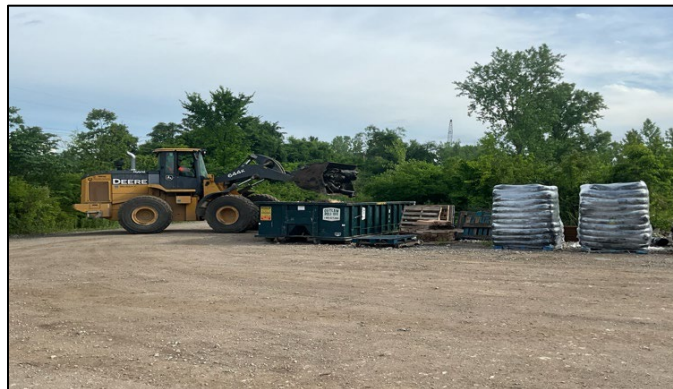
In accordance with the Materials Management Plan, all waste products requiring disposal throughout the Blue Valley South capital improvement project were placed in the permitted dumpsters and removed by service company. Dumpsters were needed on the project, and the contractor had multiple dumpsters available for disposal of trash collected on the project.

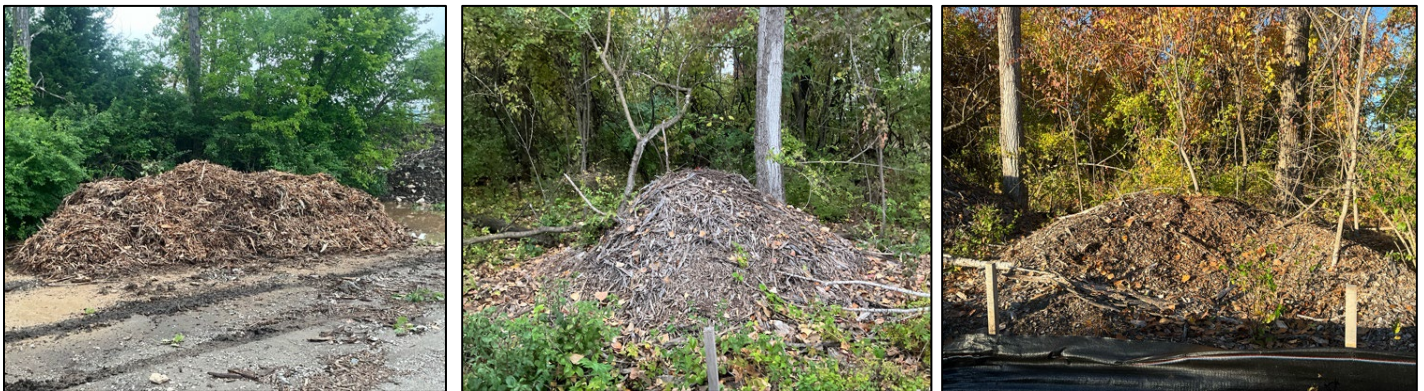
After tree clearing was complete, areas where trees had been cleared were marked with flagged survey limits so contractors could easily identify any area within ROW and near bridges where bat species could potentially be present. No bat habitat or nesting was identified throughout the Blue Valley South capital improvement project. The photos below show some of the areas that were inspected for bats.

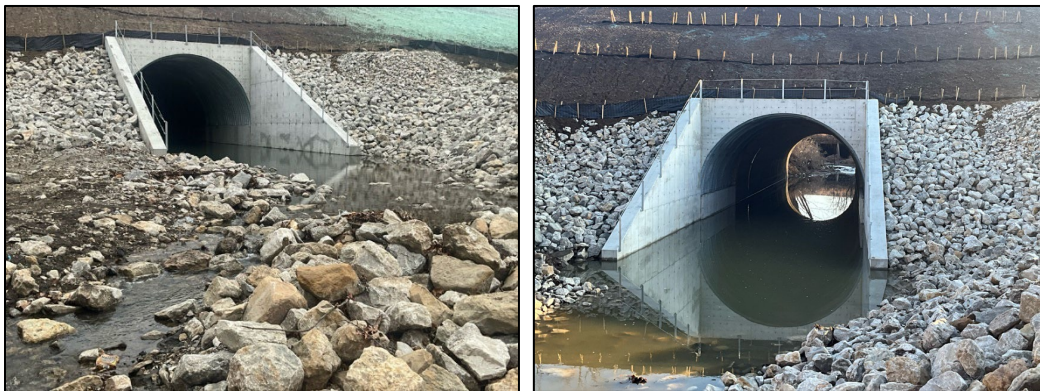
Daily monitoring of bat species was completed by the EM, followed with a complete inspection by Kyle Kosovich, Environmental Specialist for CPKC. No bat species was present before or during the installation process.

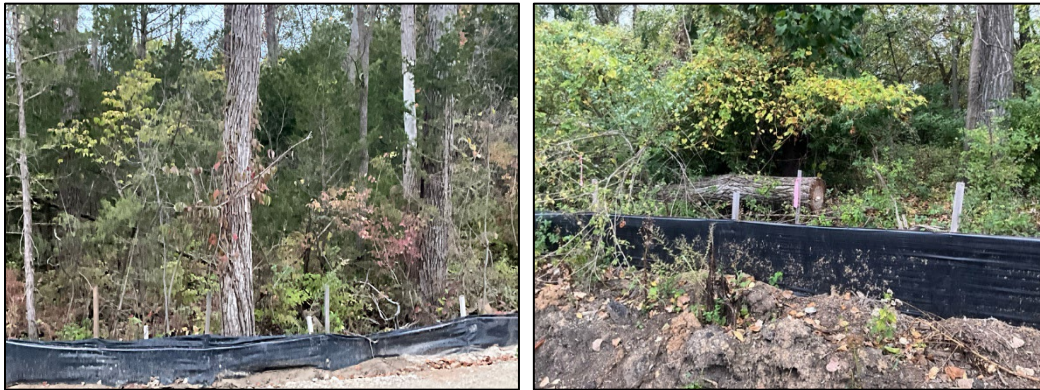
occurred within the ROW but outside of areas identified as sensitive habitats. No barricades or fencing was used.

Photos below show orange ribbon in various locations along the project:

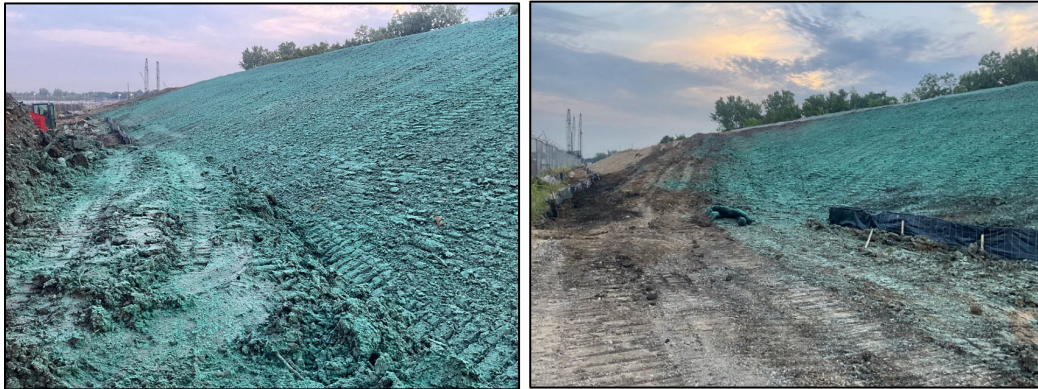
Seed mixes used for revegetative efforts on the Blue Valley South capital improvement project were verified according to seed tags and the DOT Seeding Type Requirements of the Missouri Standard Specifications for Highway Construction. See photos below for some of the reseeding efforts that occurred on site.

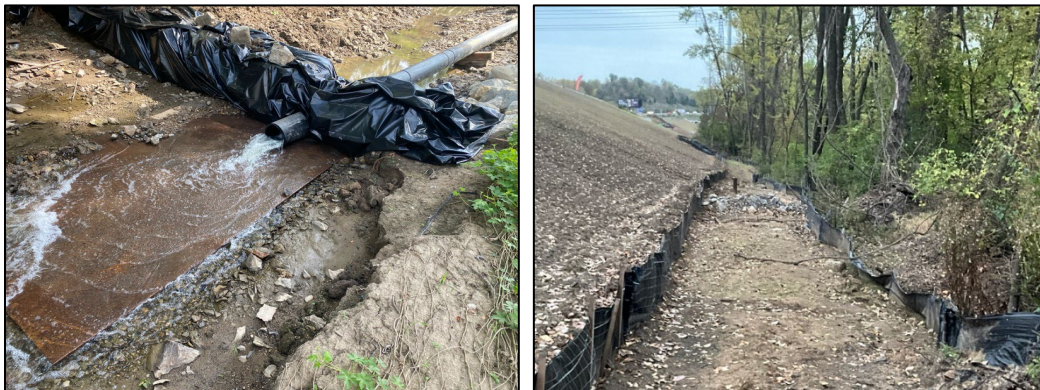
Weekly and post rain event SWPPP inspections were completed throughout the construction phase of the project and continued through 70% post-construction.

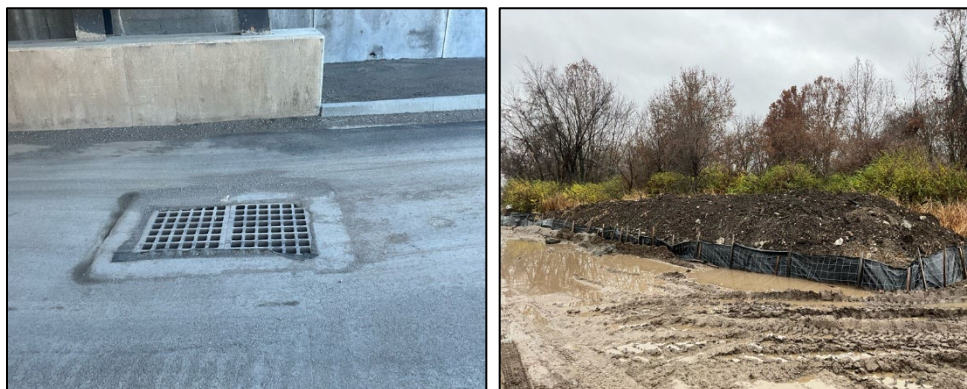
A site-specific WQMP was developed prior to construction of the Blue Valley South capital improvement project. The EM evaluated potential surface water and stormwater quality impacts due to project construction activities throughout the project. Routine sampling and analysis of instream surface water and site stormwater sources during project construction activities was not deemed necessary at the Blue Valley South capital improvement project to ensure adherence to the WQMP.

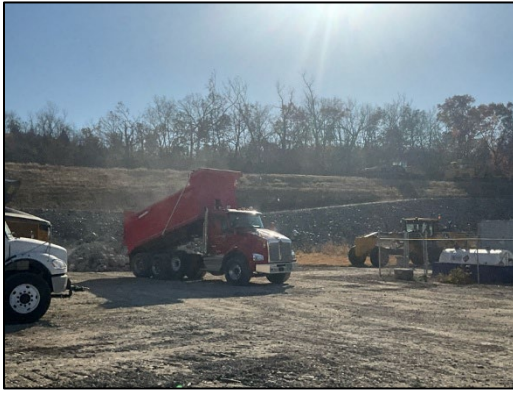
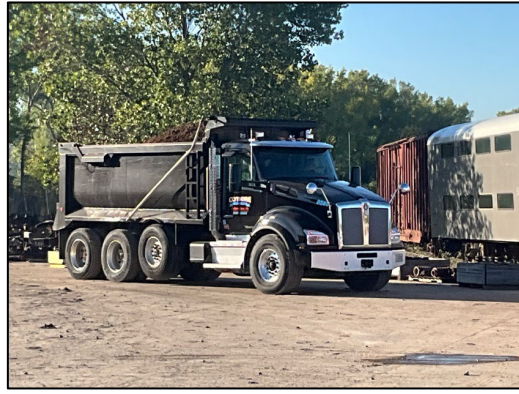
Suitable fill materials used within the Blue Valley South capital improvement project consisted of primary reused Native soils, Clean Fill and ballast material previously approved by project engineers and contractors and from state licensed local sources.

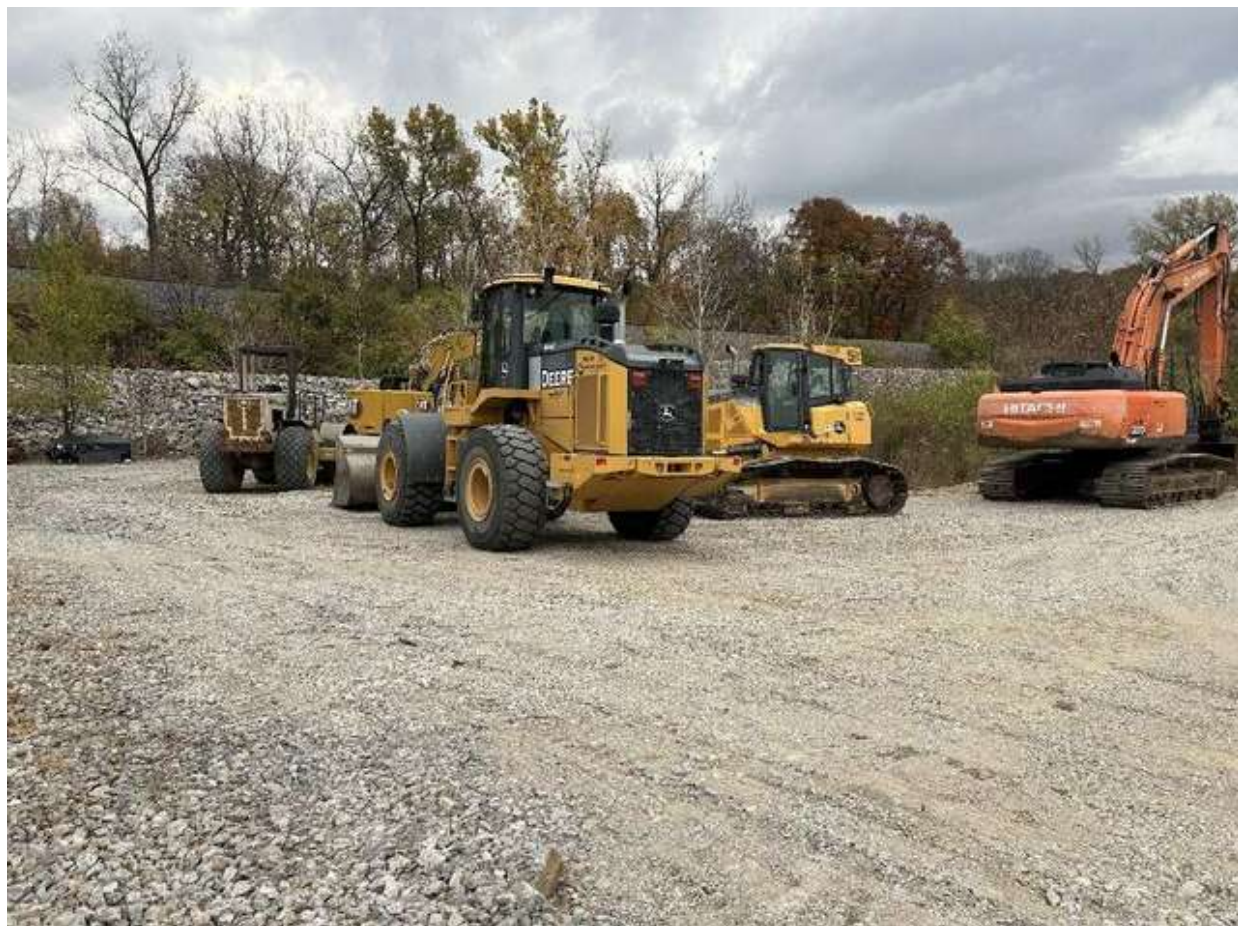
**Photo Date:** October 30, 2024

**Description of photo:** Arrival and staging of equipment into main yard for use during project.

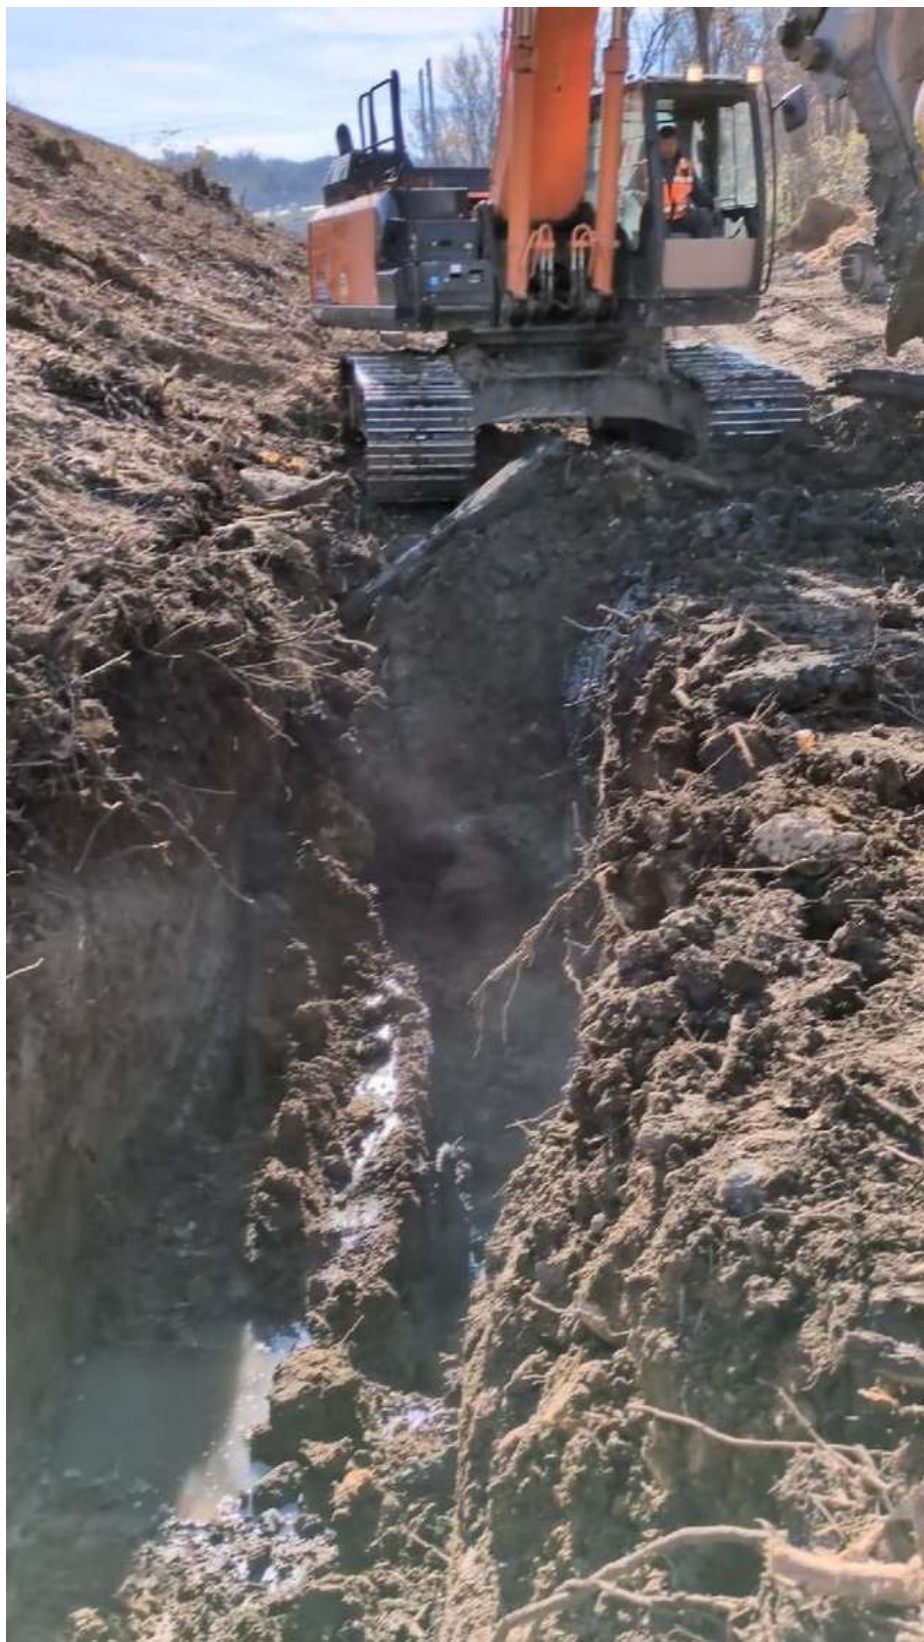
**Photo Date:** November 22, 2024

**Description of photo:** Excavation of 27-inch culvert.

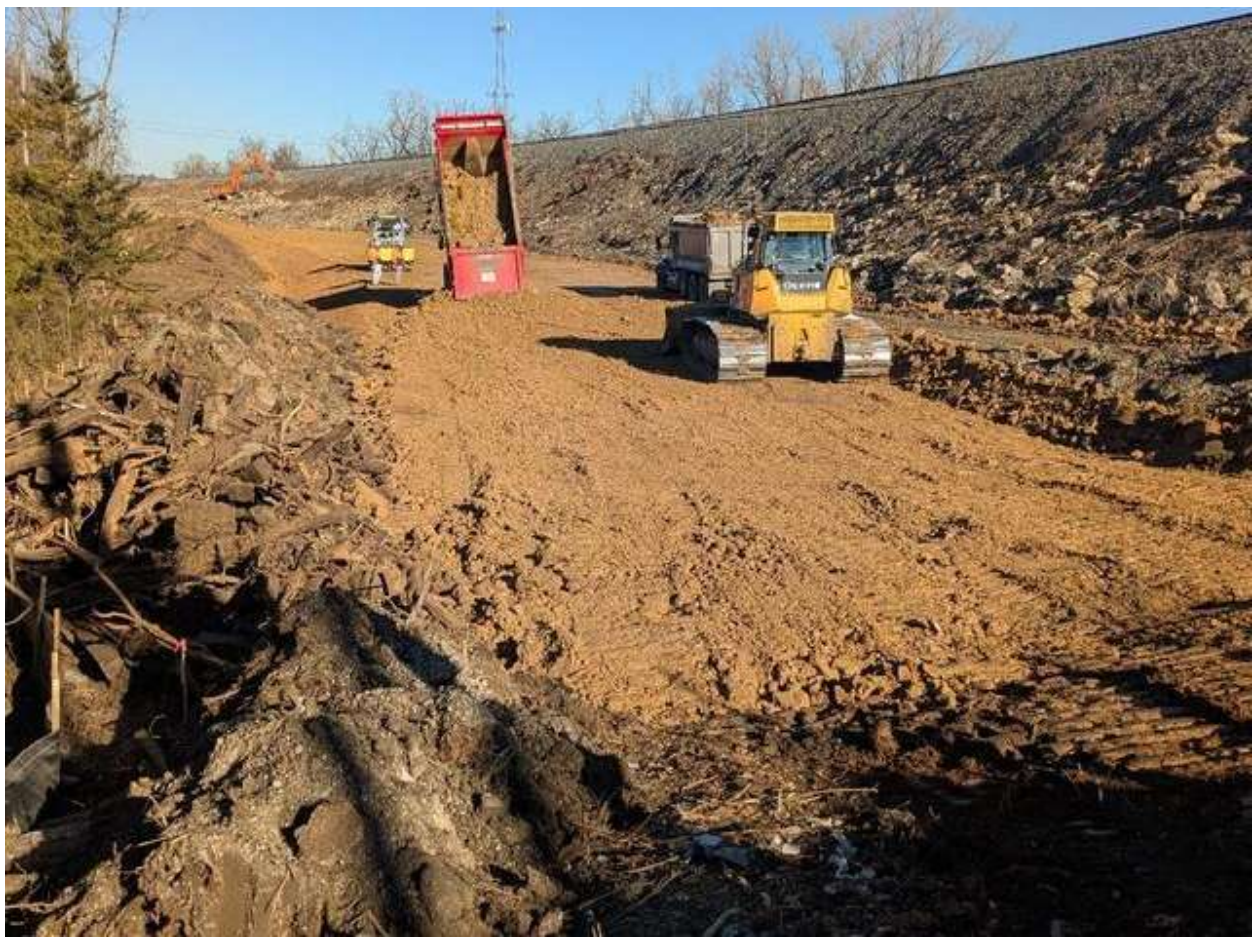
**Photo Date:** December 7, 2024

**Description of photo:** Filling of ROW on the north side of Coalmine Road for crane pad construction.

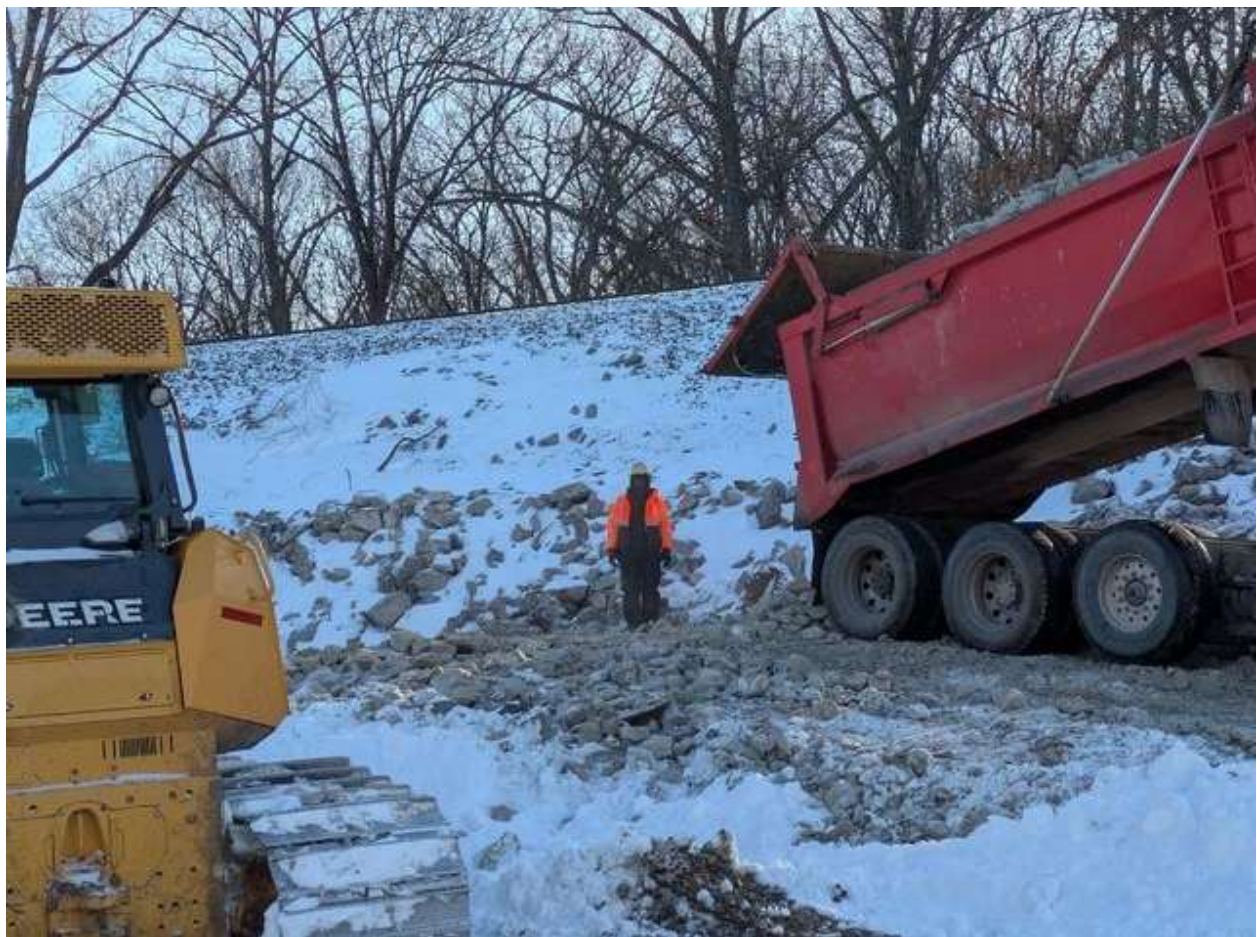
**Photo Date:** January 9, 2025

**Description of photo:** Loading in riprap near Coalmine Road.

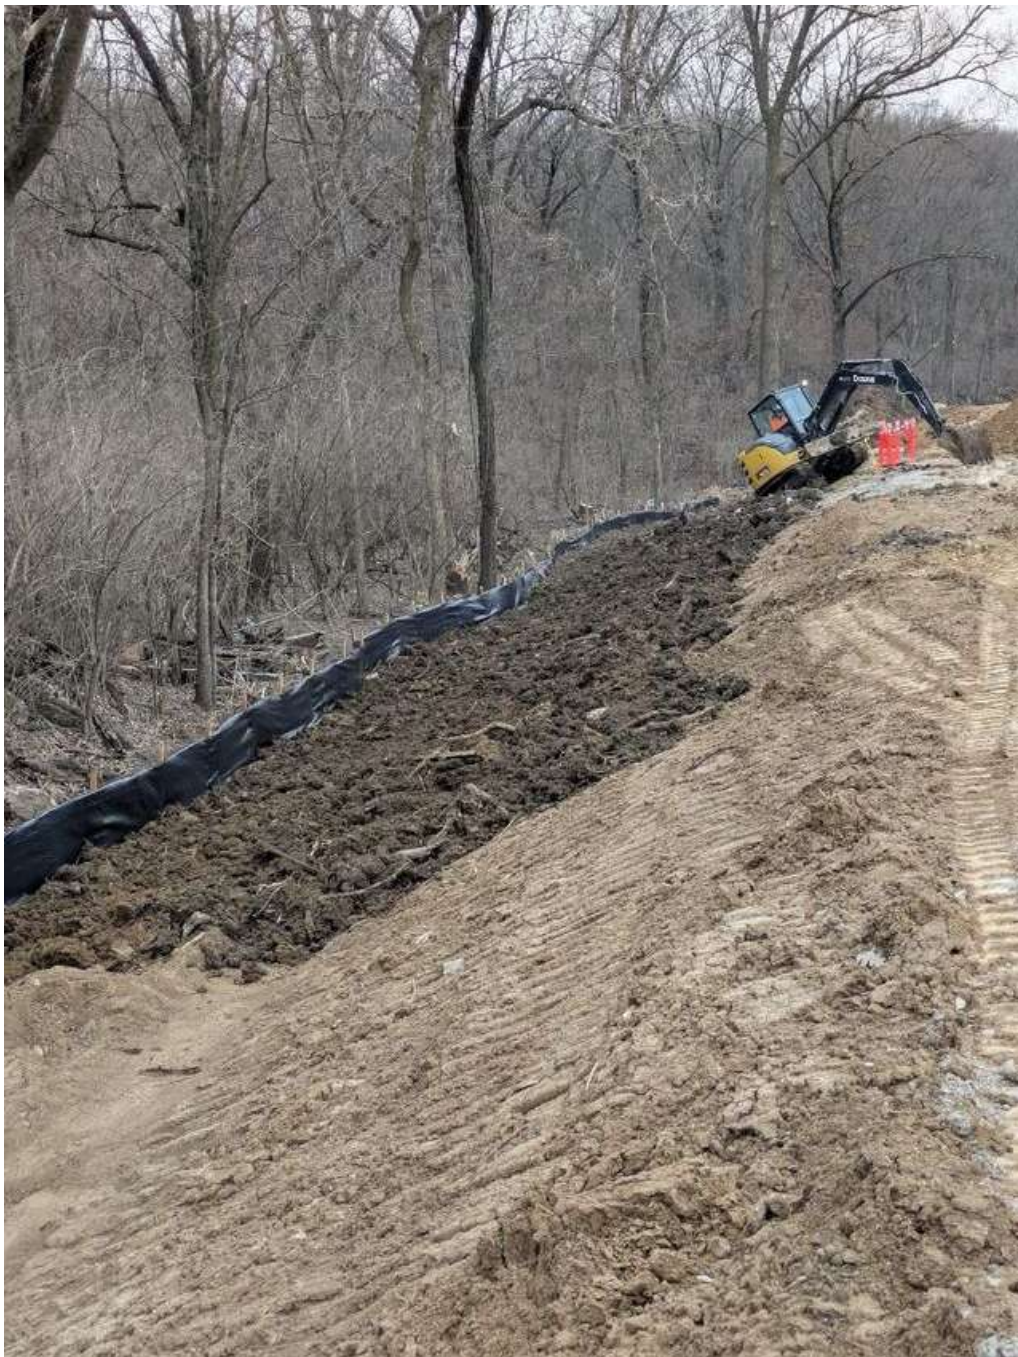
**Photo Date:** February 11, 2025

**Description of photo:** Topsoiling on the east side of tracks, south of Coalmine Road.

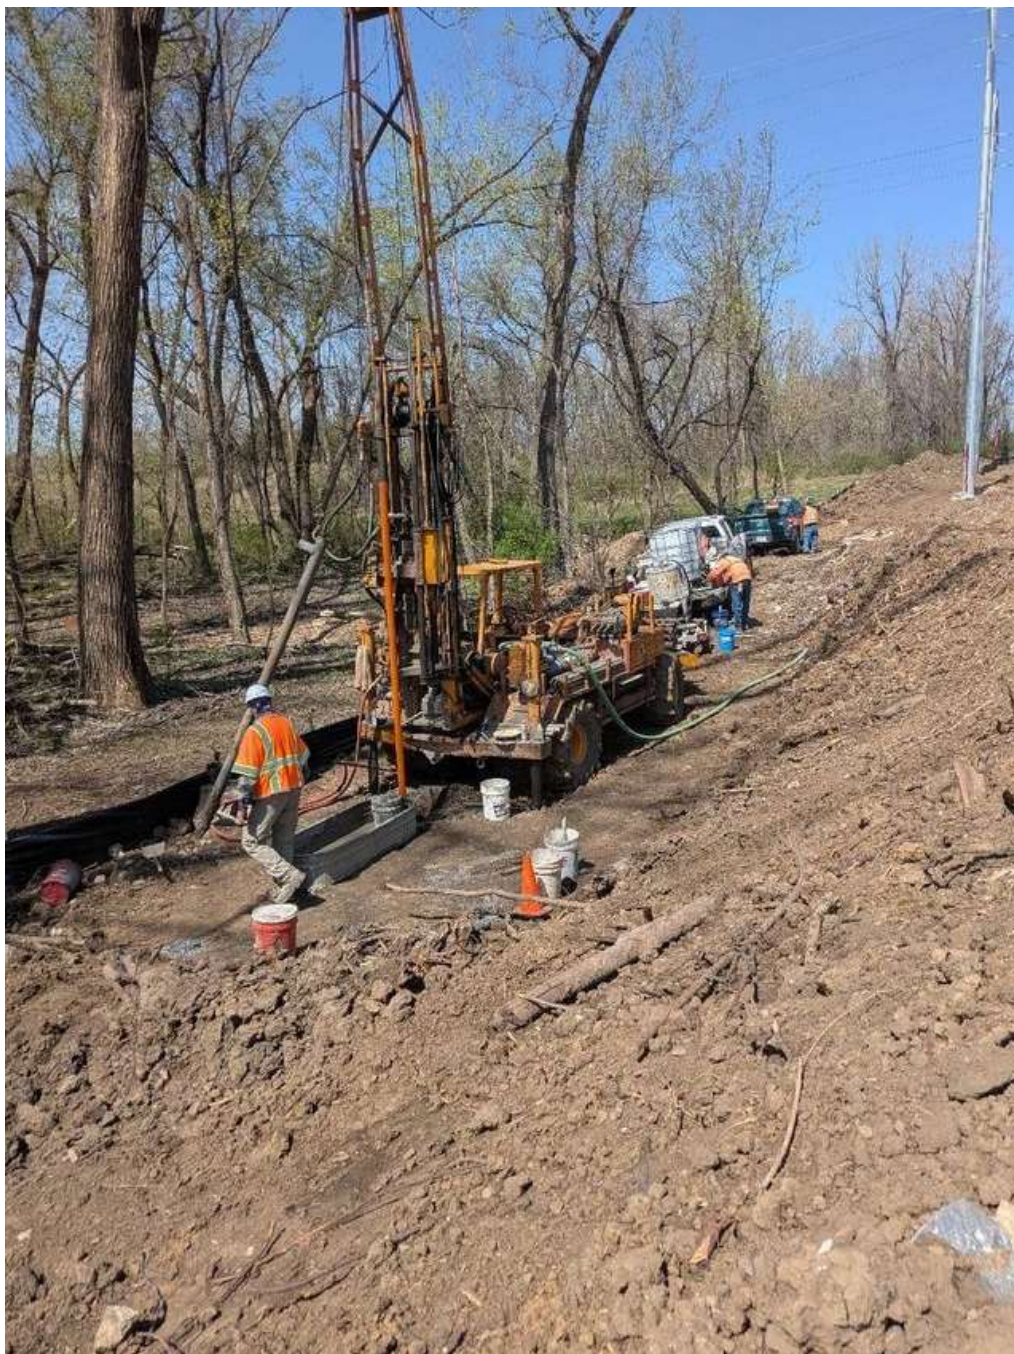
**Photo Date:** March 31, 2025

**Description of photo:** Drilling for inclinometer installation.

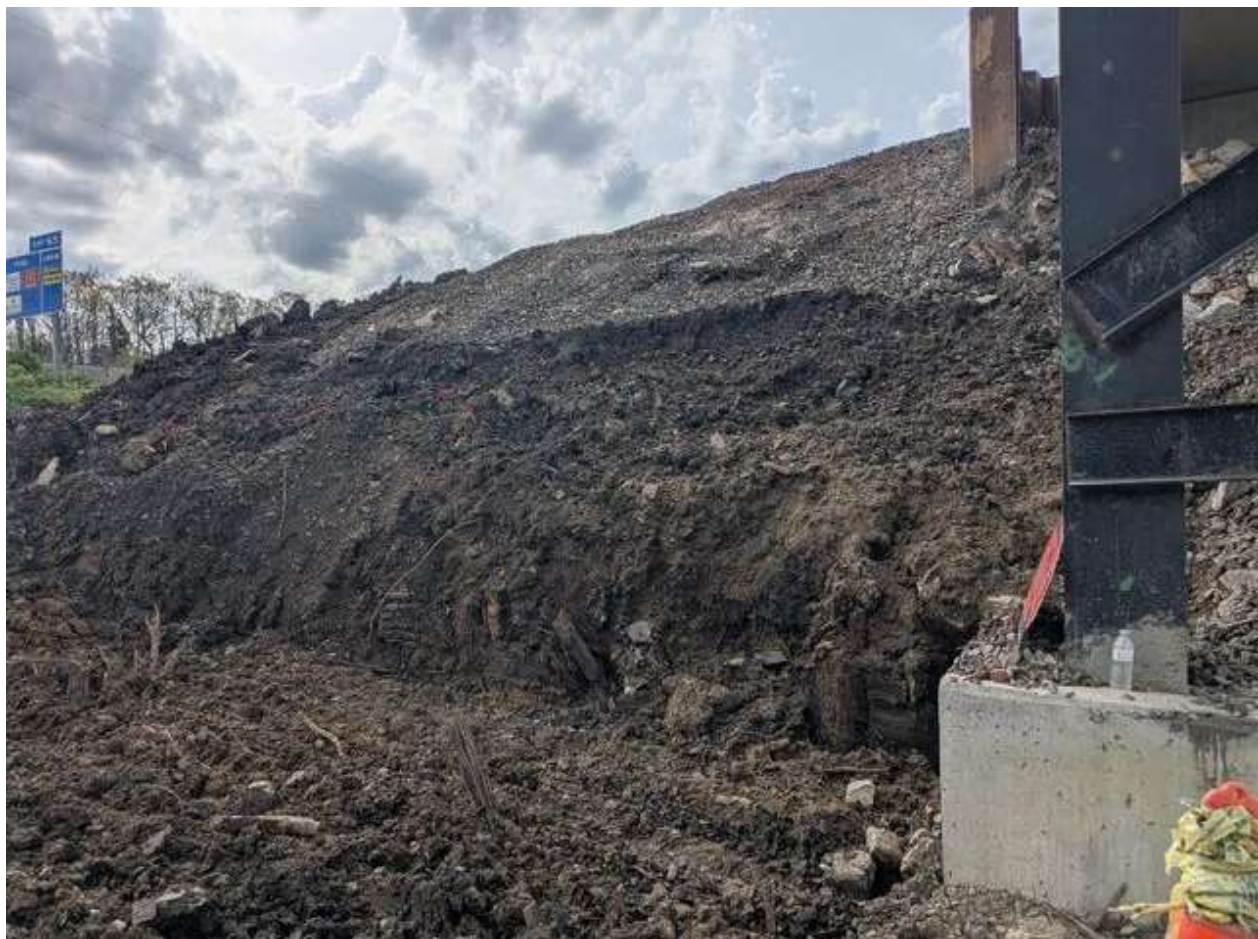
**Photo Date:** April 25, 2025

**Description of photo:** Excavation profile of existing railroad embankment.

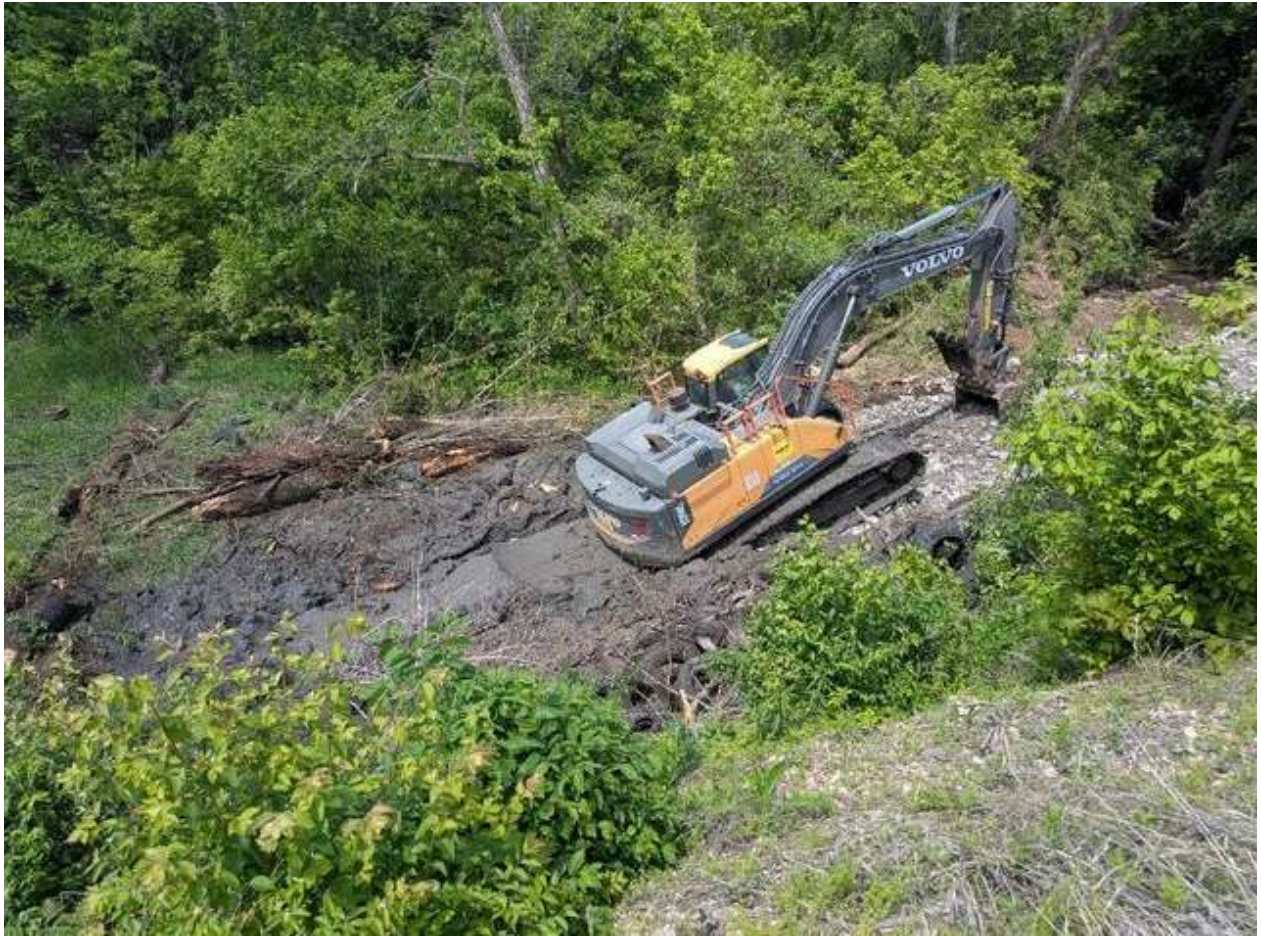
**Photo Date:** May 8, 2025

**Description of photo:** Ramp and rock road base installation to access wetlands.

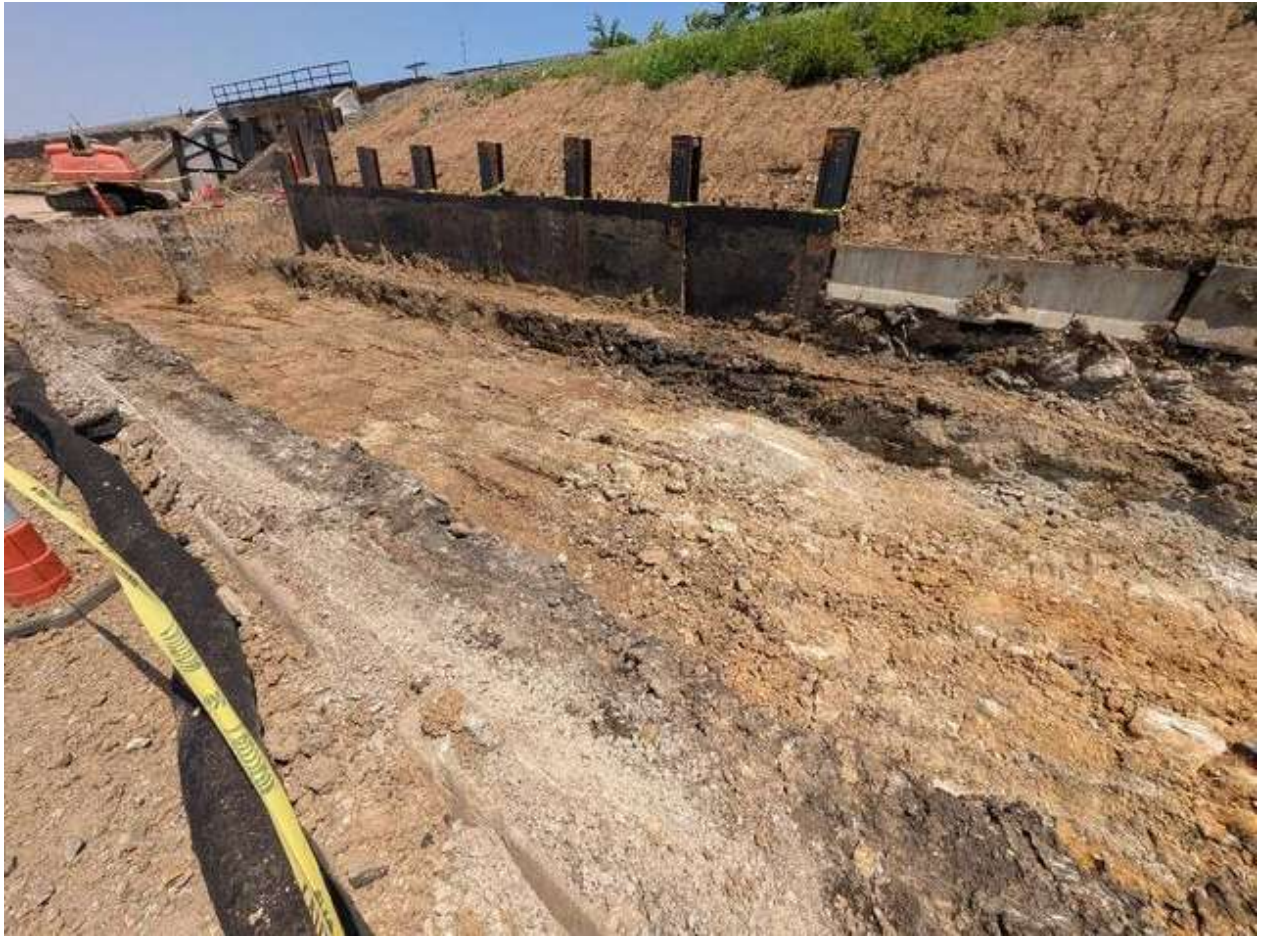
**Photo Date:** June 9, 2025

**Description of photo:** Excavation of Wall 3 at 39<sup>th</sup> Street.

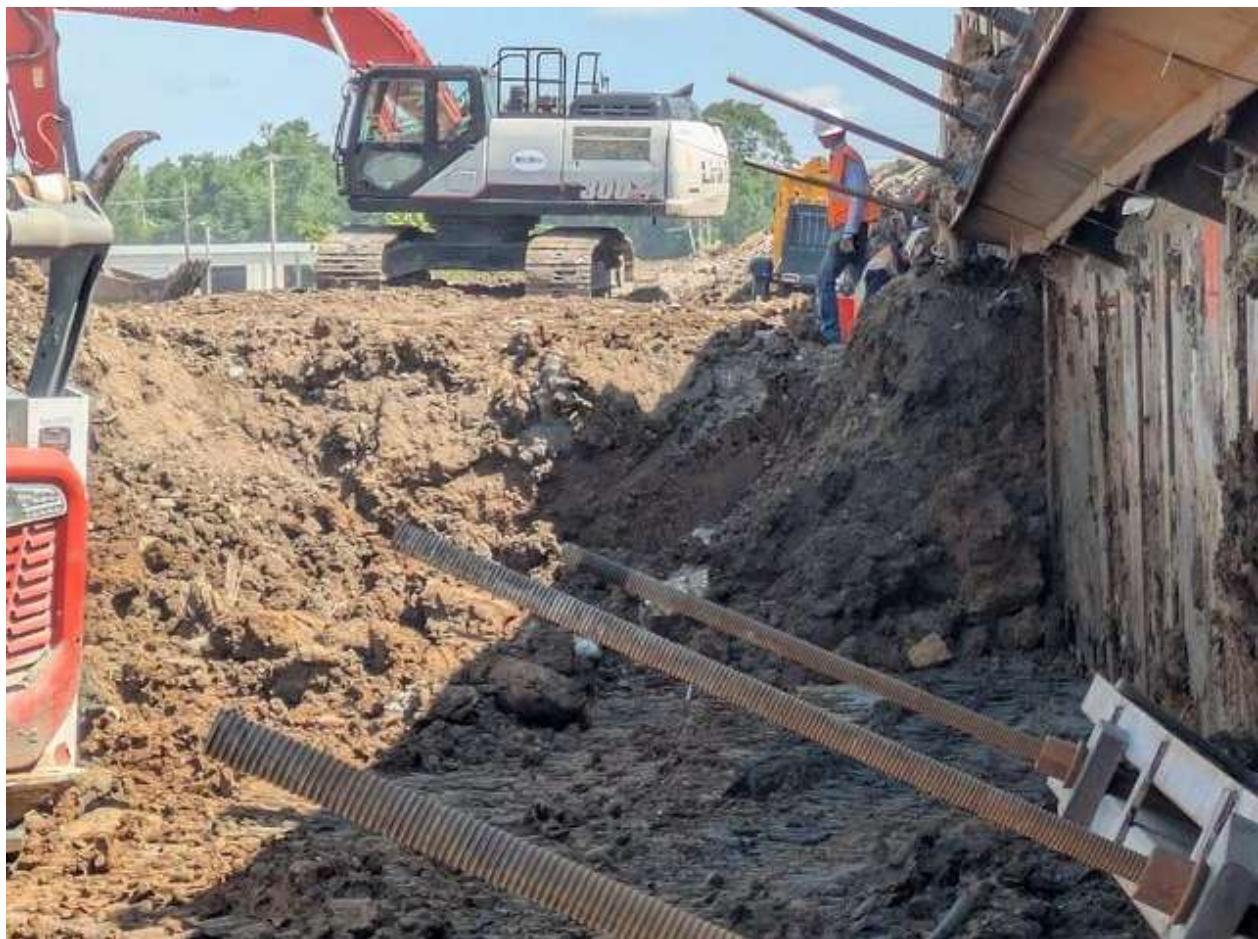
**Photo Date:** July 10, 2025

**Description of photo:** Installing walers and excavation for tieback installation.
