## **APPENDIX D**

### **WATER RESOURCES**

**CSXT/L&I JOINT USE SUPPLEMENTAL EA  
Elvin & Brook Siding Extensions & Flatrock River Bridge Replacement**

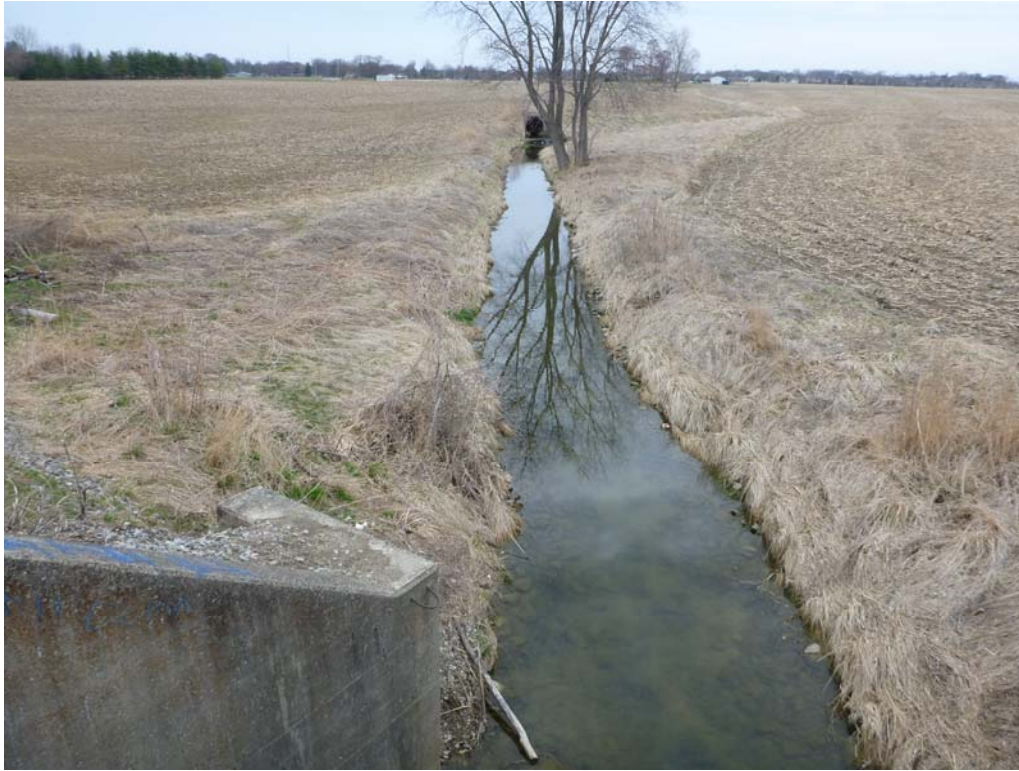
**Photo 1. WOUS-1.** Unnamed tributary of Young's Creek that is conveyed under L&I Line through a large concrete structure. Orientation northeast (upstream).

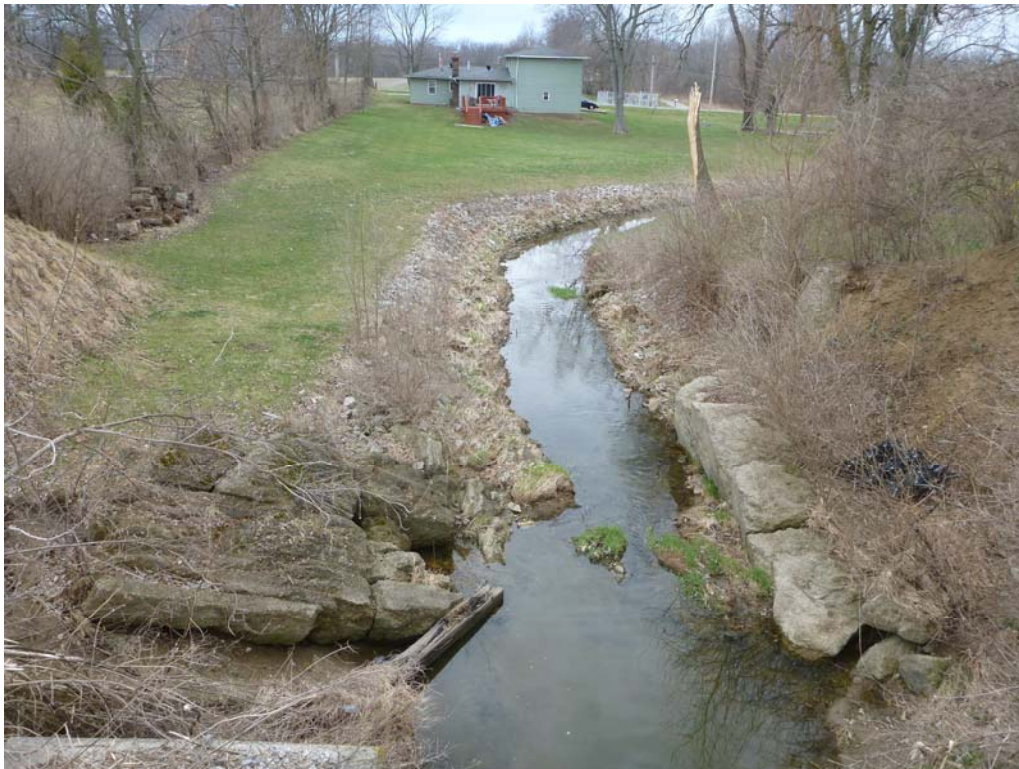
**Photo 2. WOUS-1.** Unnamed tributary of Young's Creek. Orientation southwest (downstream).

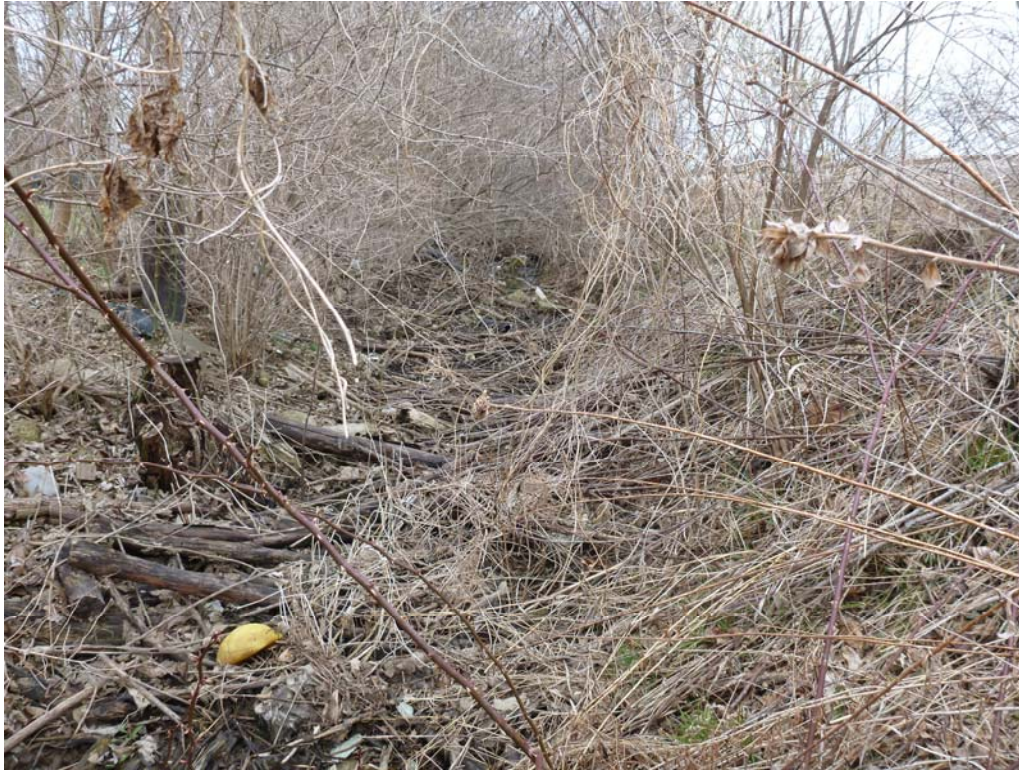
**Photo 3. WOUS-2.** Narrow depression located on the edge of L&I ROW; ephemeral drainage drains toward WOUS-1. Orientation northwest.

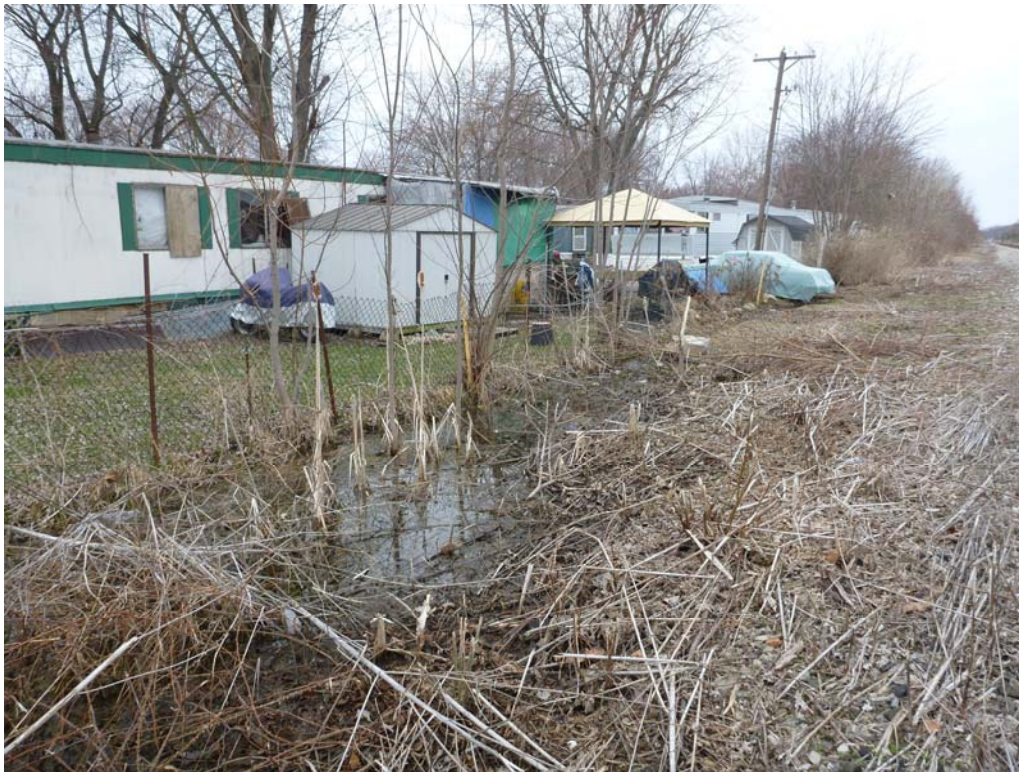
**Photo 4. S-1.** Emergent wetland located near the edge of L&I ROW. Orientation northwest.

| Sample Point <sup>a</sup> | Fig 2 Sheet No. | Photo No. | Wetland Classification <sup>b</sup> (Cowardin) | Area <sup>c</sup> (acre) | Nearest Siding | Comments |
|---|---|---|---|---|---|---|
| S-1 | 2 | 4 | PEMA/PEMC | 0.02 | Elvin | Isolated emergent wetland located at the base of the railroad embankment. The narrow depression was dominated by emergent hydrophytes, and standing water was observed at the time of the field visit. |

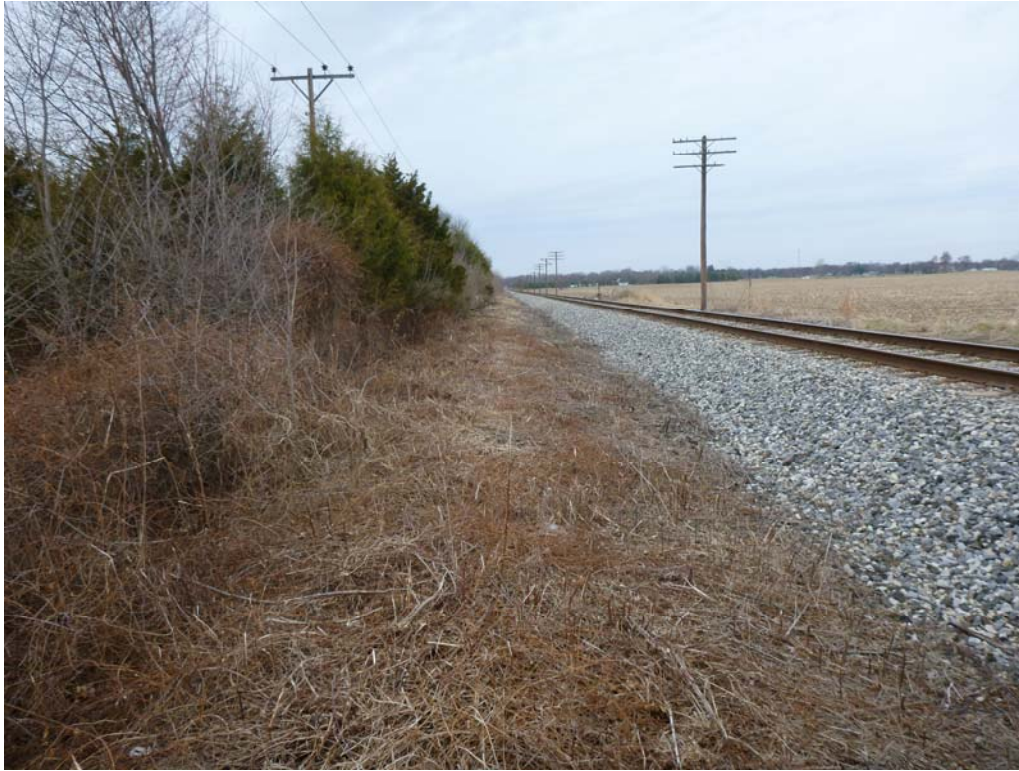
**Photo 5. S-2.** Upland area adjacent to the wetlands described by S-1 and S-3. Orientation northwest.

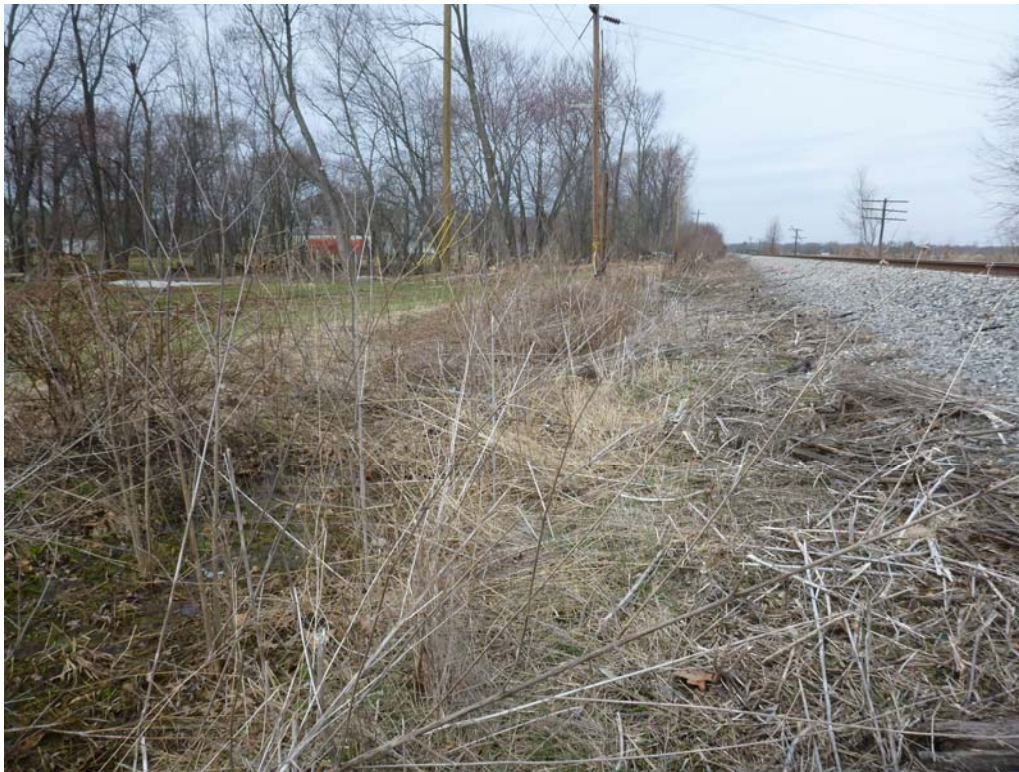
**Photo 6. S-3.** Emergent wetland located at the base of the railroad embankment. Orientation northwest.

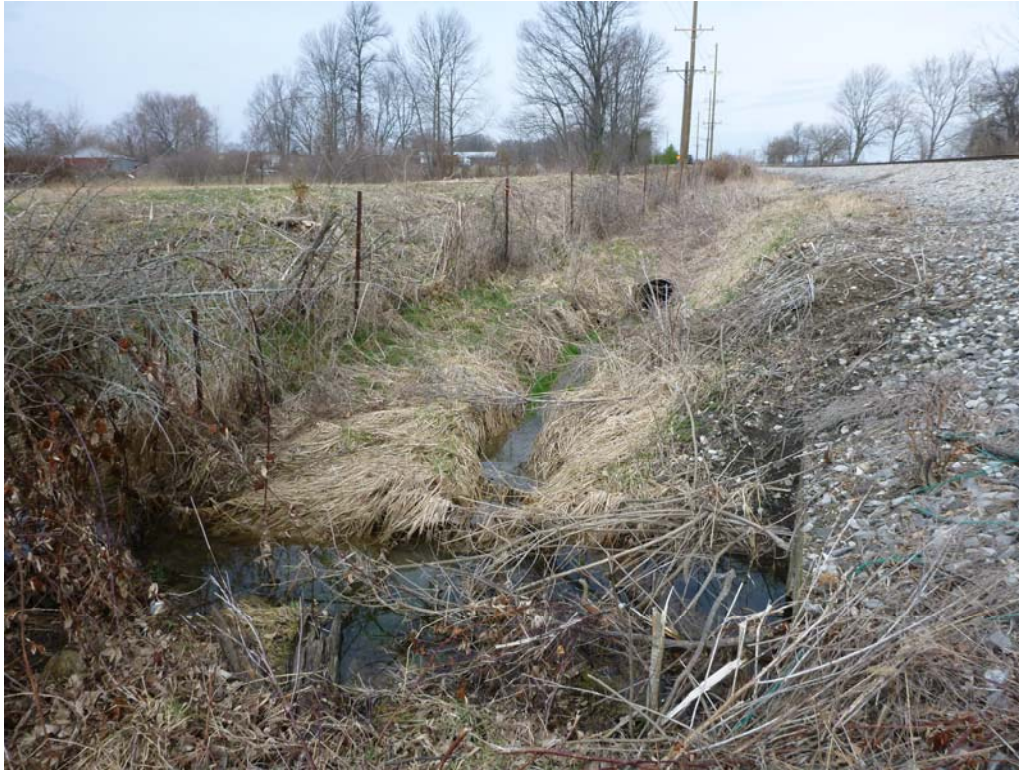
**Photo 7. WOUS-3.** Ephemeral channel conveyed under L&I Line, drains to the west into a human-made impoundment. Orientation northwest.

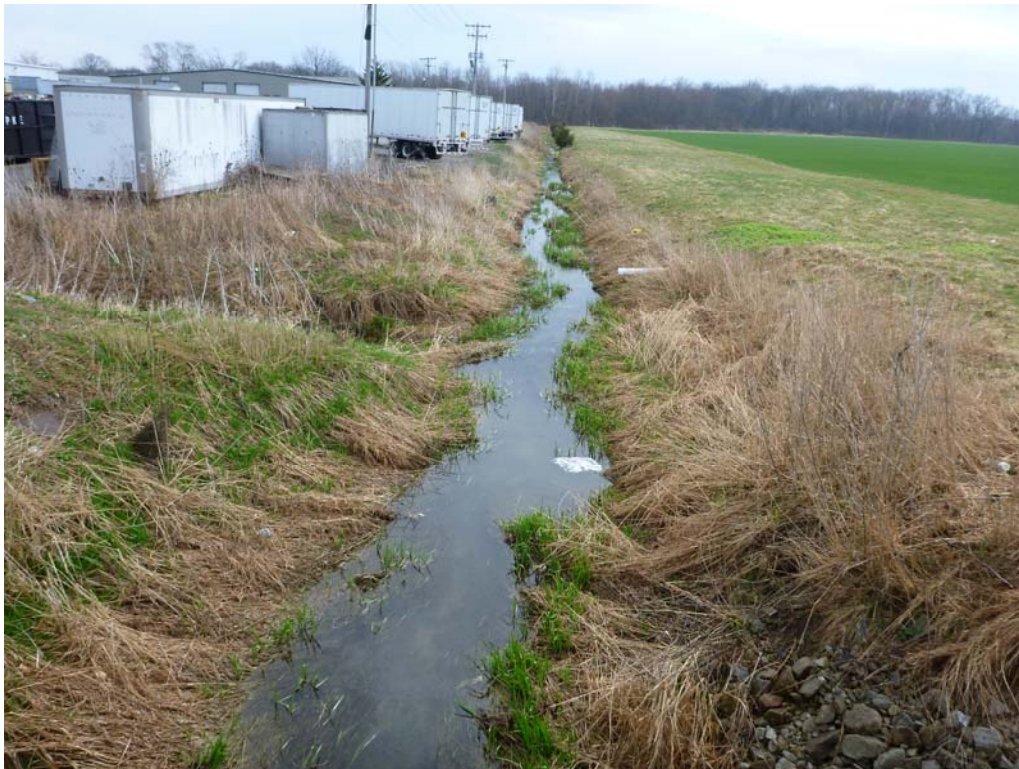
**Photo 8. S-4.** Emergent wetland located adjacent to the channel described by WOUS-4. Orientation east.

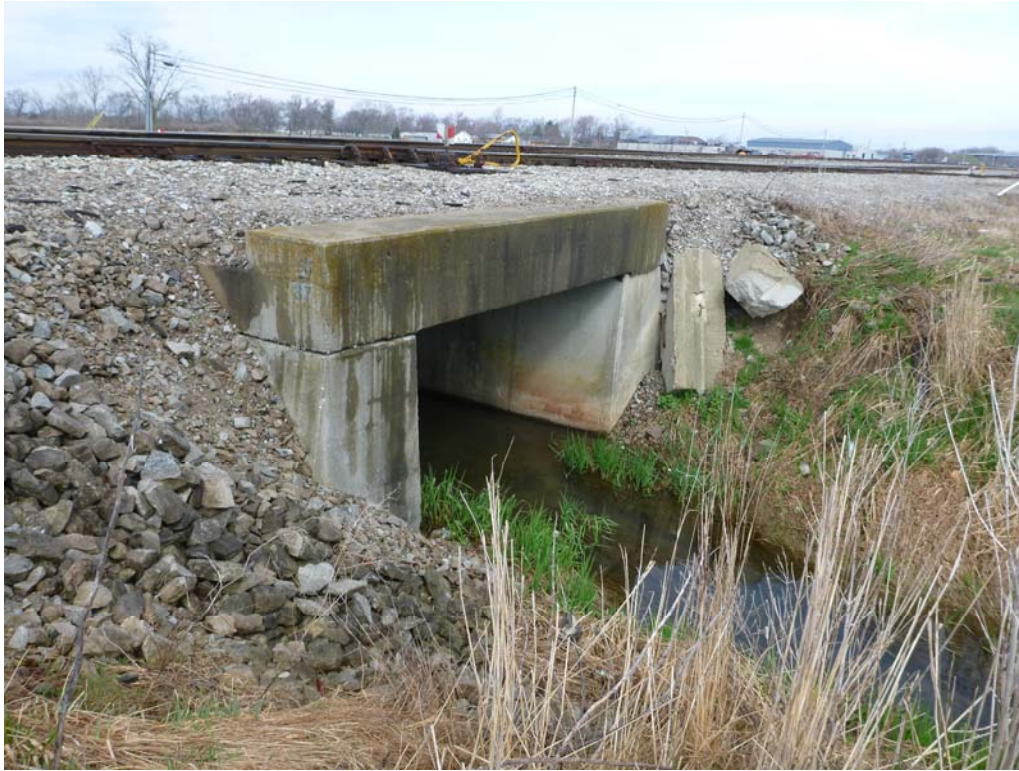
**Photo 9. WOUS-4.** Channel conveyed under L&I Line. Orientation northwest.

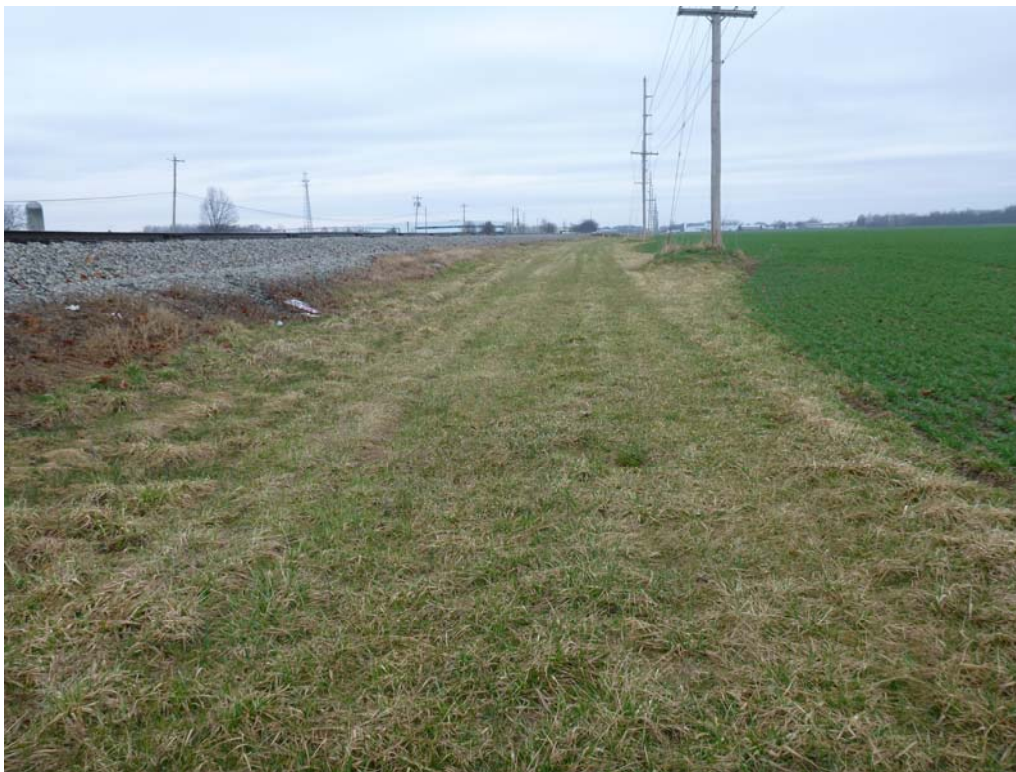
**Photo 10. S-5.** Upland ditch located within L&I ROW. Orientation north.

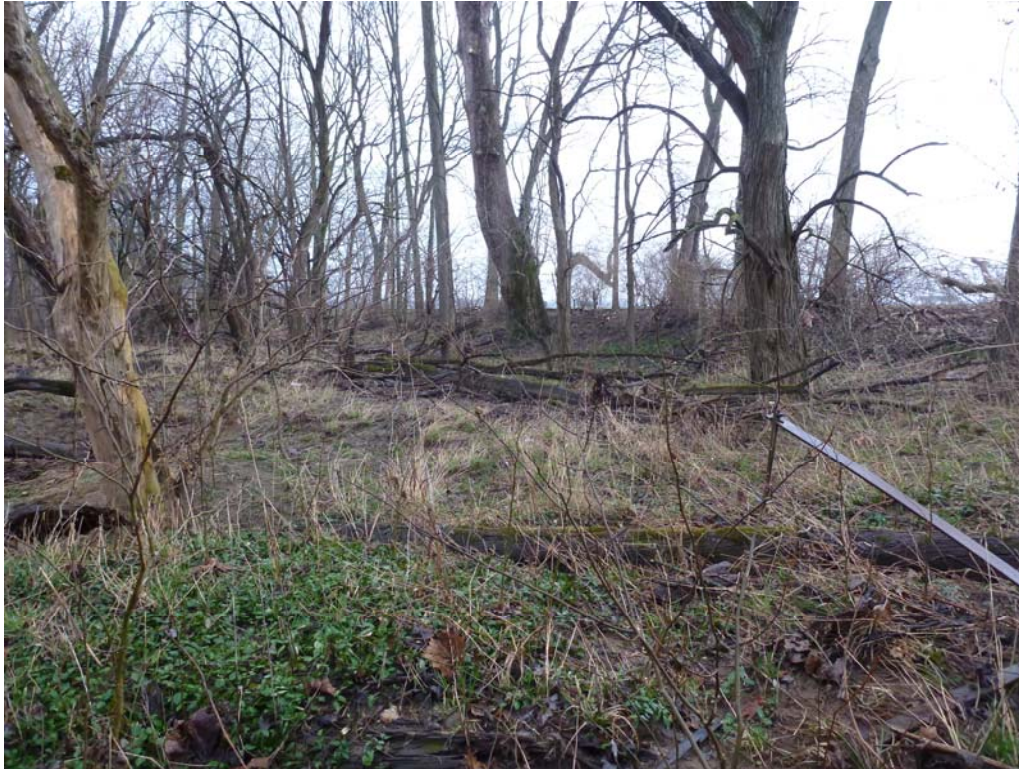
**Photo 11. S-6.** Upland forested area located on the northwest bank of Flatrock River. Orientation north.

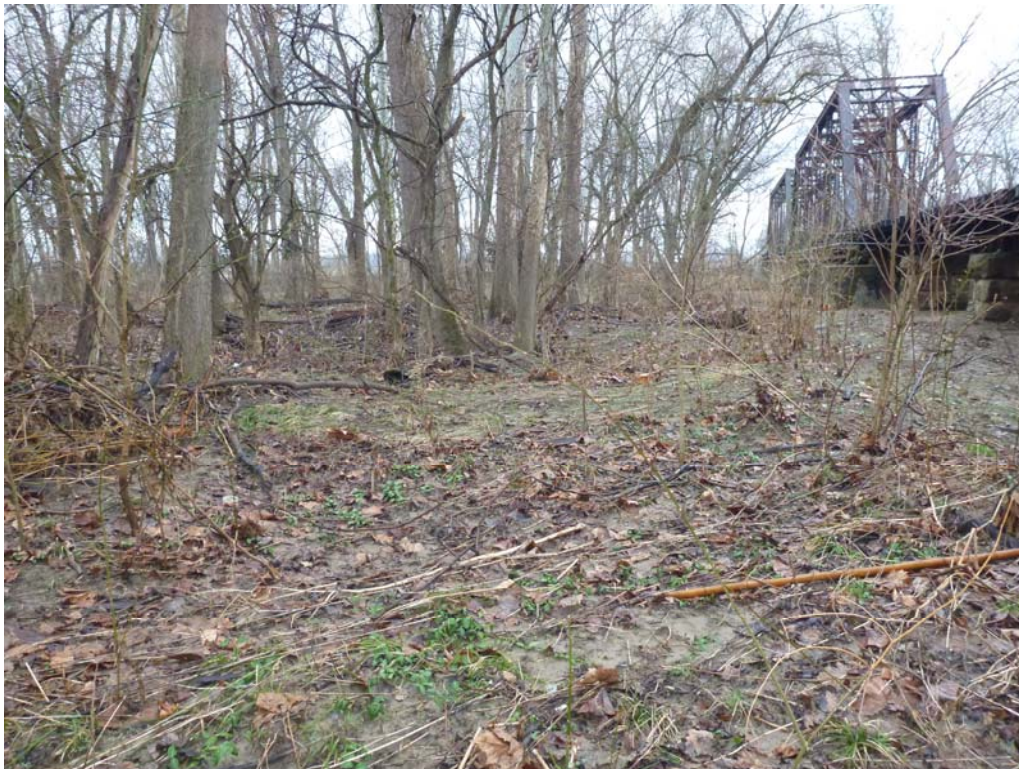
**Photo 12. S-7.** Upland forested area located on the southwest bank of Flatrock River. Orientation north.

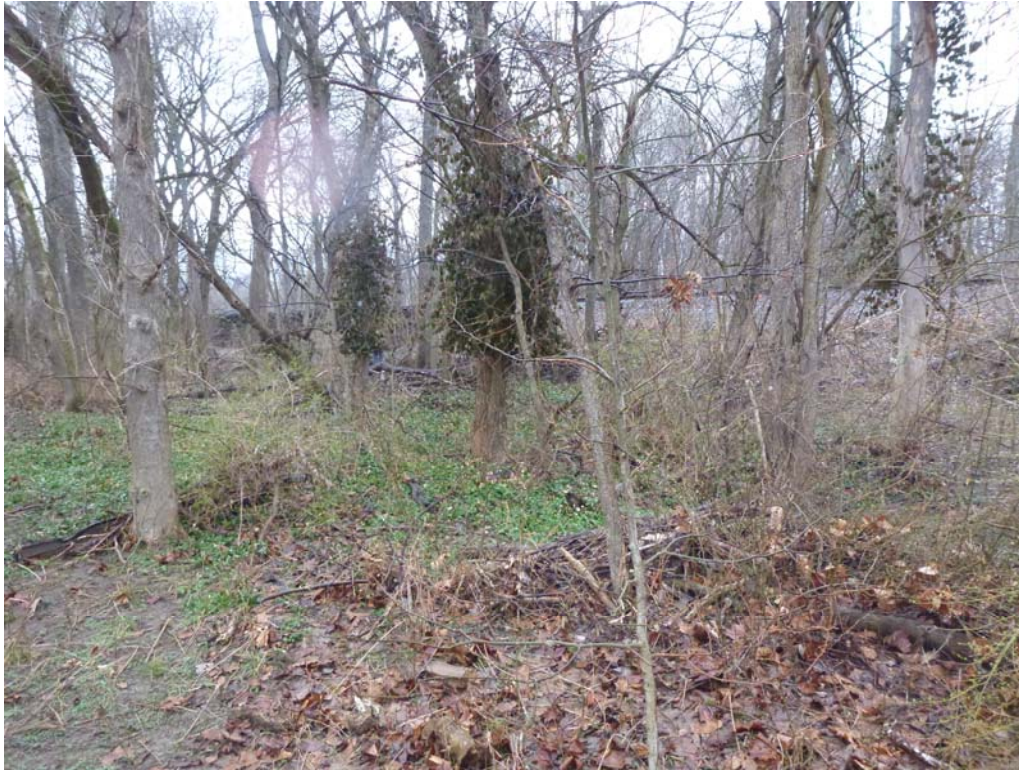
**Photo 13. S-8.** Upland forested area located south of S-7, west of the L&I Line. Orientation south.

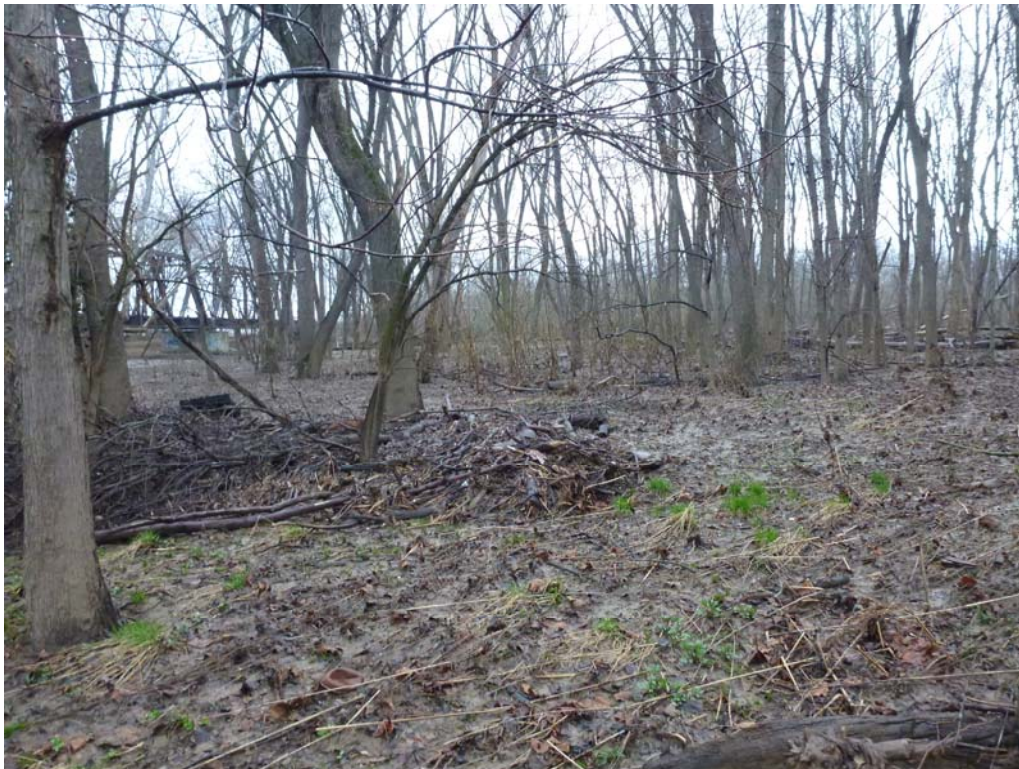
**Photo 14. S-9.** Forested wetland located southeast of the Flatrock River Bridge. Orientation northwest.

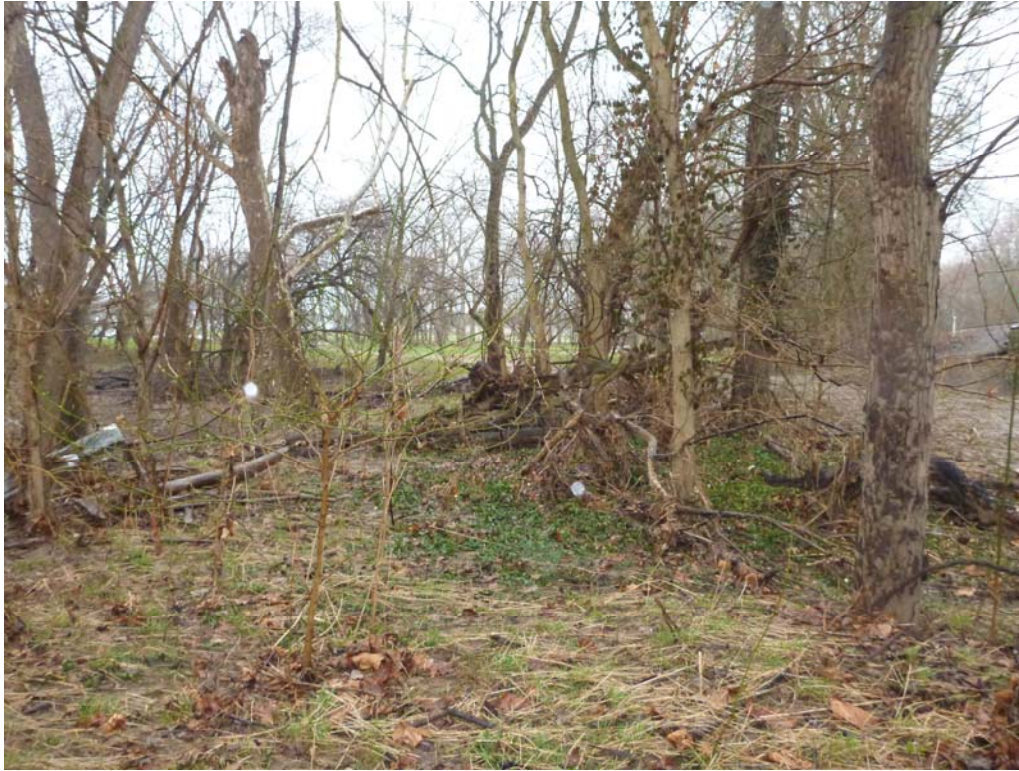
**Photo 15. S-10.** Upland area located adjacent to the wetland described by S-9; the area is located upslope from S-9. Orientation south.

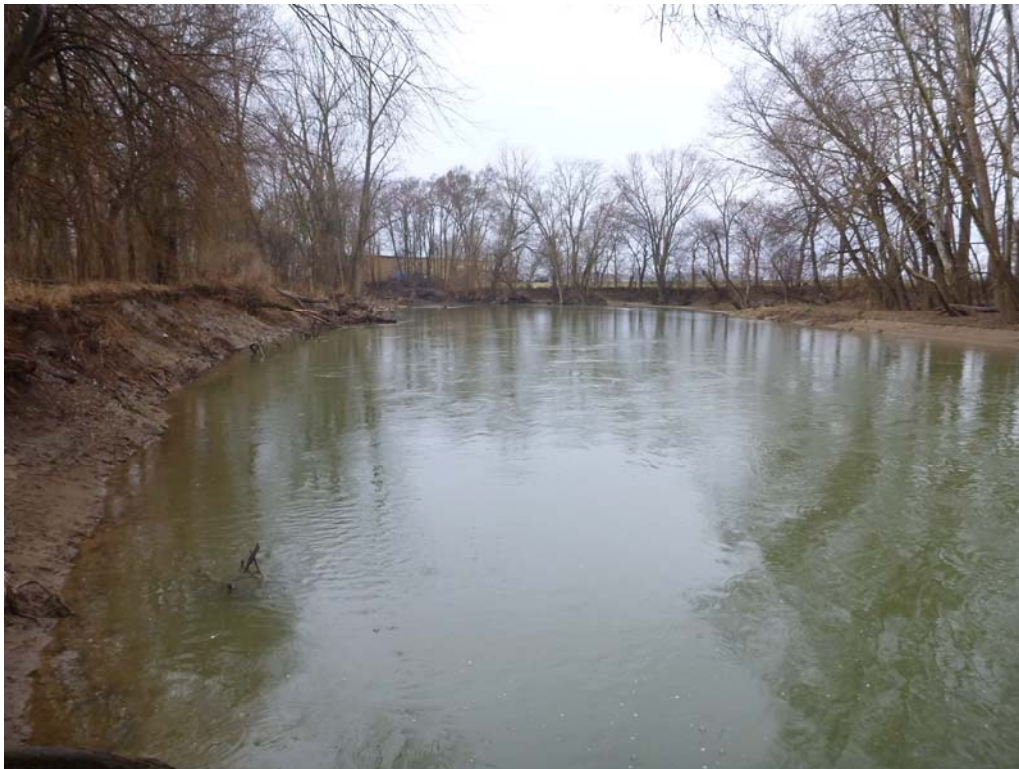
**Photo 16. WOUS-5.** Flatrock River. Orientation west (downstream).

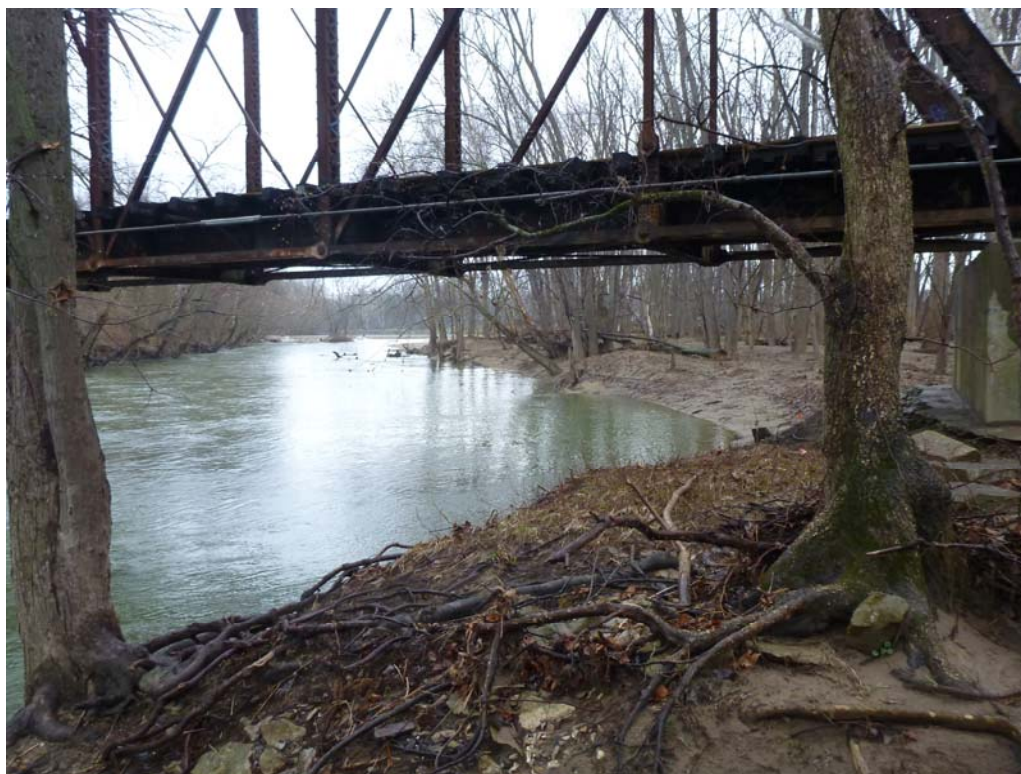
**Photo 17. WOUS-5.** Flatrock River. Orientation east (upstream).
