Re: Environromental Impact Statement Information  
Village of Barrington Hills, Illinois

## **Civil Engineer's Field Report**

**Project:** Barrington Hills

JOB 9355,000 BARRINGTON HILLS- EJ+E CULVERT

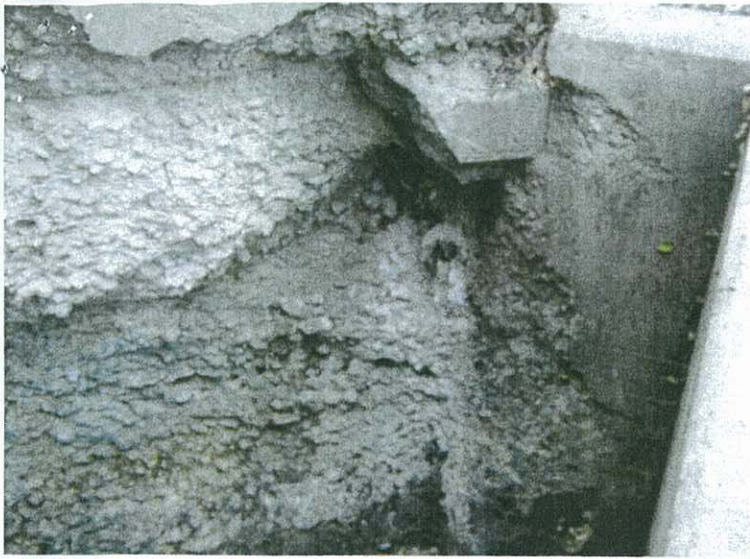
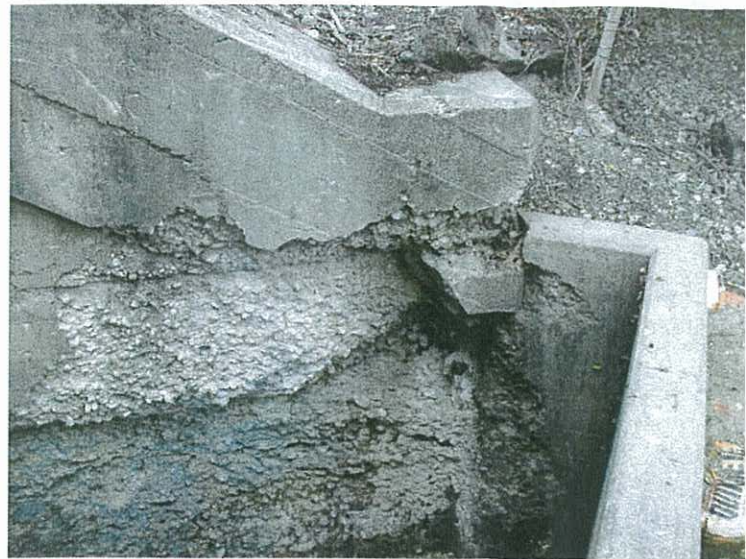
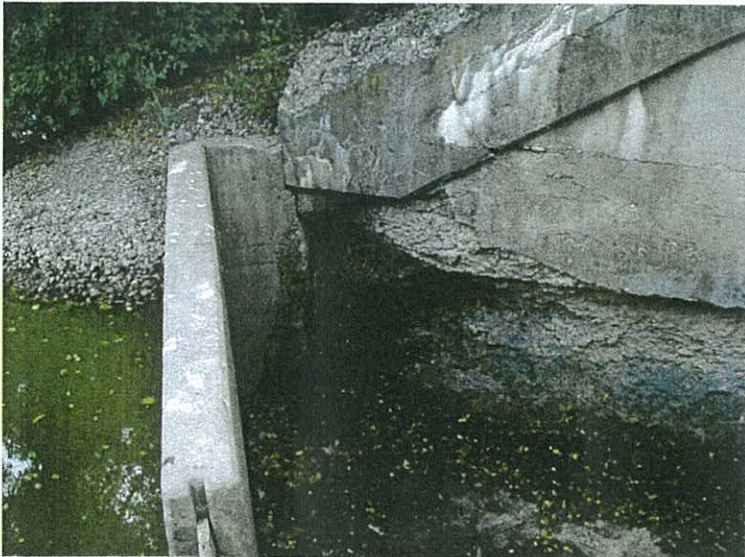
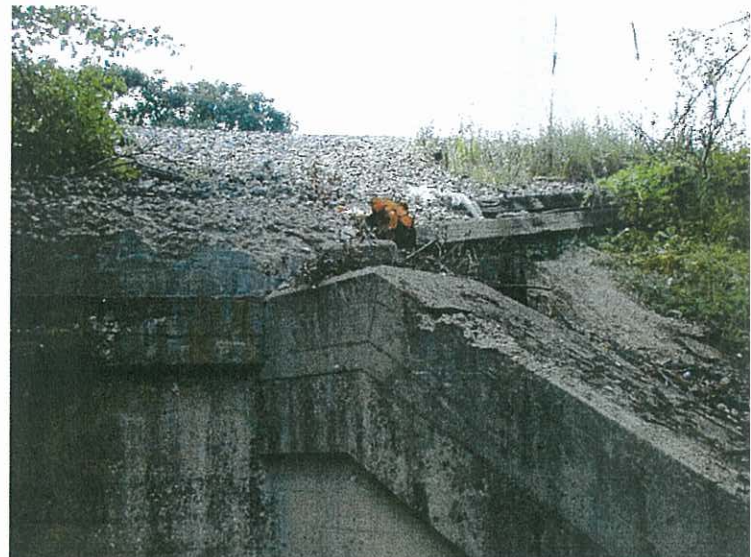
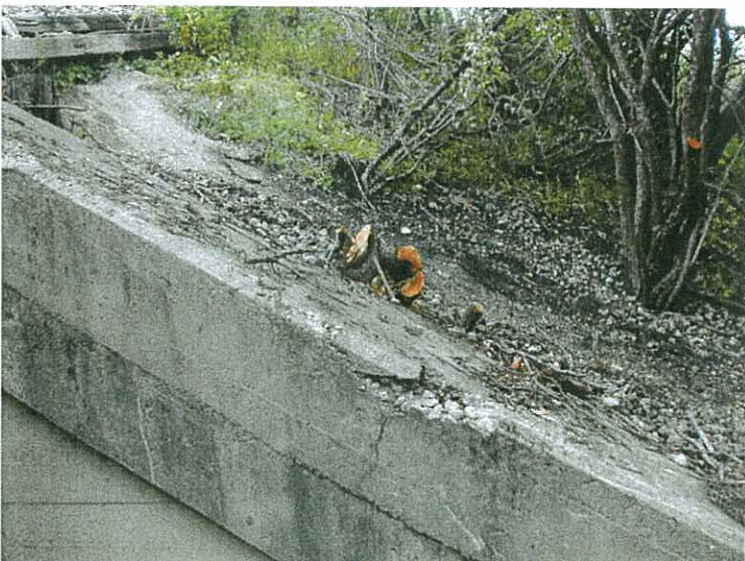
8/26/2003

1. As a follow up to the field report dated 8-12-03 I took photos of the repairs made at the EJ&E Culvert. The photos are attached.
2. The repairs appear to be temporary in nature. The hole in the east side of the weir was mortared, and bags of ready-mix concrete were placed around the outside of the wall. No repairs were made to the west side of the weir, where similar distresses were noted. Several trees were removed from the area surrounding this culvert.

1. On Friday, September 5 I spoke with Mark Paull of EJ&E Railway Company, who was present when the problem was first noted. He said that the improvements in place were temporary in nature, but would remain in place until water begins to flow through again. If and when this occurs, he said they would revisit the problem and come up with a more permanent solution.

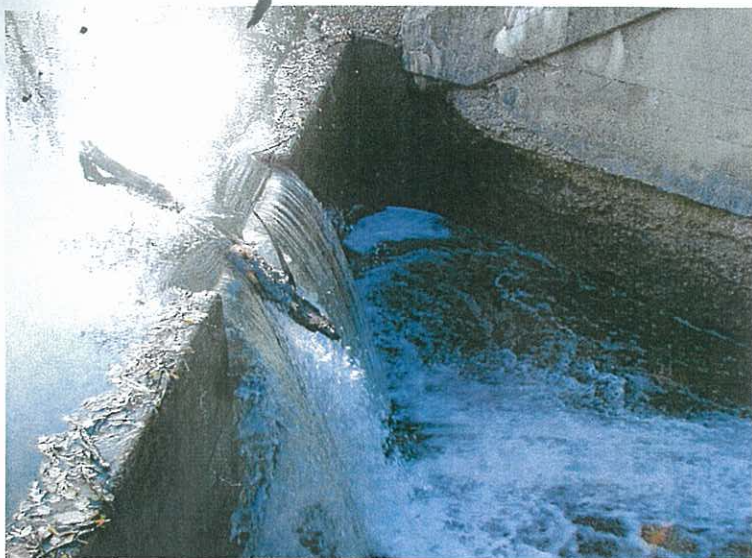
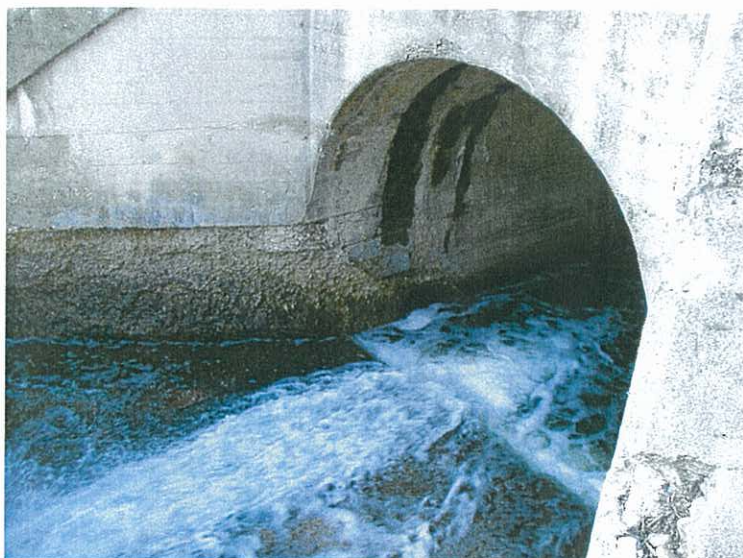
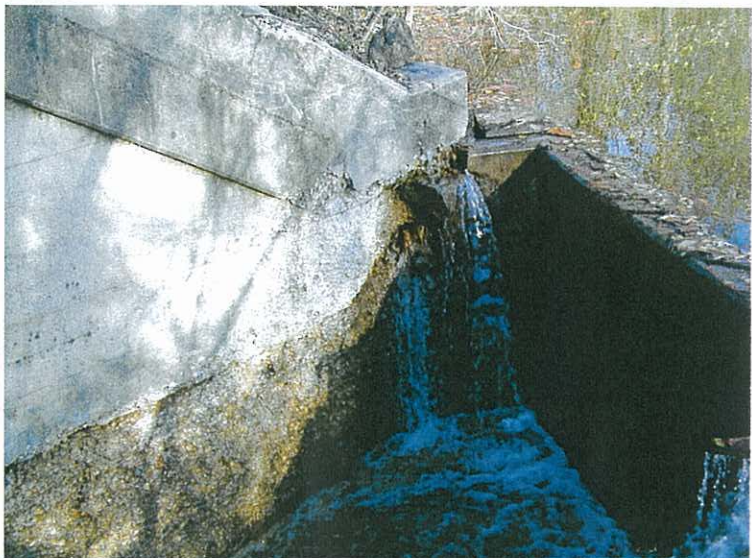
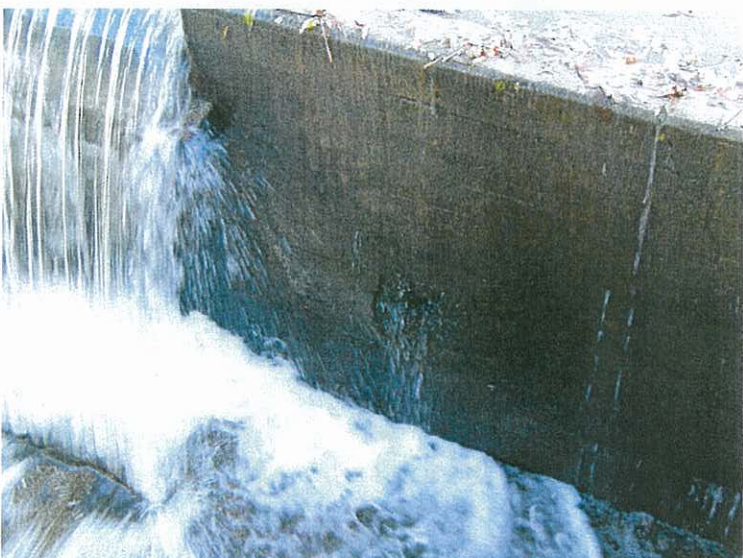
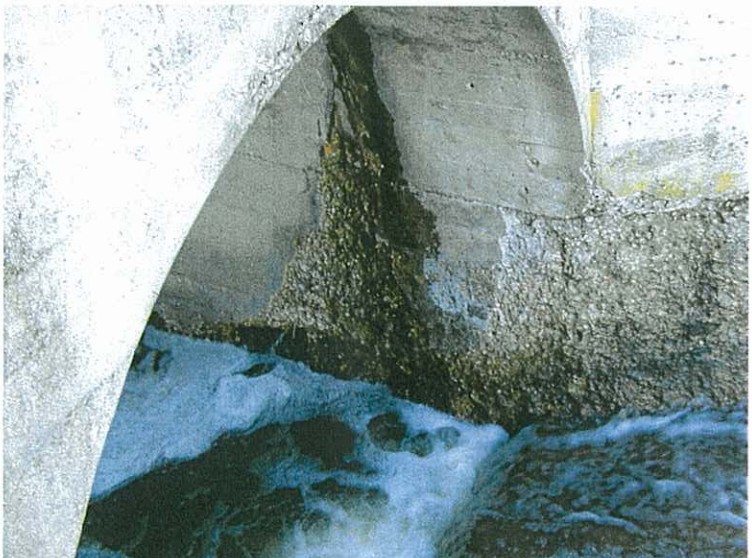
PHOTOS TAKEN 11/7/03

1. I visited the EJ&E culvert to check on the condition of the repairs made to the weir walls, given recent heavy rainfalls. Please see attached photos.
2. The water appears to have broken through the repairs, and the culvert is now in much the same condition that it was in prior to repairs. Water is penetrating the east wingwall, though the volume of water flowing through this hole is smaller than what was noted in the August 7 field report. Also, a small amount of water appears to be flowing out of a hole in the wall under the tracks, away from the wingwalls.
3. I contacted Mark Paull of EJ&E Railway Company, who first handled the initial repairs, to notify him that water was again flowing through the wingwalls of the culvert. He said they would revisit the site and notify the village as to what further repairs would be made.
