Re: Docket No. FD 36500, CPKC Quarterly Environmental Mitigation  
Measures Report for March 15 to June 14, 2024

# CPKC Quarterly Environmental Mitigation Measure Compliance Report Number 5

This report includes compliance activities completed between March 15 and June 14, 2024 (Quarter 1, Year 2 of the STBs oversight period following the acquisition of KCS by CP, STB Docket FD 36500)

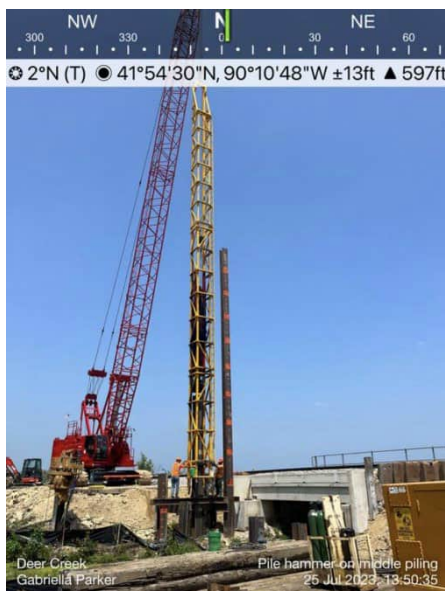
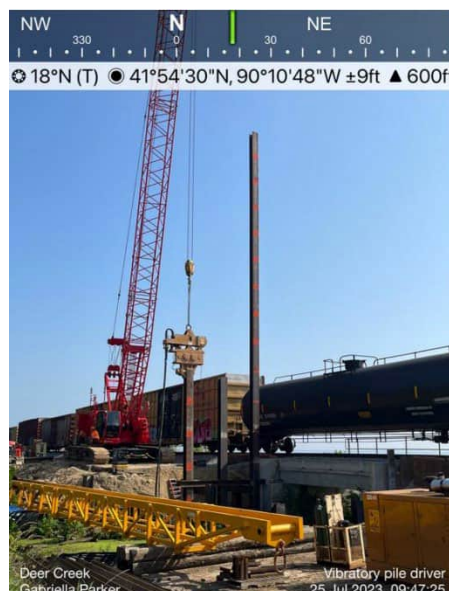
All noise on project was within acceptable limits of the project permits at all times.

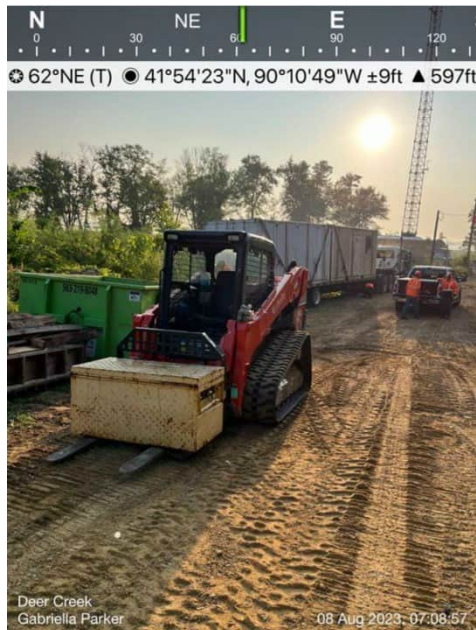
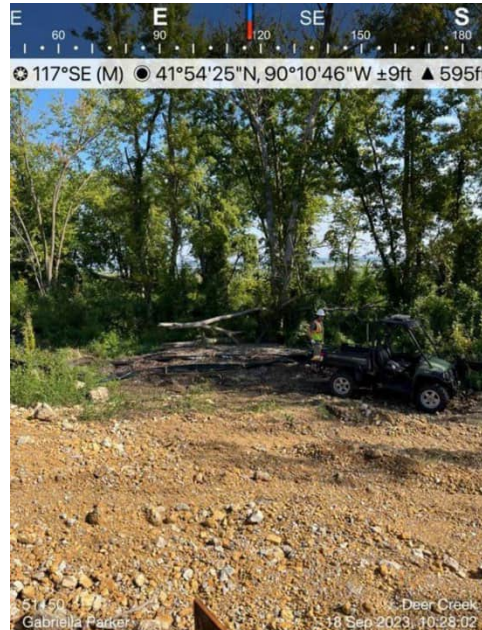
The anti-idling policy was discussed in the morning job briefings with all onsite personnel. Equipment and vehicles were not run unless being utilized for operations.

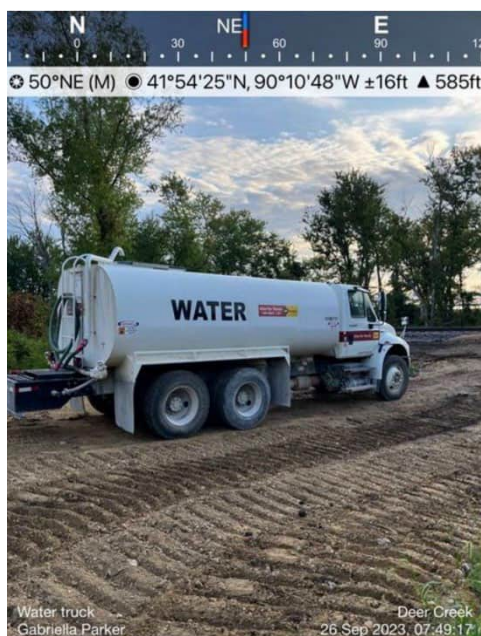
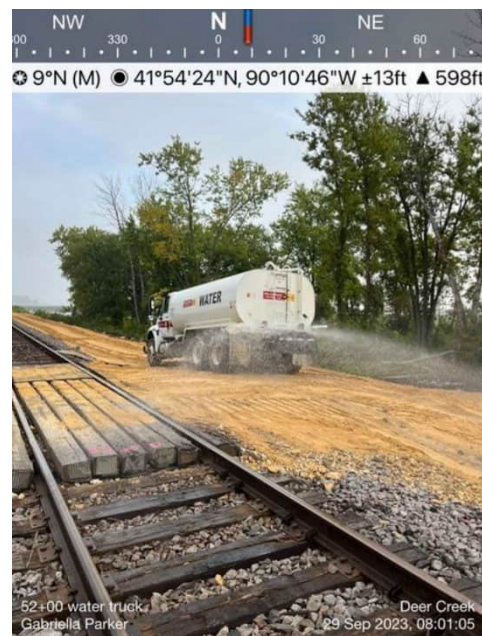
Water trucks were used to suppress dust throughout the duration of the project.

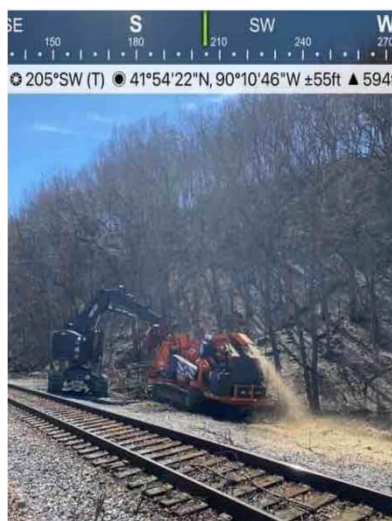
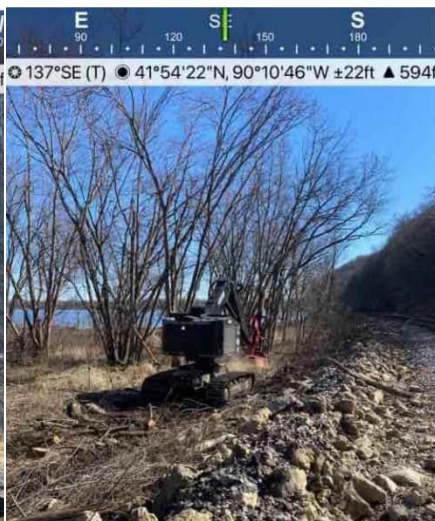
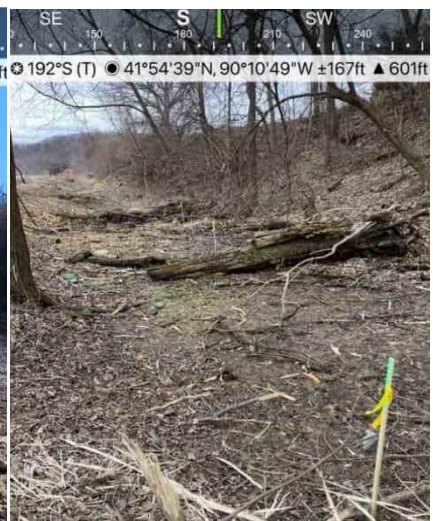
All clearing operations were completed outside of the above-listed dates. Environmental monitor inspected area for any signs of bats or birds before clearing took place.

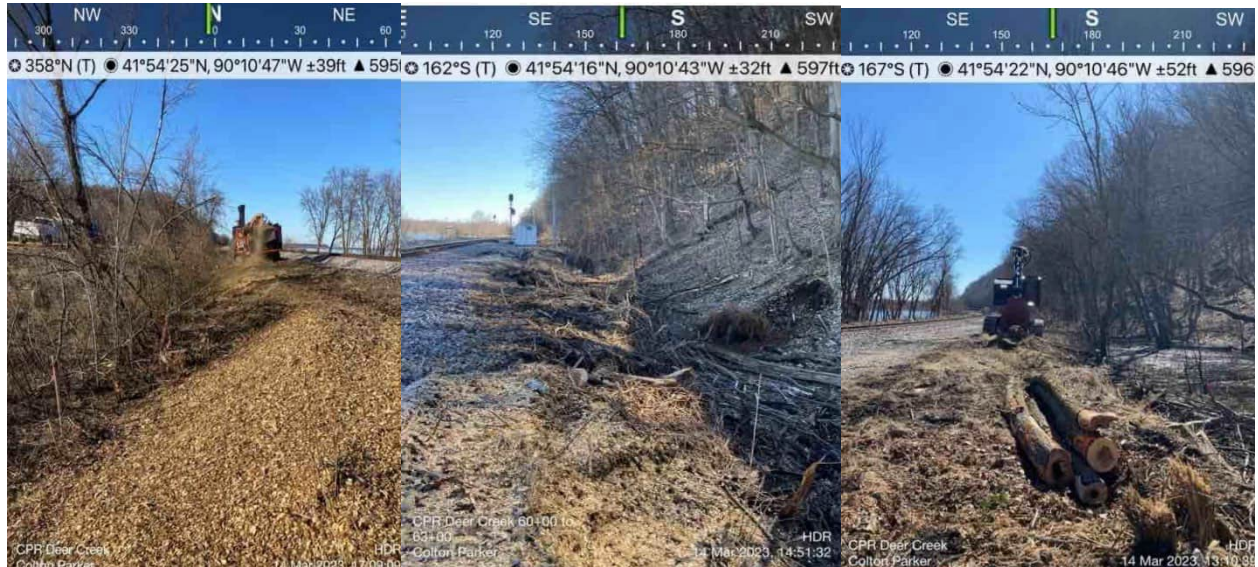
The clearing and construction boundaries were defined using survey stakes. Plan sets were provided to contractors outlining ROW boundaries. All contractors were made aware of any suitable bat habitats on ROW. There was no evidence of bats onsite throughout the duration of the project.

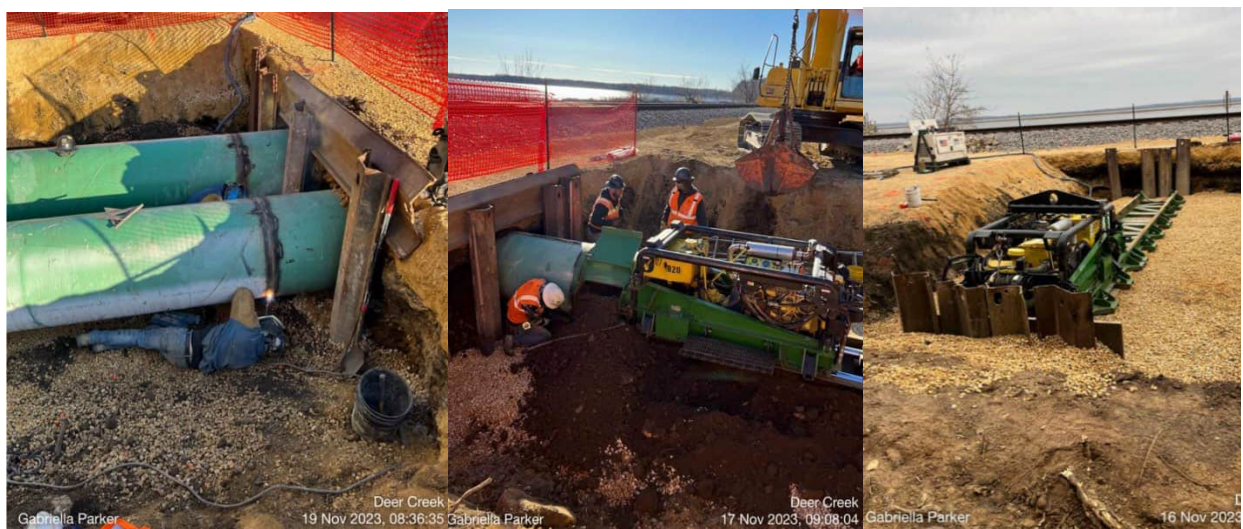
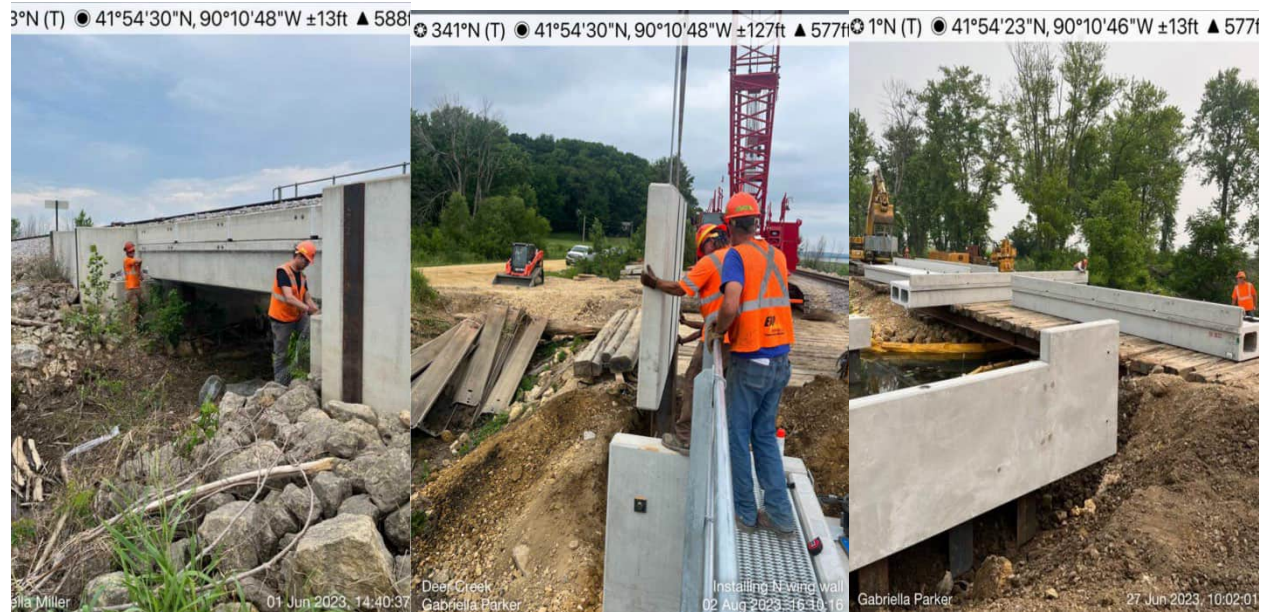
After it was determined that no bats or signs of bats were present in structures or onsite, culvert work and bridge construction was able to commence during the bat active season. Continued inspection of bat presence continued to be conducted throughout the construction phase.

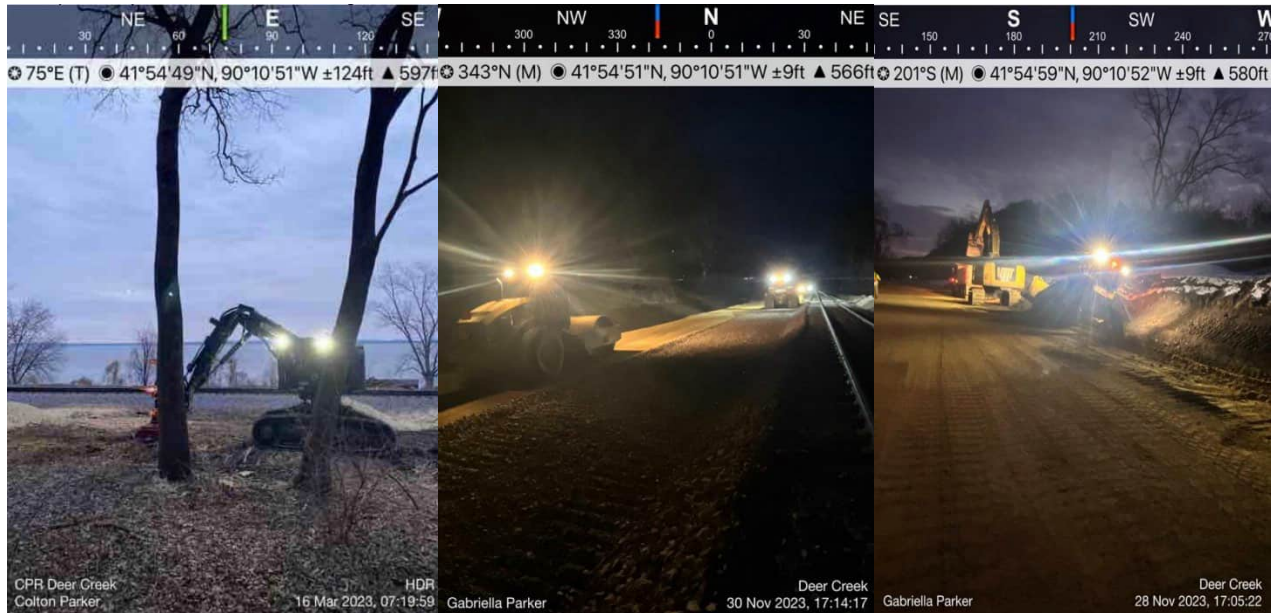
All temporary lighting was directed away from any suitable habitat for the northern long-eared bat and Indiana bat during their active season of April 1 to October 31. Full cut off lens were used during work at night, all work at night was performed outside of the roosting season.

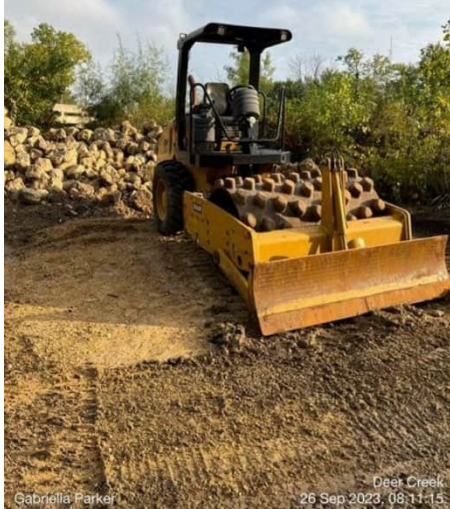
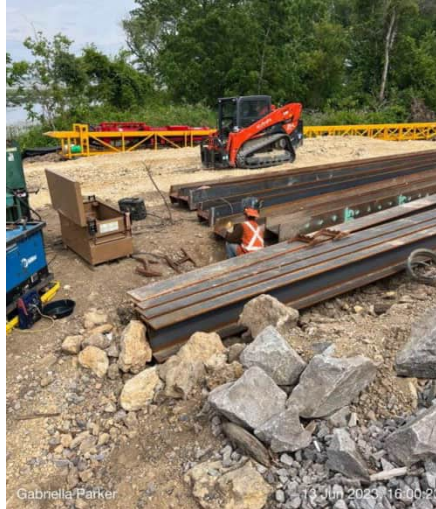
The construction boundaries and limits have been marked out by survey. Sensitive areas such as wetlands and the stream crossing were marked with green and yellow lath. Equipment was staged on previously disturbed sites on ROW away from sensitive habitat areas.

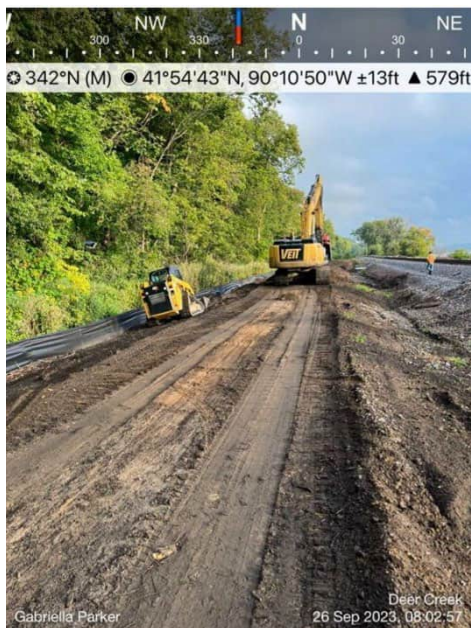
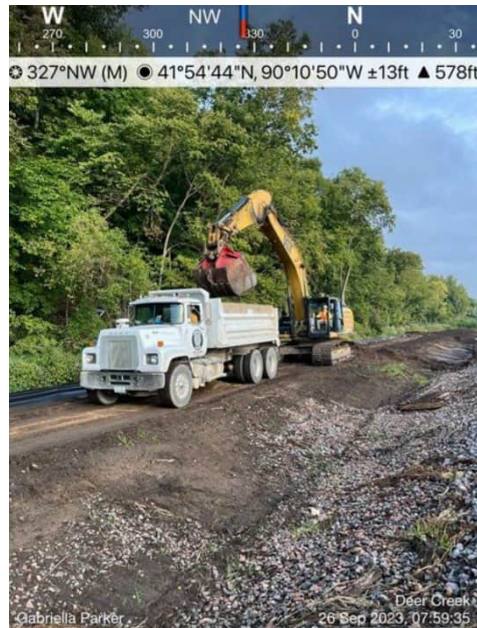
Ground disturbance took place within the ROW and within the approved work areas only (MP 151.5-152.5) for construction operations.

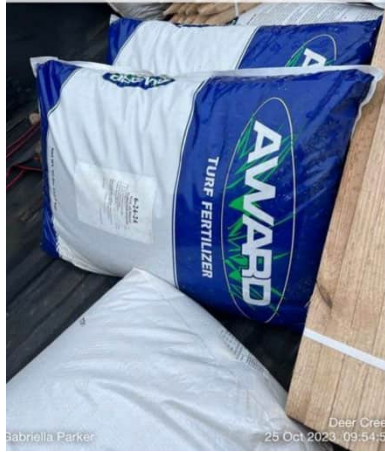
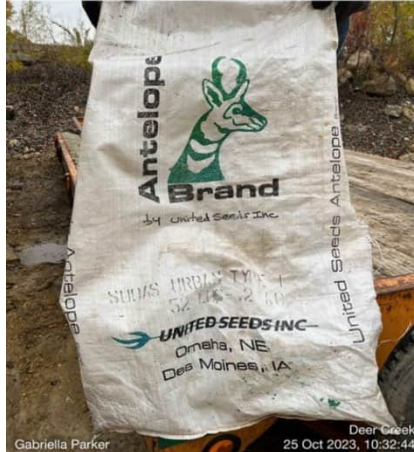
All seed mixtures used on the Deer Creek project for stabilization/restoration were approved by the environmental monitors ensuring no noxious weeds were included in the mix. Annual rye, turf fertilizer, IL DOT Class 2A salt tolerant mix and SUDAS Urban Type 1 were used onsite. No herbicide sprays were used on the Deer Creek siding project.

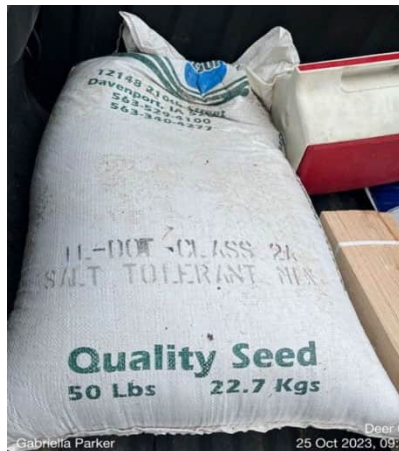
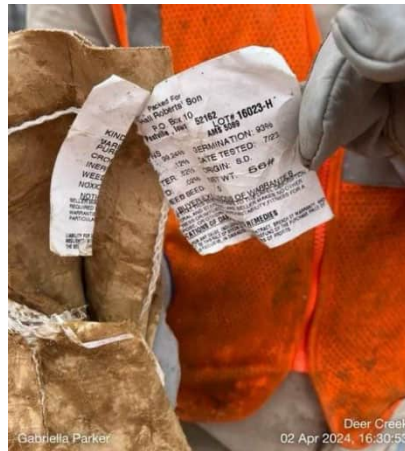
Environmental monitors inspected each seed tag prior to use to ensure no invasive weed species were present. The seed mixtures adhered to Iowa DOT requirements specified in the plans.

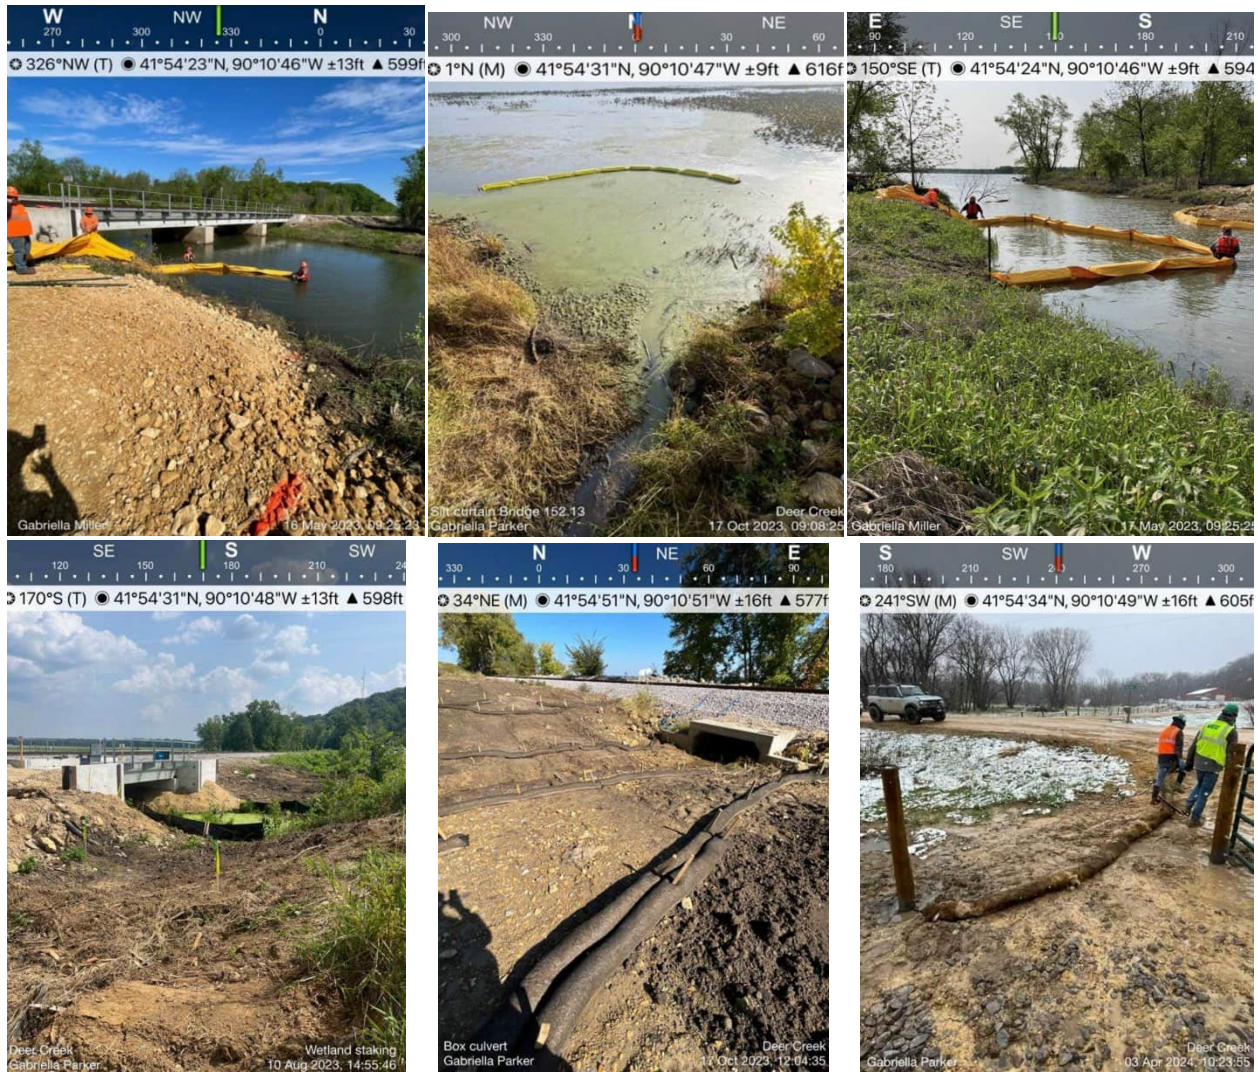
The contractor followed all water quality control requirements in all permits including the Water Quality Certification. A site-specific Stormwater Pollution Prevention Plan SWPPP was provided to all contractors onsite. Following the plan, Environmental monitors and contractors worked together on the installation/maintenance of erosion control devices and best management practices minimizing the potential for erosion and sediment affecting the waterways. Routine SWPPP/rain event inspections will be conducted appropriately until the site reaches 70% uniform vegetation.

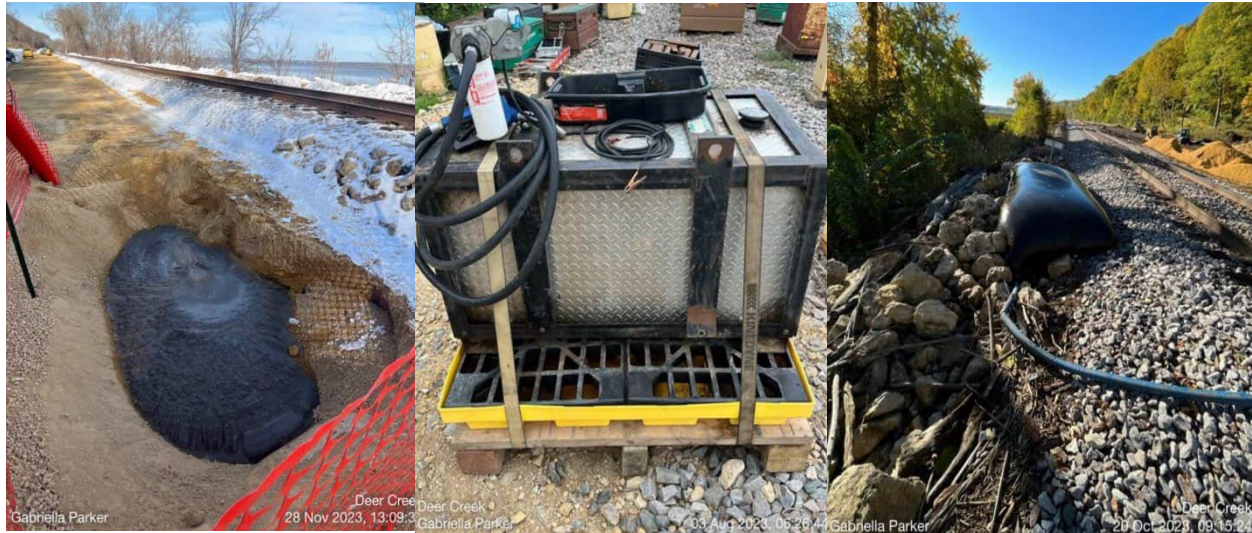
The contractor complied with the approved site-specific SWPPP plan. Following the plan, environmental monitors and contractors worked together on the installation of erosion control devices and best management practices near and around waterways including the creek and culverts to reduce the amount of sediment and pollutants entering surface waters and ground waters. Implemented examples include silt curtains, biologs, secondary containment, filter bags and concrete washout areas.

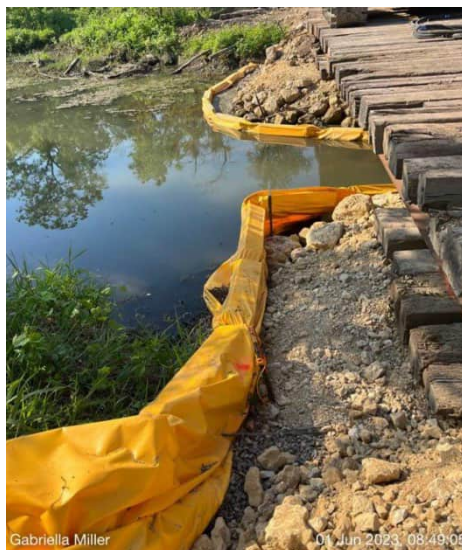
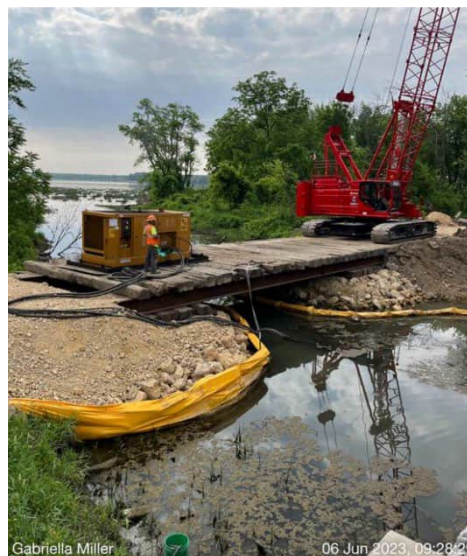
A site-specific water quality monitoring plan was implemented by the environmental monitors on site. Waterways were inspected regularly prior and during construction and at least once weekly since operations have ceased.

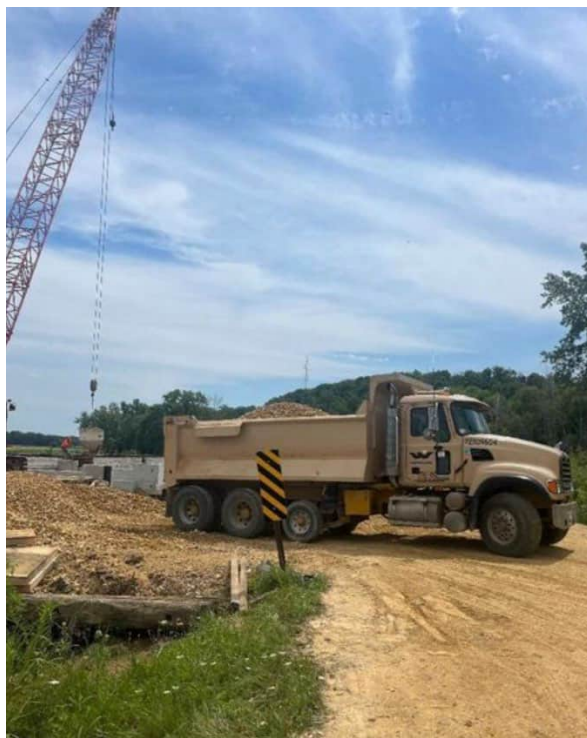
The fill material was imported from Wendling Quarry, an approved offsite source.

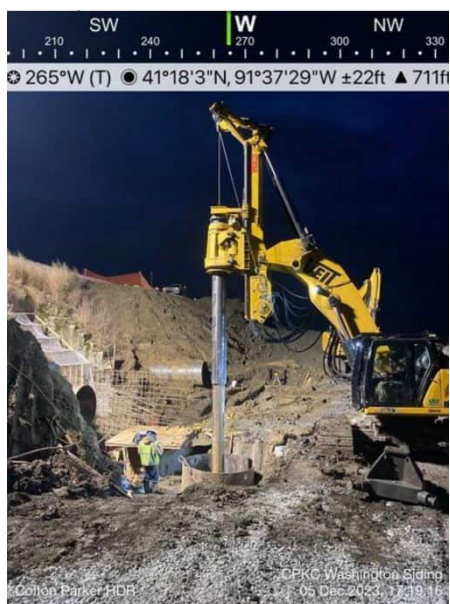
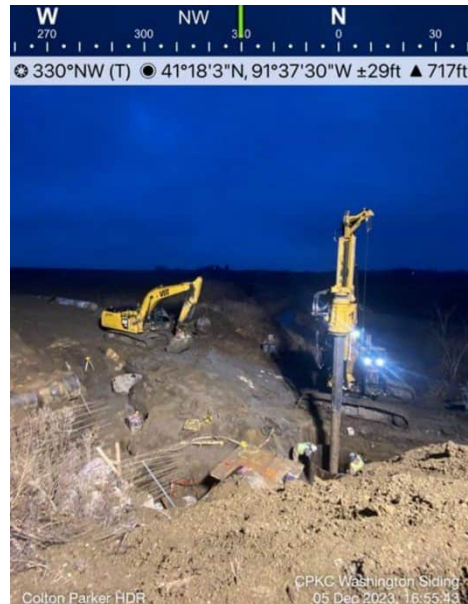
**VM-Noise-02.** While building the Capital Improvement Projects, the Applicants will work with their construction contractors to minimize, where practicable, construction-related noise disturbances between the hours of 2100 and 0700 local time.

All noise on project was within acceptable limits of the project permits at all times.

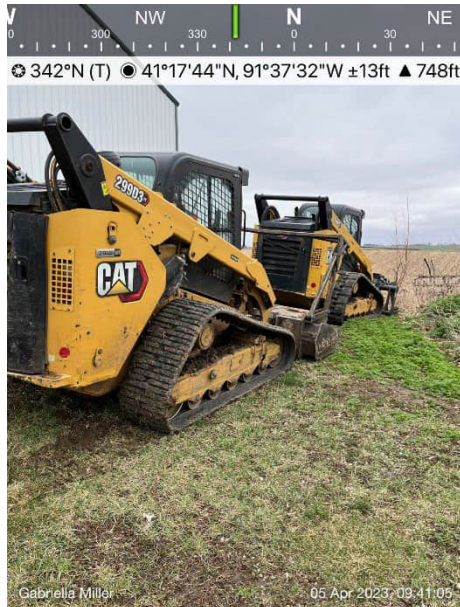
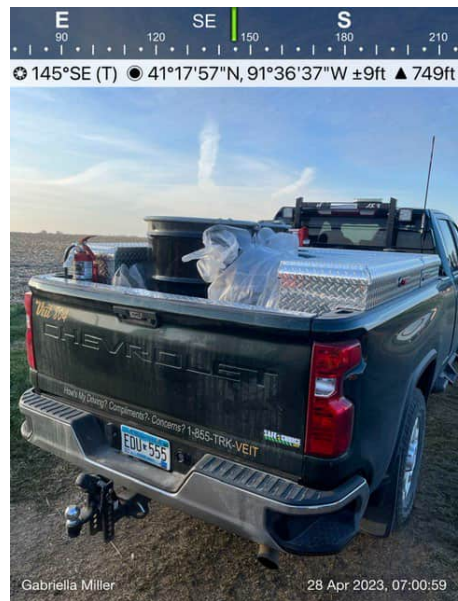
**VM-Air-05.** The Applicants will develop an anti-idling policy for use in potentially affected communities on the combined network. The policy will capture both idling of construction equipment used on the Capital Improvement Projects as well as ongoing operations.

The anti-idling policy was discussed in the morning job briefings with all personnel onsite. Equipment and vehicles on site were not run unless being utilized for operations.

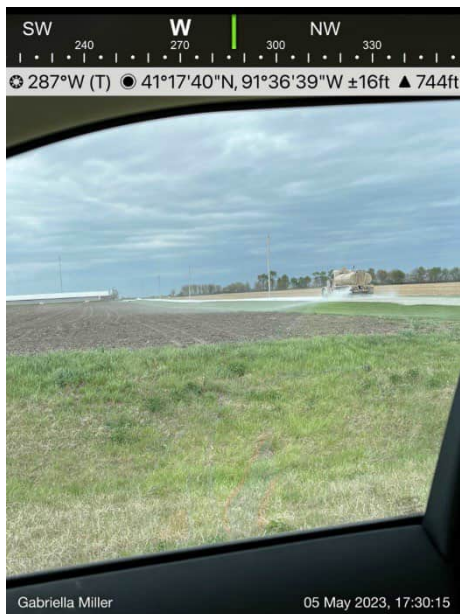
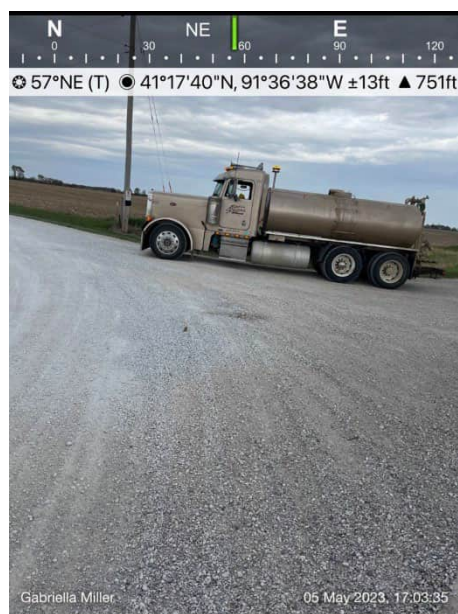
**VM-Air-06.** To minimize fugitive dust emissions created during the construction of the Capital Improvement Projects, the Applicants will implement appropriate fugitive dust suppression controls, such as spraying water or other approved measures.

Calcium chloride was applied to the gravel access road next to the Hog Farm to control dust on 5/5/23. Water trucks were also used to suppress dust throughout the duration of the project.

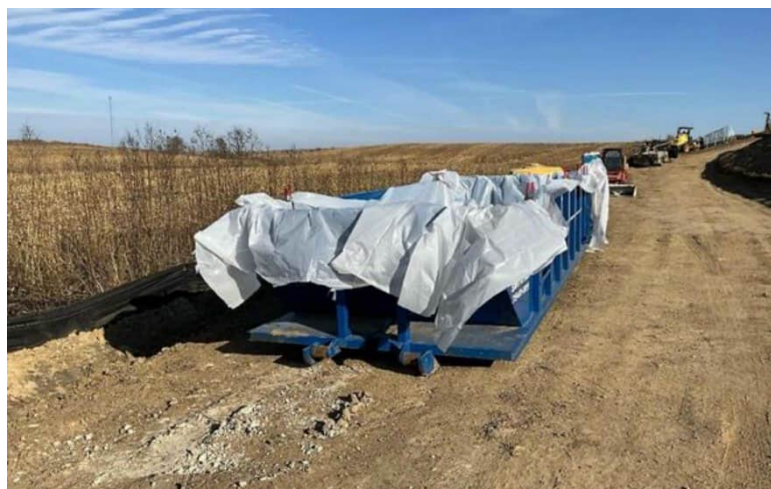
**VM-Haz. Material Sites-05.** The Applicants will require contractors to dispose of waste generated on the Capital Improvement Projects in accordance with all applicable federal, state, and local regulations.

All waste generated on Washington site was disposed of in accordance with all applicable federal, state, and local regulations.

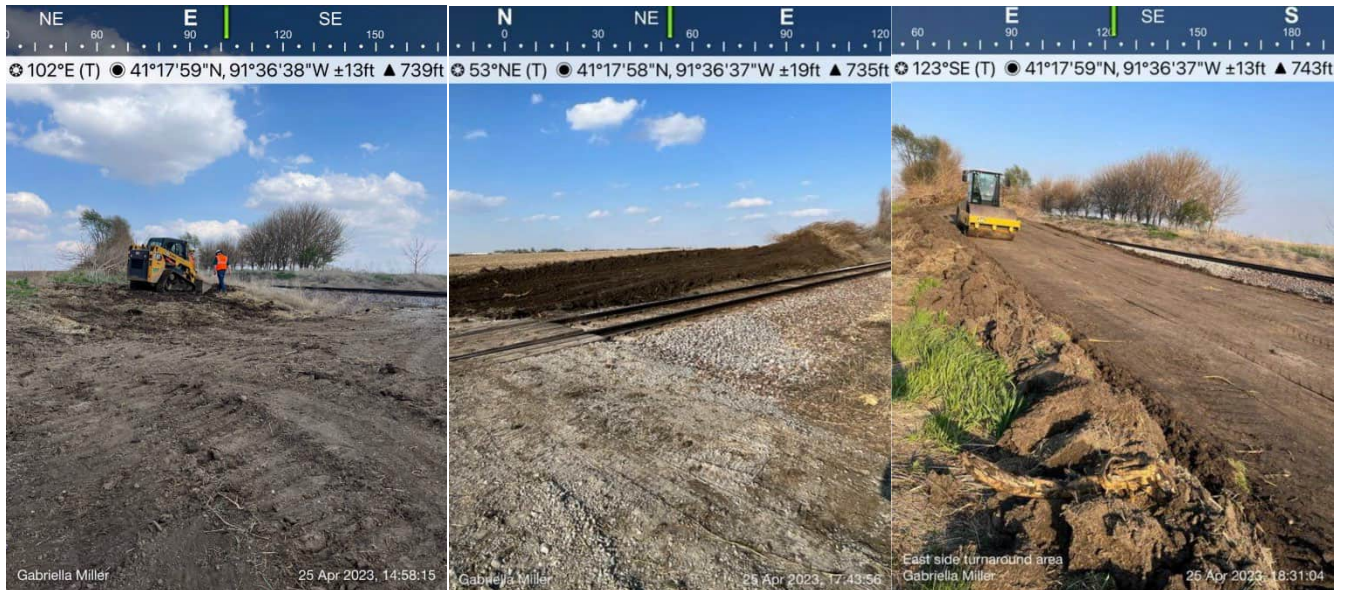
**VM-Biological-03.** The Applicants will not conduct construction related tree removal for the Capital Improvement Projects during the active season for the Indiana bat and the northern long-eared bat (April 1 to October 31).

All clearing operations were completed outside of the above-listed dates, except for on 4/25/2023 where a 50 square foot area owned by CPKC but outside of the marked ROW was cleared. Action was approved by CPKC prior to clearing. Environmental monitor inspected area for any signs of bats or birds before all clearing took place.

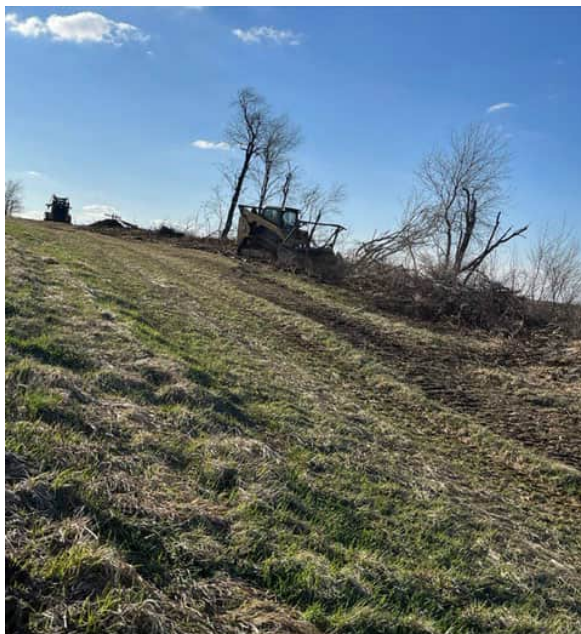
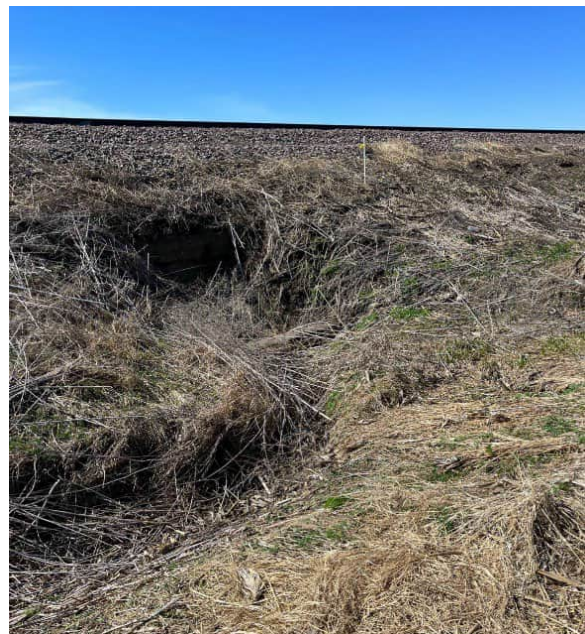
**VM-Biological-04.** During the construction of the Capital Improvement Projects, the Applicants will take steps to reduce the unnecessary removal of bat habitat outside of active bat season by limiting tree removal to only the areas necessary to safely construct and operate the new siding or second track, marking the limits of tree clearing through the use of flagging or fencing, and ensuring that construction contractors understand clearing limits and how they are marked in the field.

The clearing and construction boundaries were defined through survey stakes. Plan sets were provided to contractors outlining ROW boundaries. All contractors were made aware of any suitable bat habitats on ROW. No sign of bats was discovered on site for the duration of the project.

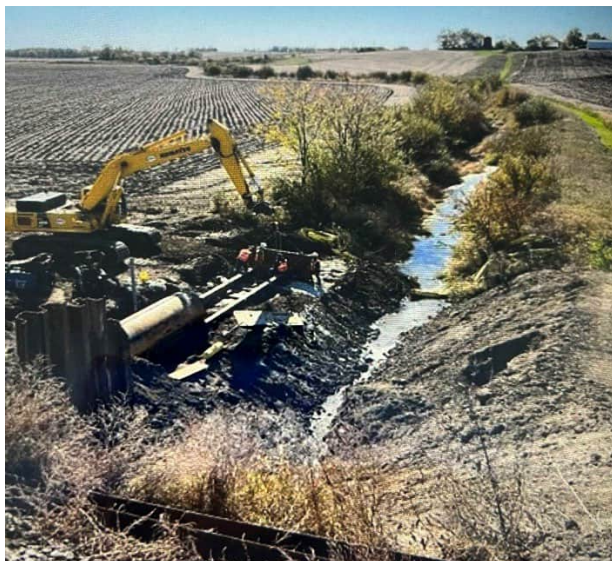
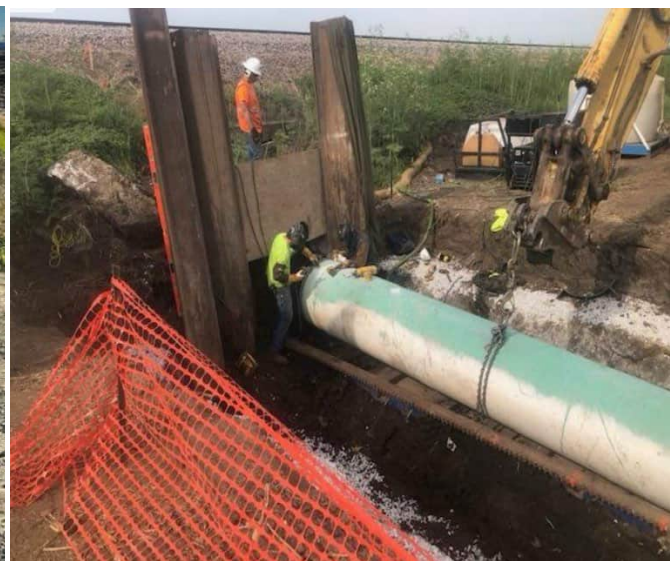
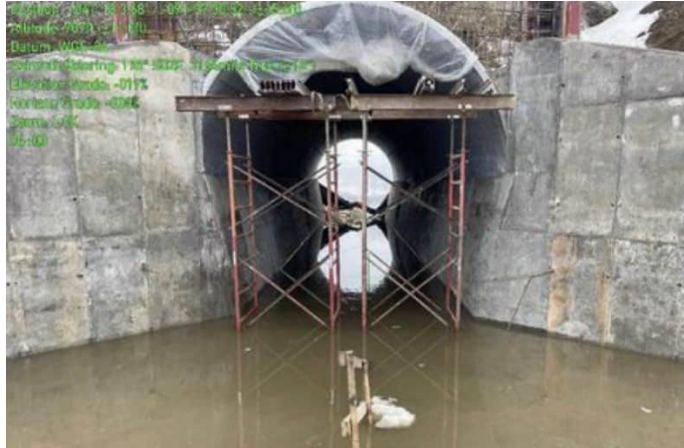
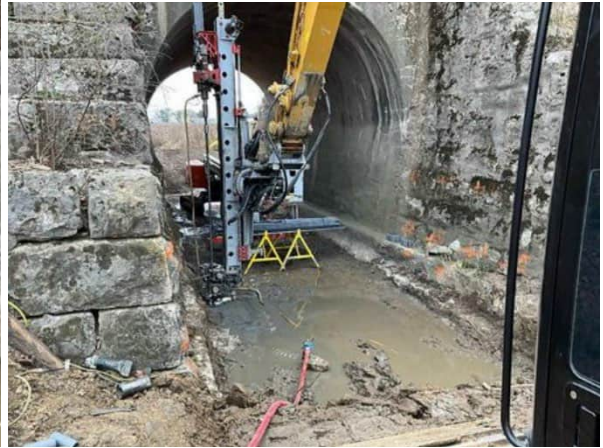
**VM-Biological-06.** Where practicable, the Applicants will conduct any culvert or bridge removal as part of the Capital Improvement Projects outside of the roosting period of bat species, specific to each project location. Where practicable, if bridge or culvert removal is required during the bat roosting period where the individual Capital Improvement Project is located, the Applicants will consult with OEA and the local USFWS office on appropriate methods to determine if bats are using the bridge or culvert as a roost.

After it was determined that no bats or signs of bats were present in structures or onsite, culverts work and arch tunnel construction was able to commence during the bat roosting season. Continued inspection of bat presence was still conducted during the construction phase.

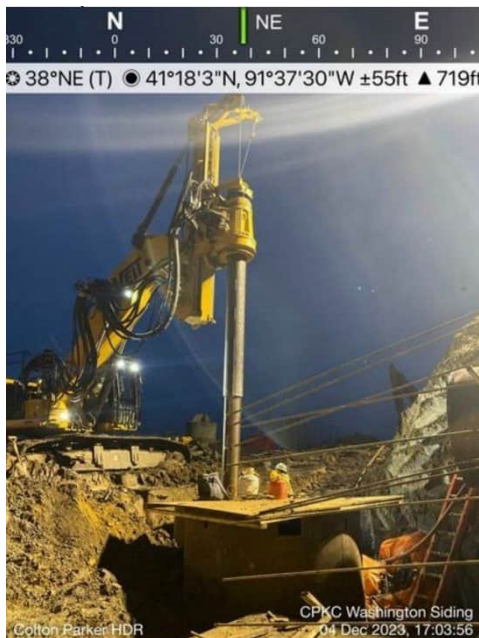
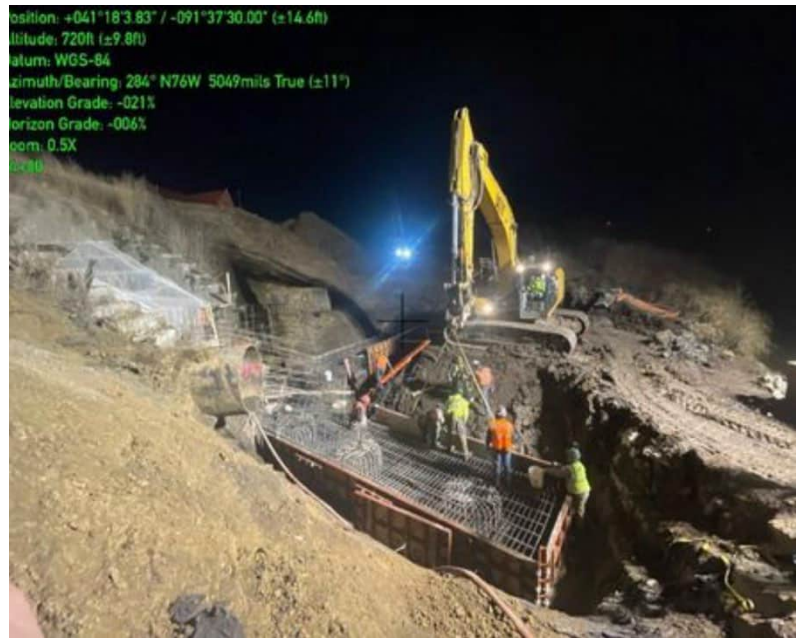
**VM-Biological-07.** During construction of the Capital Improvement Projects, the Applicants will direct any temporary lighting away from suitable habitat for the northern long-eared bat or the Indiana bat during the active season for those species (April 1 to October 31). The Applicants will use downward-facing, full cut-off lens lights for any temporary lighting used during the construction of the Capital Improvement Projects.

All temporary lighting was directed away from any suitable habitat for the northern long-eared bat and Indiana bat during their active season of April 1 to October 31. Full cut off lens were used and the lighting was faced downward during their few nights of construction outside of the roosting season.

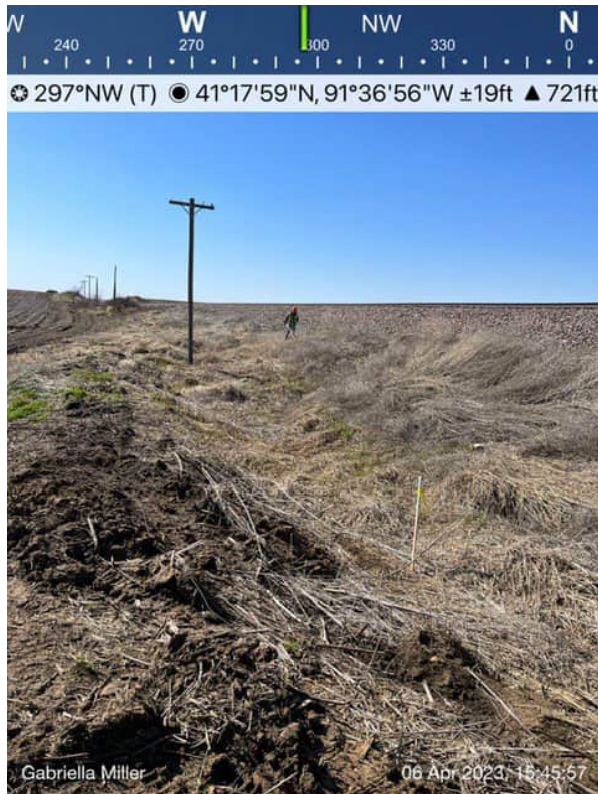
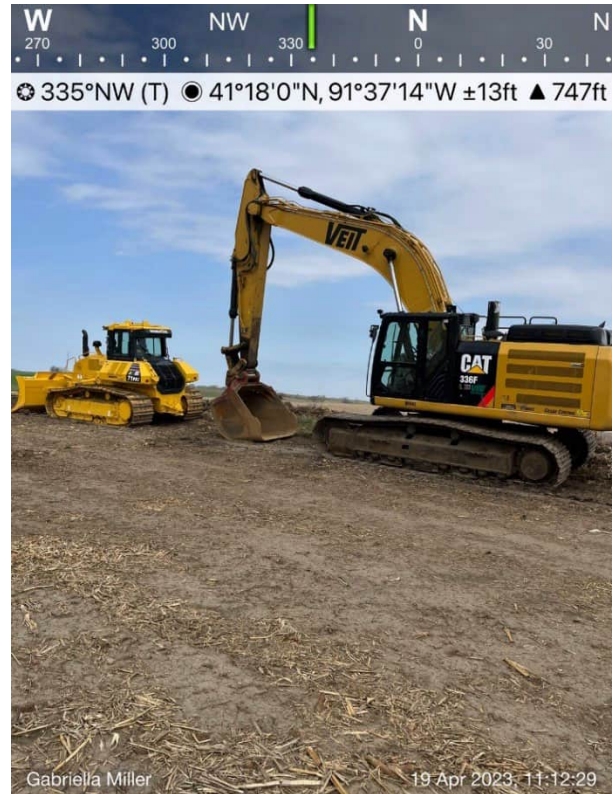
**VM-Biological-09.** During construction of the Capital Improvement Projects, temporary barricades, fencing, and/or flagging will be used in sensitive habitats to contain construction related impacts to the

area within the construction ROW. To the extent possible, staging areas will be located in previously disturbed sites and not in sensitive habitat areas.

The construction boundaries and limits were marked out by survey. Sensitive areas such as wetlands and the creek crossing were marked with green and yellow lath. Equipment was staged on previously disturbed sites on ROW away from sensitive habitat areas.

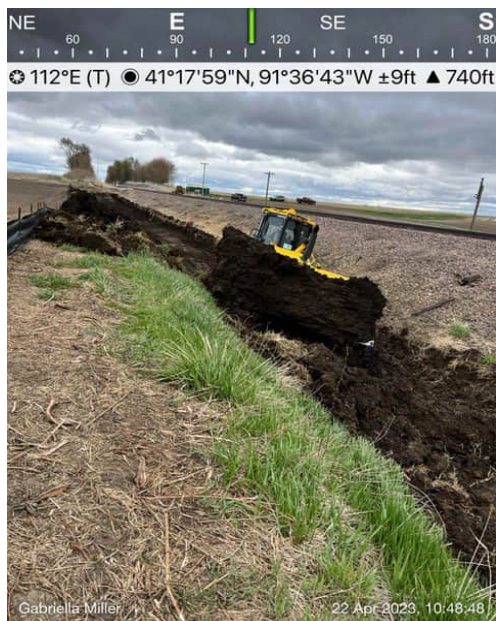
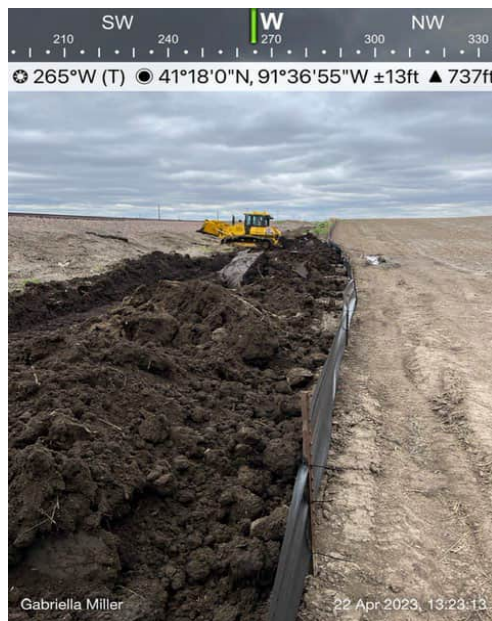
**VM-Biological-10.** The Applicants will limit ground disturbance to only the areas necessary for the construction of the Capital Improvement Projects.

Ground disturbance took place only in the approved work areas (MP 253.30-255.80) throughout construction operations.

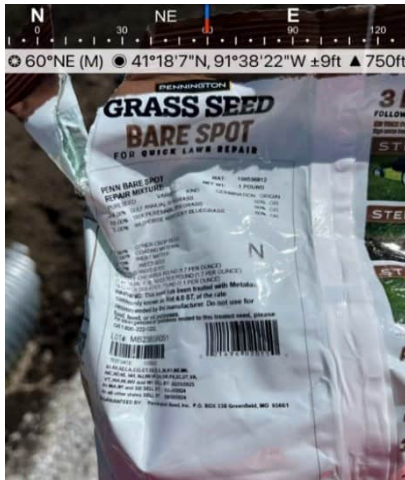
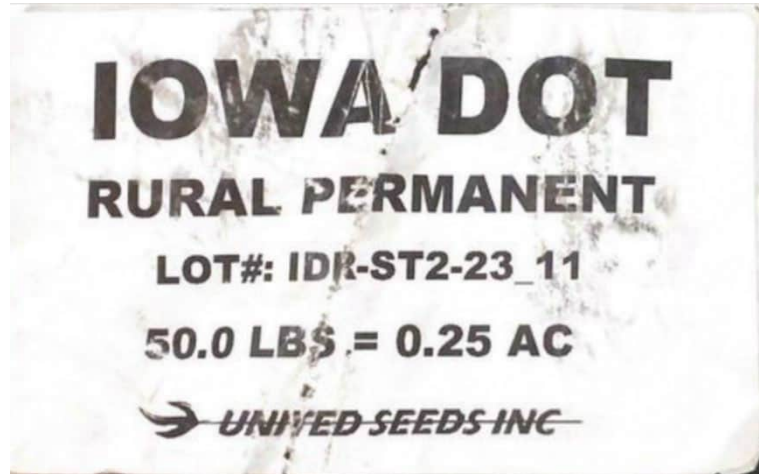
**VM-Biological-11.** The Applicants will use construction methods and seed mixes that minimize introduction and spread of noxious weeds on the Capital Improvement Projects. Noxious weed control will include combinations of mechanical and herbicide spray methods.

All seed mixtures used on Washington siding for stabilization/restoration were approved by the Environmental monitors ensuring no noxious weeds were included in the mix. No herbicide sprays were used on the Washington siding project.

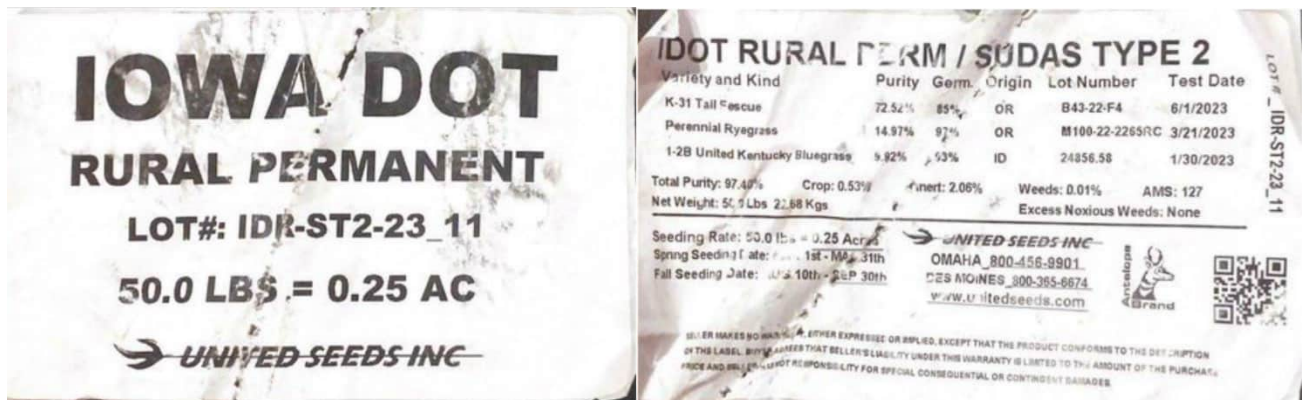
**MM-Biological-01.** For capital improvements related to the Proposed Acquisition, the Applicants shall not knowingly include any federally- or state-listed invasive weed species in seed mixes for revegetating disturbed areas within the rail ROW.

Environmental monitors inspected each seed tag prior to use to ensure no invasive weed species were present. The seed mixtures adhered to Iowa DOT requirements specified in the plans.

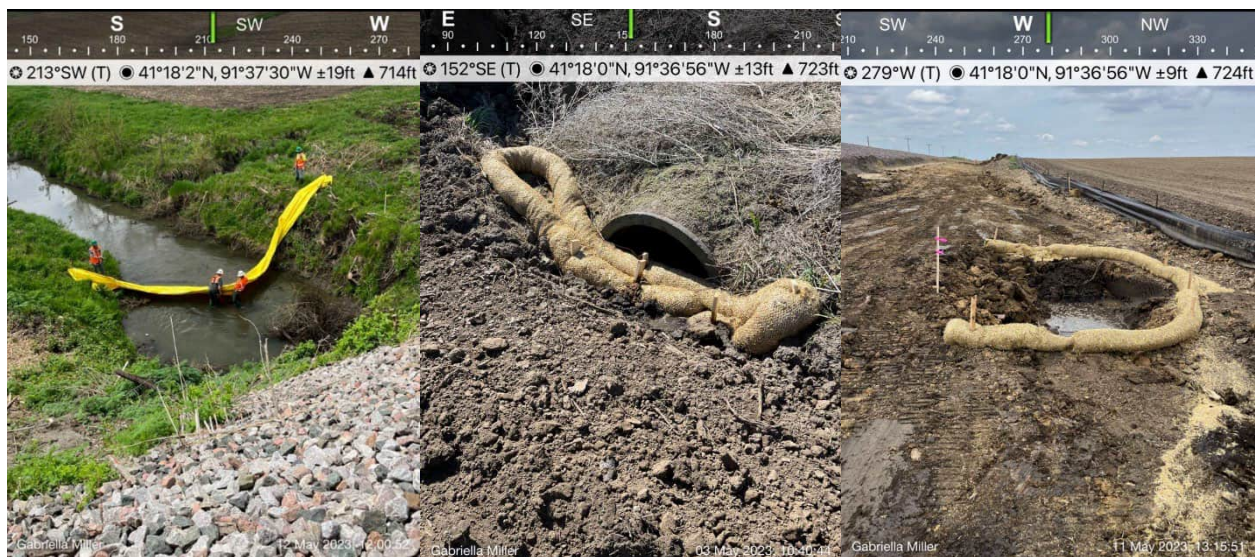
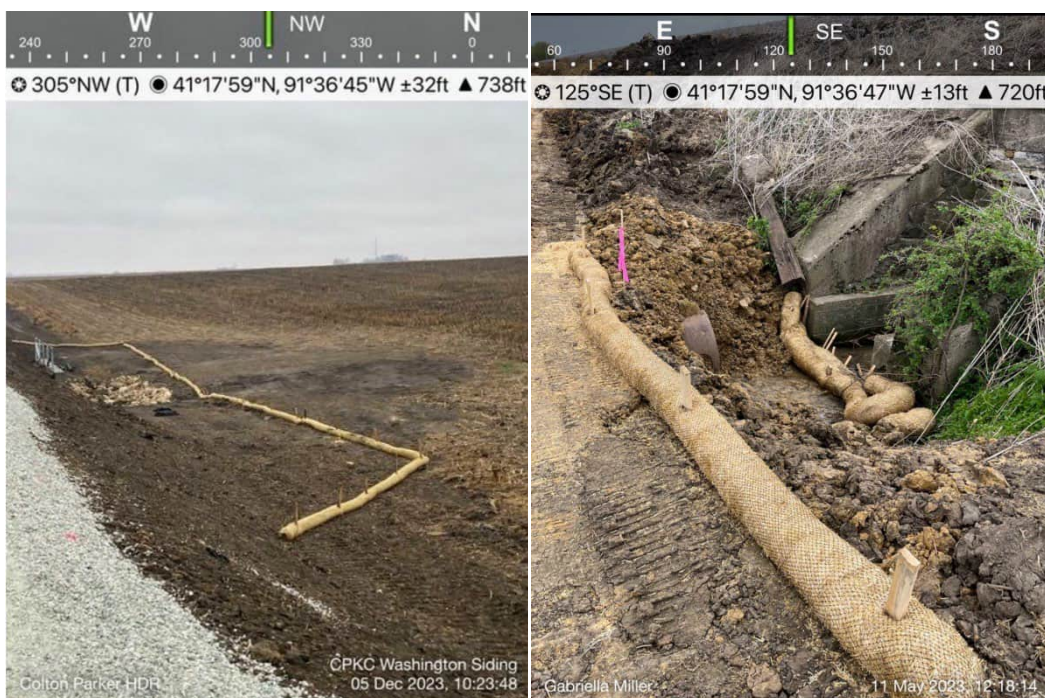
**VM-Water-04.** As applicable to each of the individual Capital Improvement Projects, the Applicants will require its construction contractor(s) to follow all water quality control conditions identified in all permits including the Water Quality Certification from the respective jurisdiction and Section 404 Permits issued by USACE.

The contractor followed all water quality control measures required in all permits including the Water Quality Certification. A site-specific Stormwater Pollution Prevention Plan SWPPP was provided to all contractors onsite. Following the plan, Environmental monitors and contractors worked together on the installation/maintenance of erosion control devices and best management practices to minimize the potential for erosion and sediment affecting the waterways. Routine SWPPP/rain event inspections will be conducted appropriately until the site reaches 70% uniform vegetation.
