Re: Docket No. FD 36500, CPKC Quarterly Environmental Mitigation  
Measures Report for March 15 to June 14, 2024

# CPKC Quarterly Environmental Mitigation Measure Compliance Report Number 5

This report includes compliance activities completed between March 15 and June 14, 2024 (Quarter 1, Year 2 of the STBs oversight period following the acquisition of KCS by CP, STB Docket FD 36500)

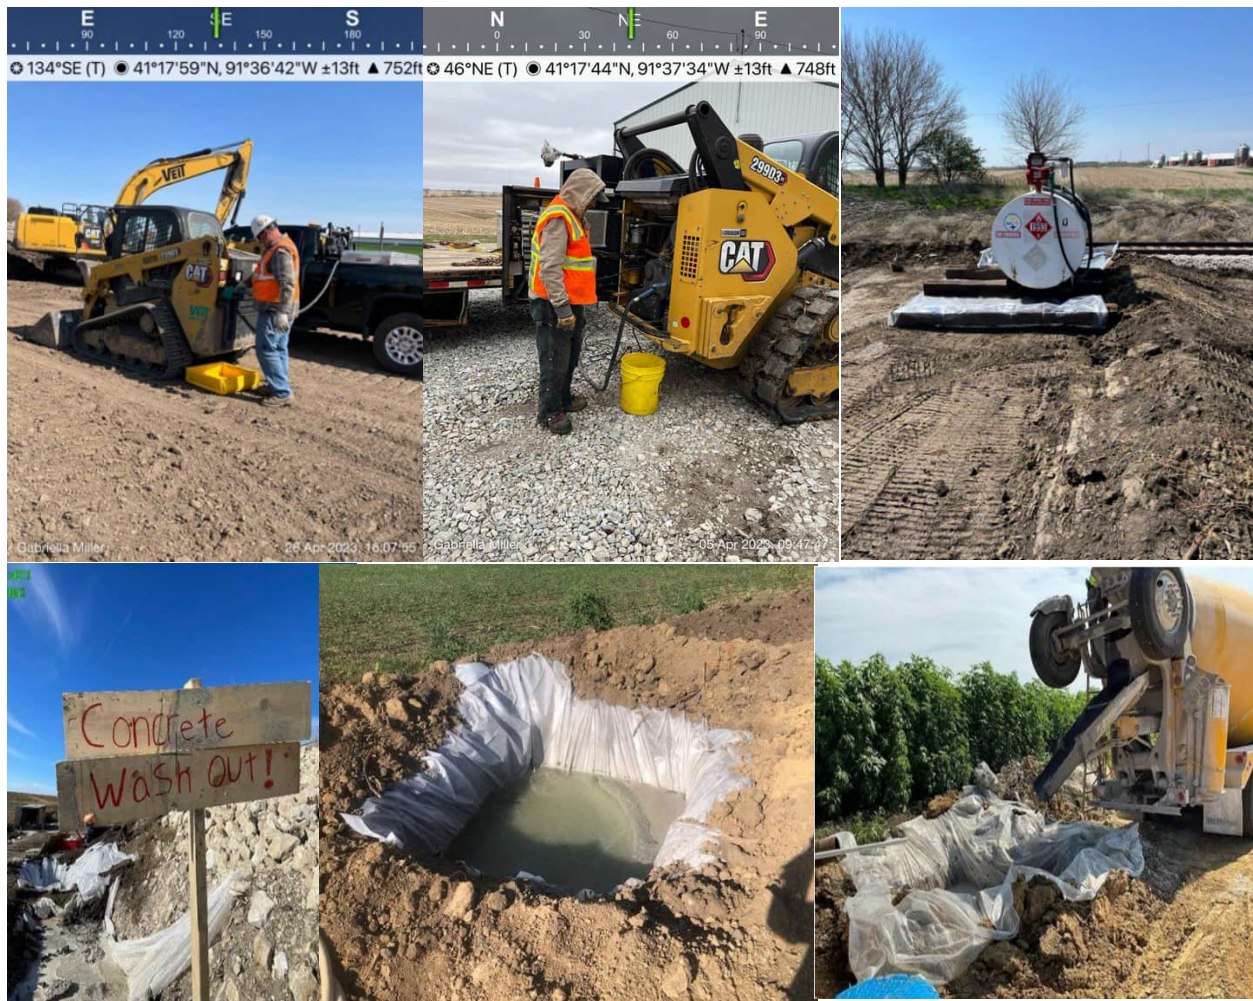
**VM-Water-05.** Prior to initiating construction at a Capital Improvement Project location, the Applicants will develop a site-specific Stormwater Pollution Prevention Plan which will incorporate Best Management Practices as well as site specific measures to control erosion and reduce the amount of sediment and pollutants entering surface waters, ground waters, and waters of the U.S.

The contractor complied with the approved site-specific SWPPP plan. Following the plan, Environmental monitors and contractors worked together on the installation of erosion control devices and best management practices near and around waterways including the creek and culverts to reduce the amount of sediment and pollutants entering surface waters and ground waters. Implemented examples include silt curtains, biologs, secondary containment and designated concrete wash out area.

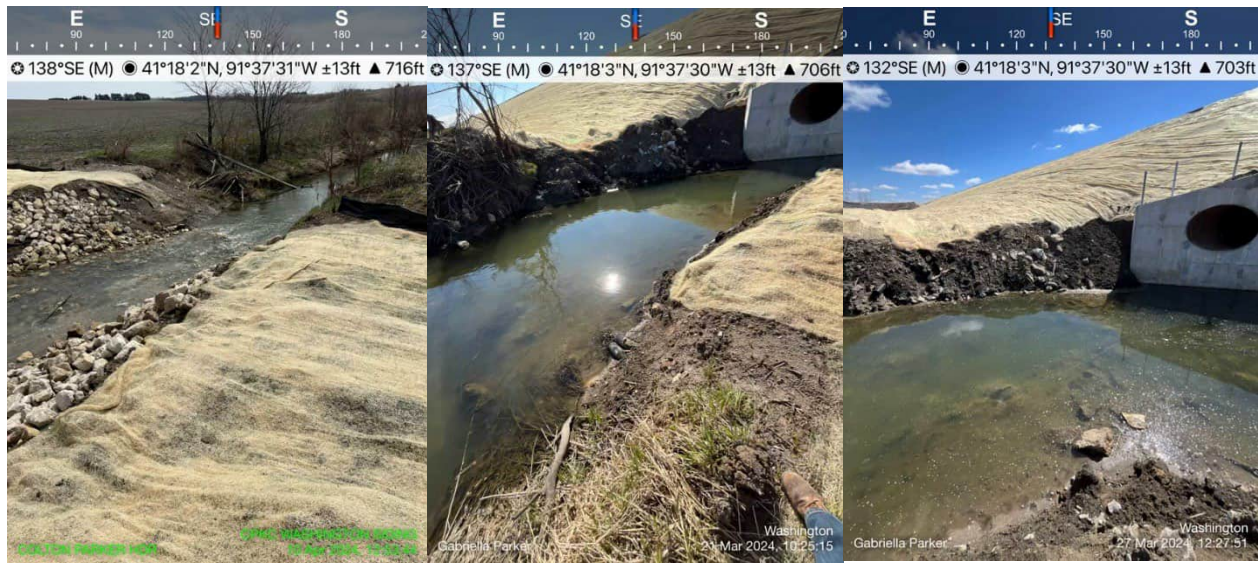
**VM-Water-06.** For Capital Improvement Project locations which will involve construction activities in proximity to surface water, prior to the start of construction the Applicants will develop a site-specific water quality monitoring plan and implement this monitoring plan throughout construction.

A site-specific water quality monitoring plan was implemented by the Environmental monitors on site. Waterways were inspected regularly prior and during construction and at least once weekly since operations have ceased.

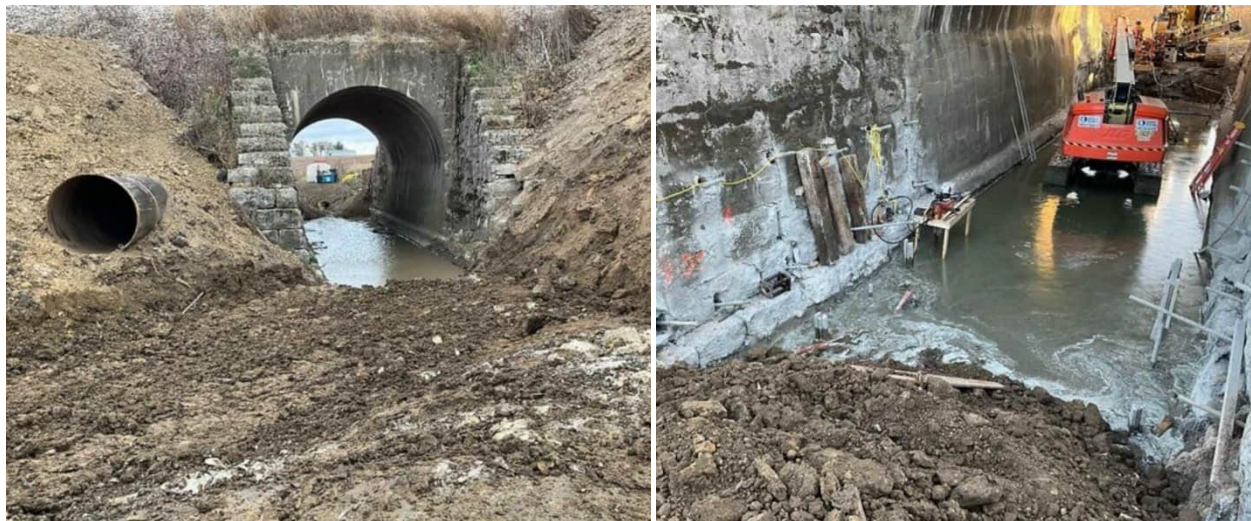
**VM-Water-10.** As applicable to each of the individual Capital Improvement Projects, the Applicants will comply with applicable in-water work windows and timing restrictions for the protection of fish species.

Environmental monitors worked together with the contractors on protecting the creek while construction was occurring. A temporary creek crossing was built and removed with minimal impact to the waters. A temporary dam was also built to aid in construction of the foundation at CV6.

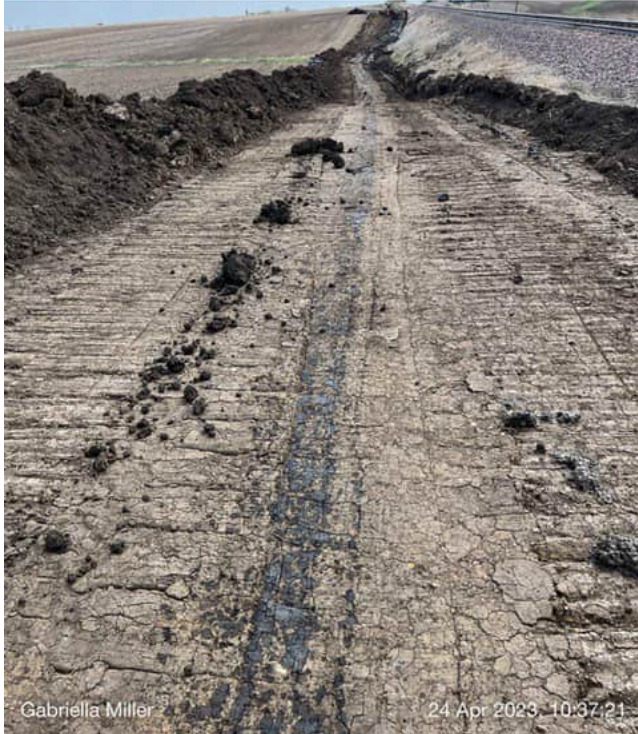
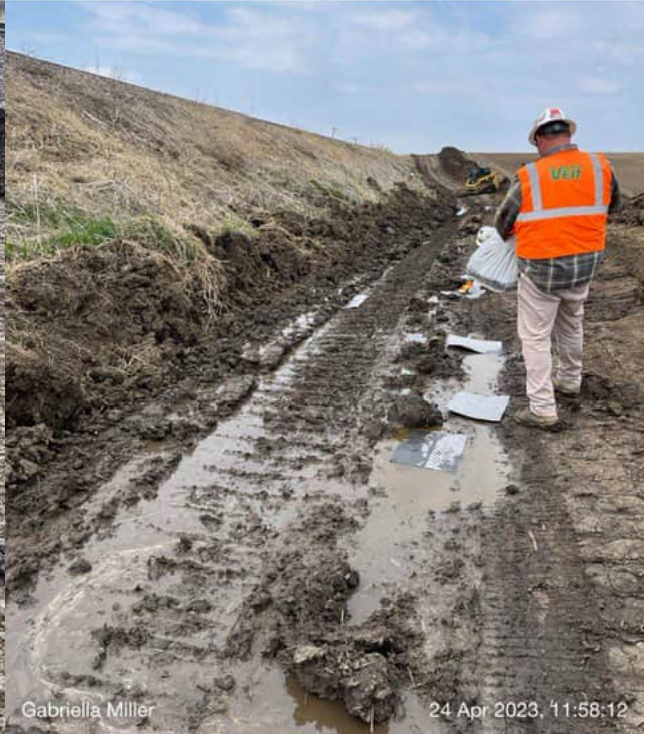
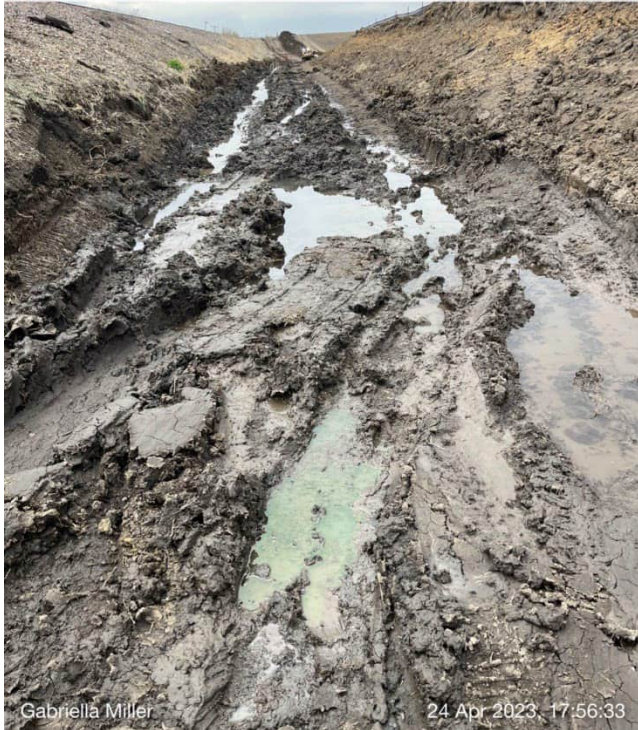
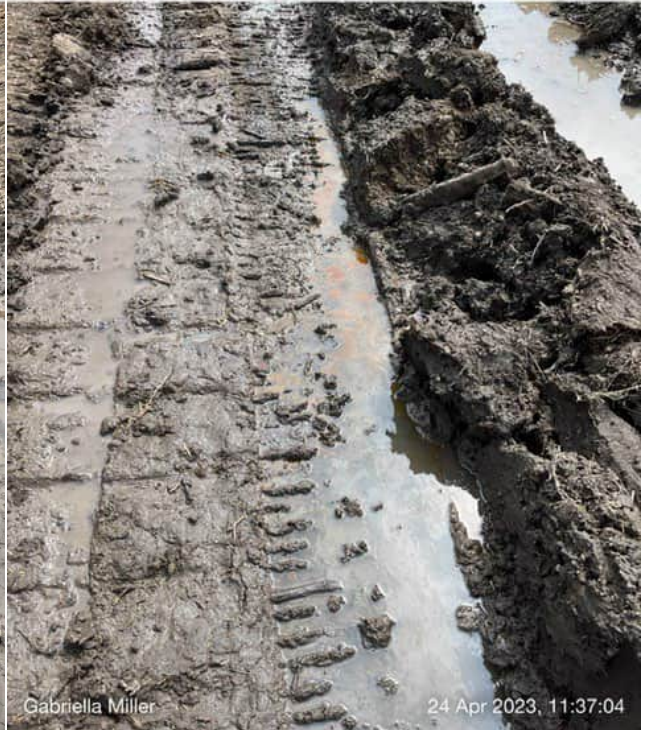
On 4/24/2023 the CAT excavator's hydraulic oil hose was damaged which led to dripping of fluid from roughly 127+00 to 118+00. The leak was noticed at 10:30AM. The contractor ceased operations and cleaned the spill with shovels and a skid steer. They used spill socks, diapers and paper towels. The spill was contained within the ROW. The debris was then contained within a 55-gallon drum and double bagged garbage bags.

| SPILL REPORT FORM | | | | |
|---|---|---|---|--|
| Cause Of Spill (if known) – Include any equipment damages and approximate cost of damage.<br>Damaged hydraulic hose. | | | | |
| Description(s) of how each oil discharge was detected:<br>Observed spots on ground following excavator during inspection walk through. | | | | |

Damaged hose under the excavator

| SPILL REPORT FORM | | | | |
|---|---|---|---|--|
| Corrective/Preventative Action(s). List procedures, repairs, or other preventative measure that will minimize the potential for this type of spill to happen again.<br>Veit is repairing all hoses on machine and repairing drain tile to minimize water seepage. | | | | |

Hoses are getting repaired tomorrow morning 04/25/23 by mechanic.

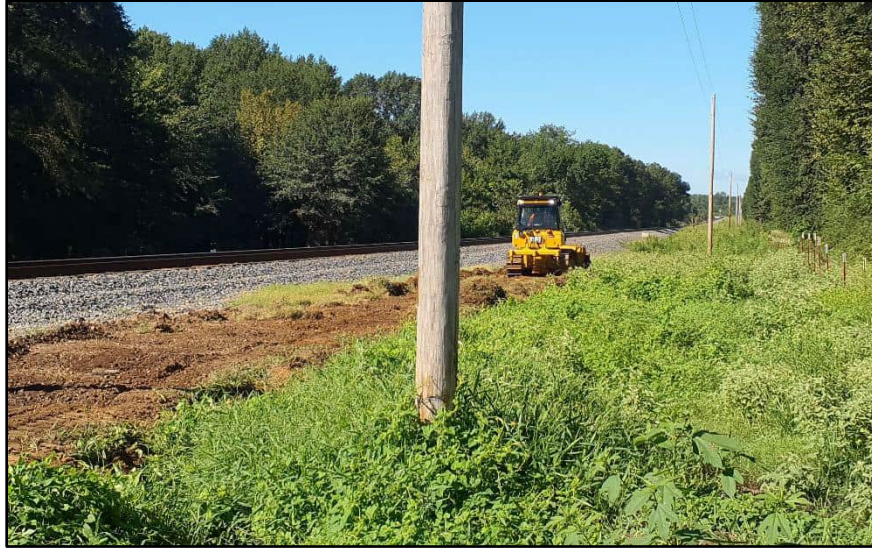
**Figure 1. Initial topsoil clearance by a bulldozer; view facing southwest. (Photograph by T. Himebaugh 8/15/23.)**

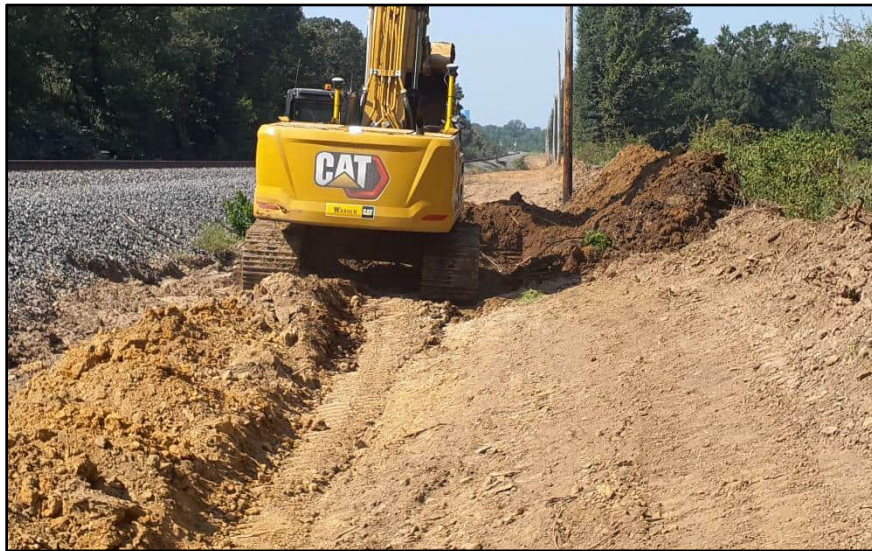
**Figure 2. Excavating along the right-of-way; view facing southwest. (Photograph by T. Himebaugh 8/24/23.)**

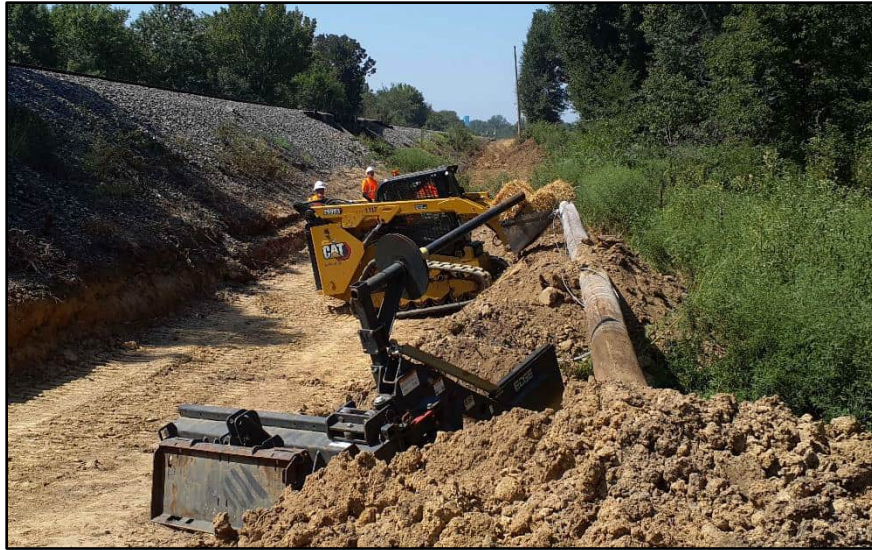
**Figure 3. Preparing area for silt fence installation, hay bales used as ballast; view facing southwest. (Photograph by T. Himebaugh 8/25/23.)**

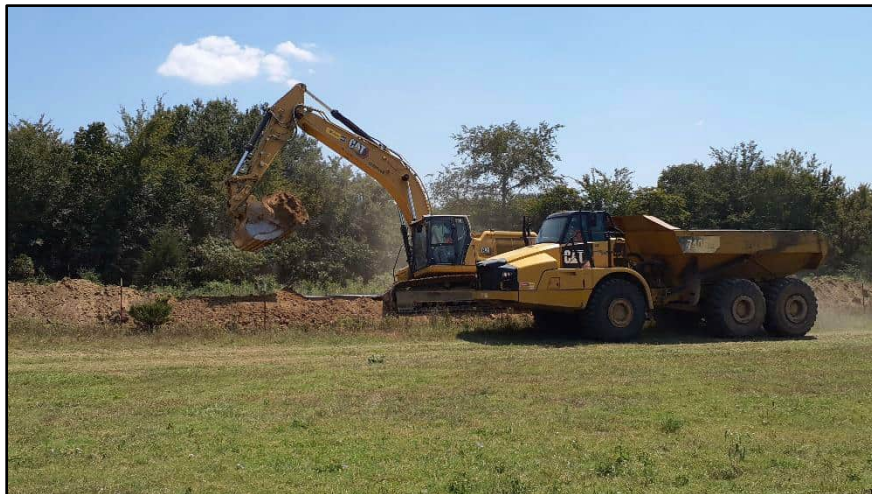
**Figure 4. Removal of backfill via excavator and dump truck; view facing south. (Photograph by T. Himebaugh 8/29/23.)**

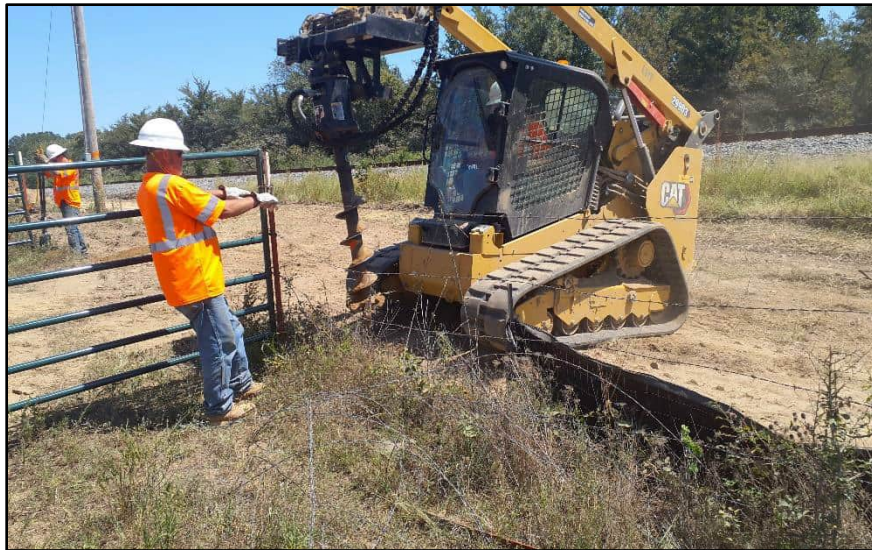
**Figure 5. Drilling for post installation; view facing east. (Photograph by T. Himebaugh 9/1/23.)**

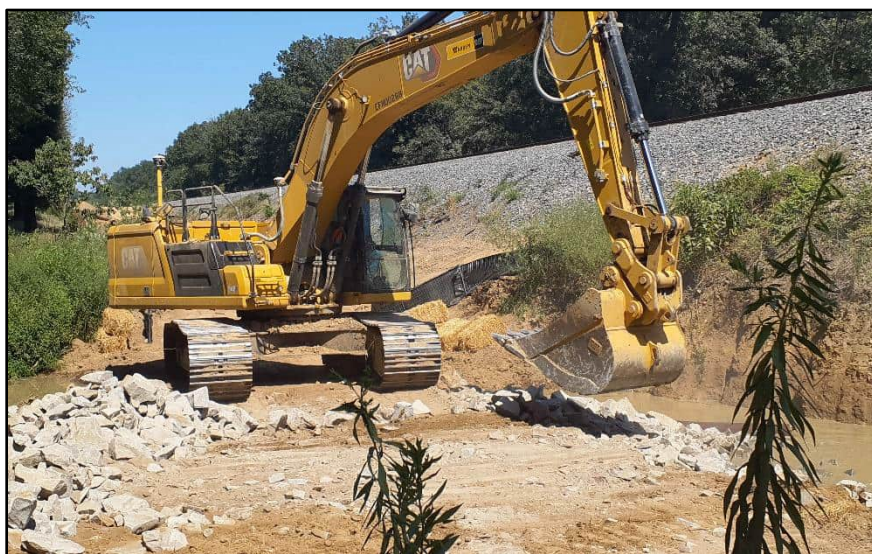
**Figure 6. Excavator spreading gravel near bridge; view facing east. (Photograph by T. Himebaugh 9/1/23.)**

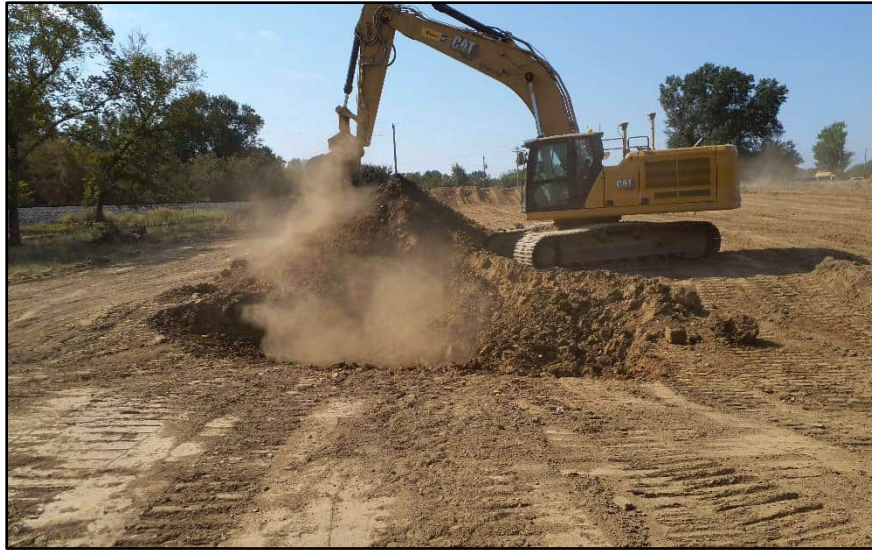
**Figure 7. Excavation of borrow pit after topsoil clearance; view facing southwest. (Photograph by R. Campbell 9/5/23.)**

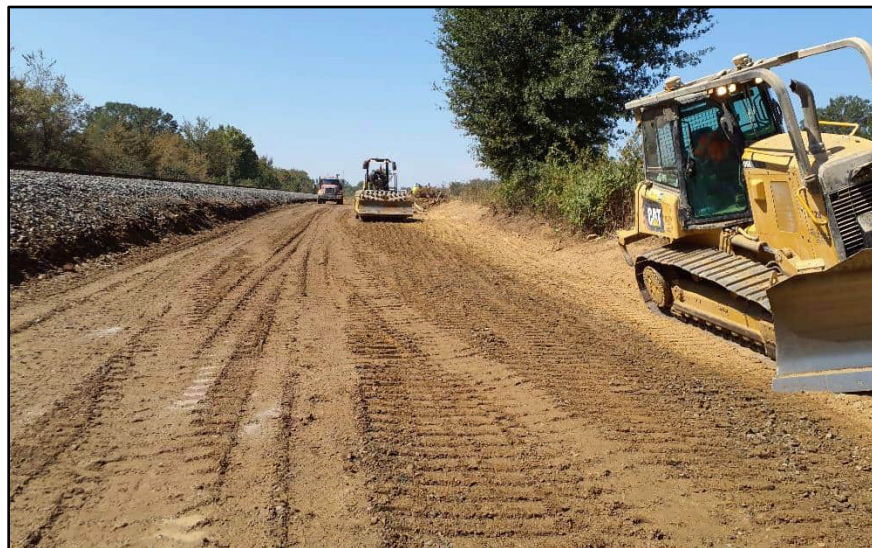
**Figure 8. Cut and fill grading using fill from the borrow pit; view facing southwest. (Photograph by R. Campbell 9/6/23.)**

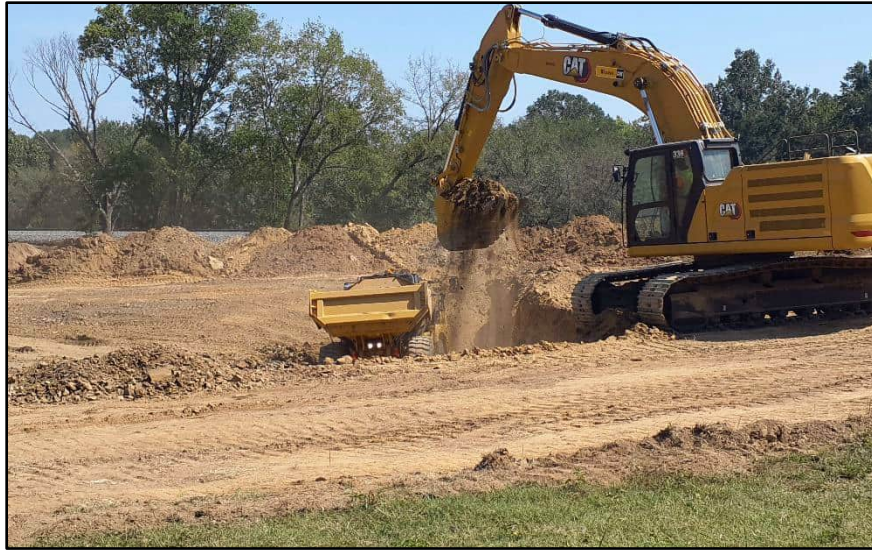
**Figure 9. Continued excavation of borrow pit; view facing southeast. (Photograph by T. Himebaugh 9/18/23.)**

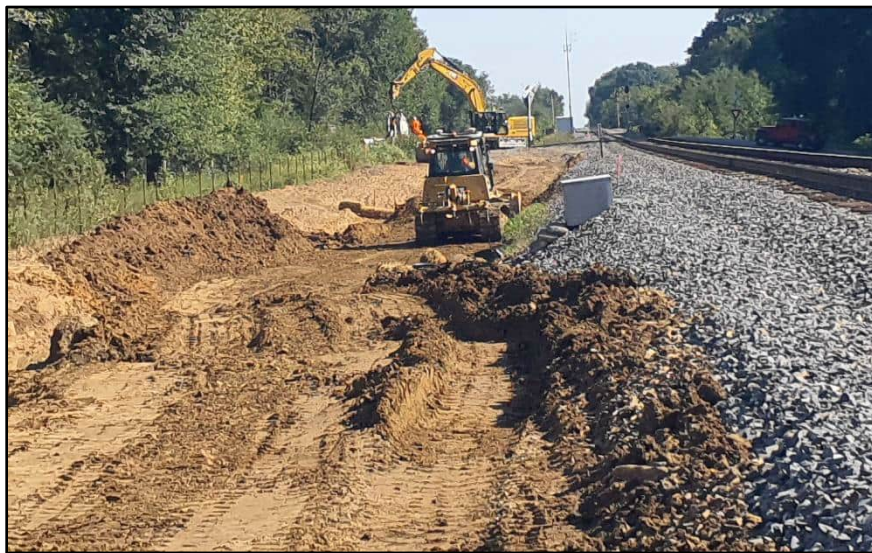
**Figure 10. Spreading fill dirt along the right-of-way; view facing northeast. (Photograph by T. Himebaugh 9/27/23.)**

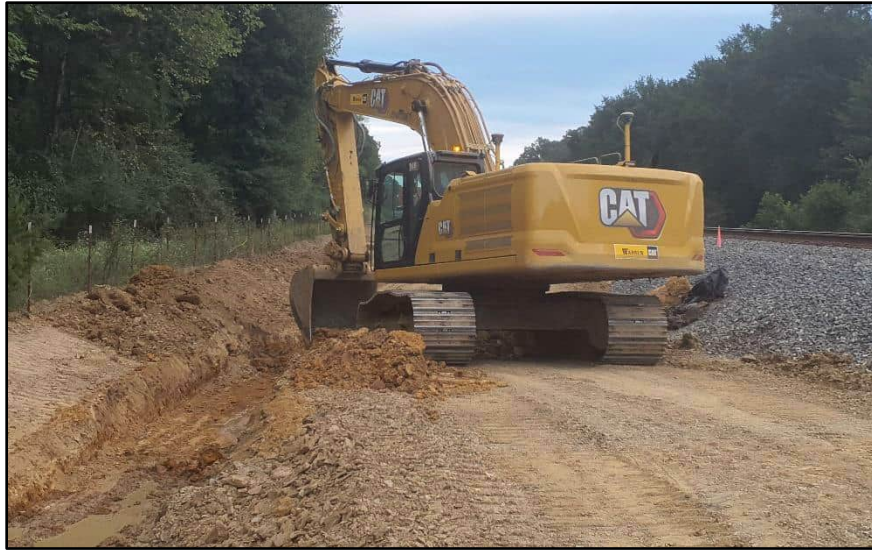
**Figure 11. Excavator clearing area for culvert installation; view facing northeast. (Photograph by T. Himebaugh 10/4/23.)**

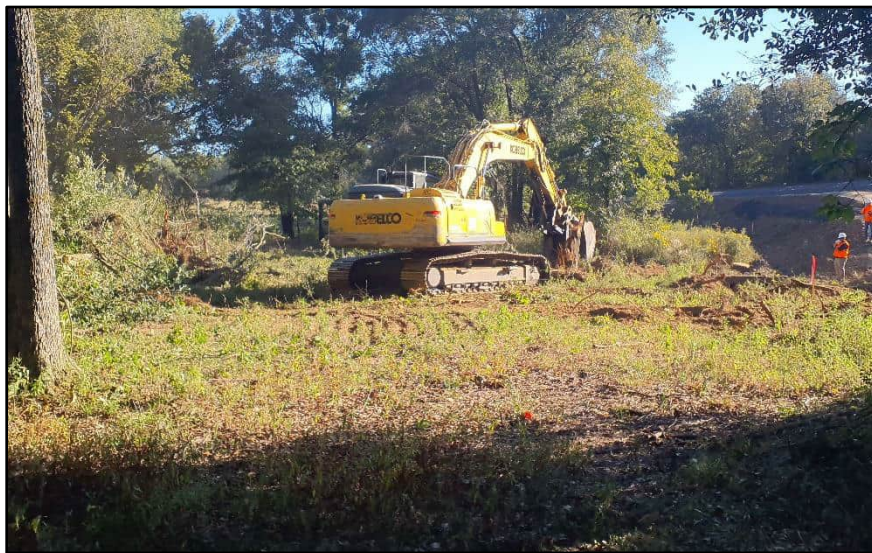
**Figure 12. Tree felling to assist with inserting culvert pipe extension; view facing northeast. (Photograph by T. Himebaugh 10/9/23.)**

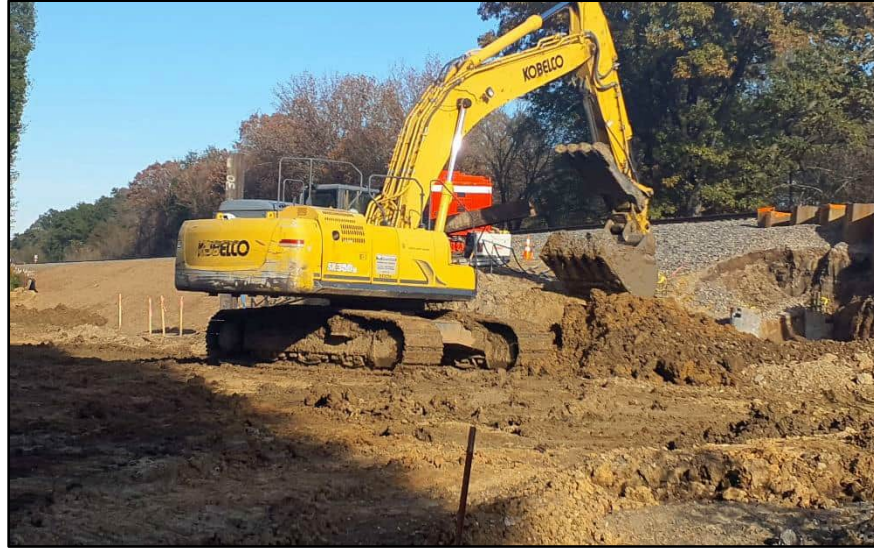
**Figure 15. Excavator cleaning out mud near drill locations; view facing northeast. (Photograph by T. Himebaugh 11/13/23.)**
