Re: Docket No. FD 36500, CPKC Quarterly Environmental Mitigation  
Measures Report for June 15 to September 14, 2025

# CPKC Quarterly Environmental Mitigation Measure Compliance Report Number 10

This report includes compliance activities completed between June 15, 2025 and September 14, 2025 (Quarter 2, Year 3 of the STBs oversight period following the acquisition of KCS by CP, STB Docket FD 36500).

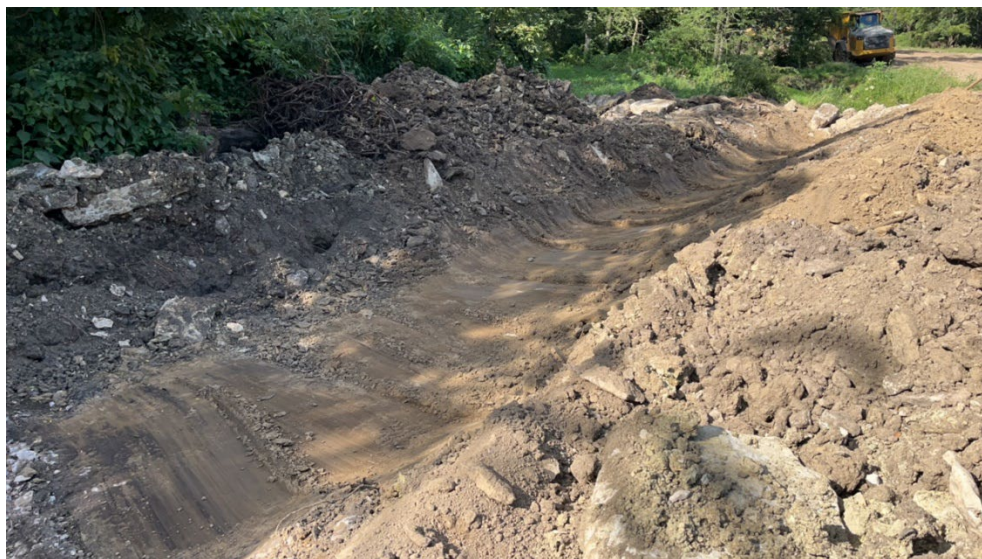
**Figure 13. Example of excavated trench for erosion and water control; facing Southeast. (M. Richison 08/09/24)**

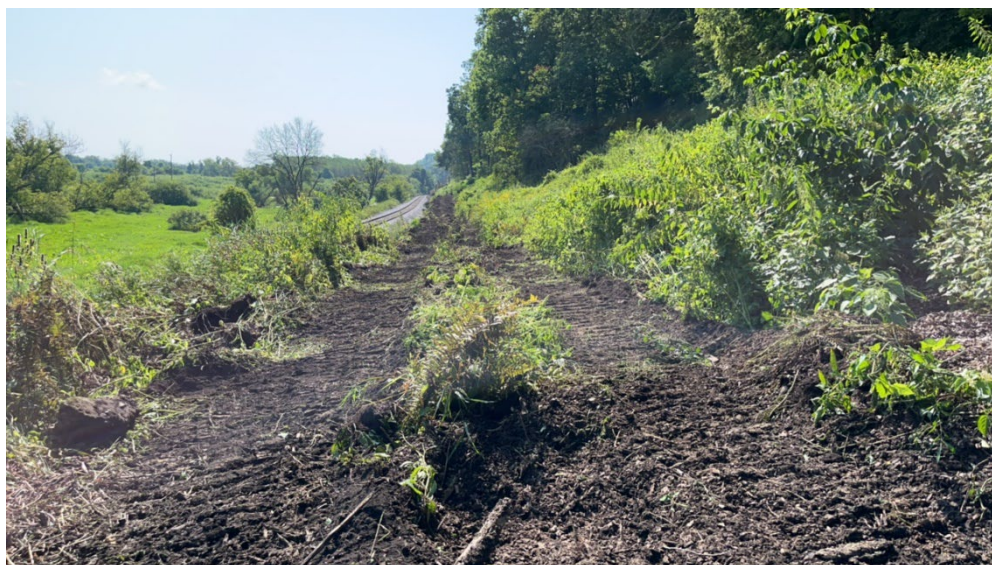
**Figure 14. South Singer Switch Cabin project location, new disturbance complete; facing Northeast. (M. Richison 05/06/24)**

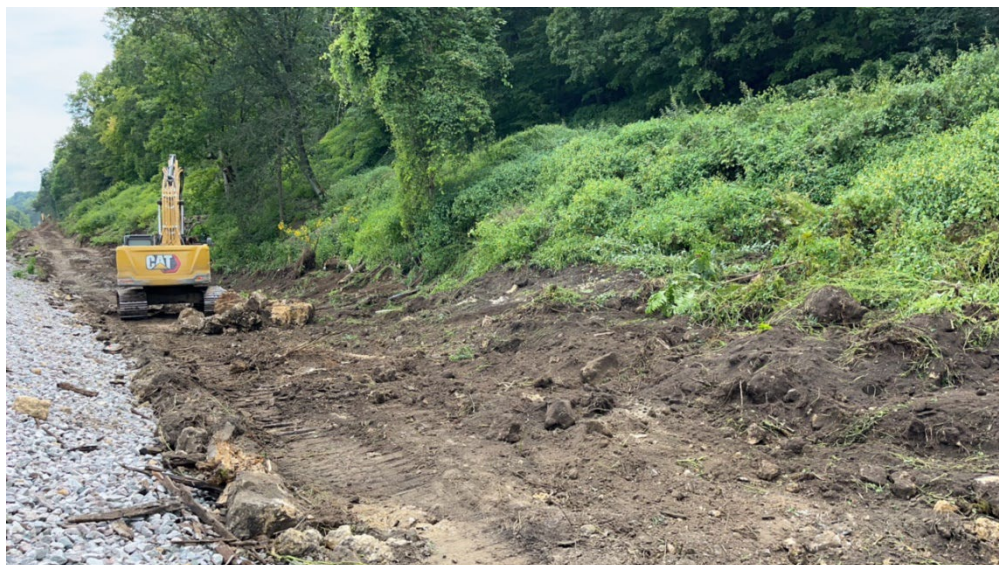
**Figure 15. Topsoil removal on western portion of ROW; facing Southeast. (M. Richison 08/20/24)**

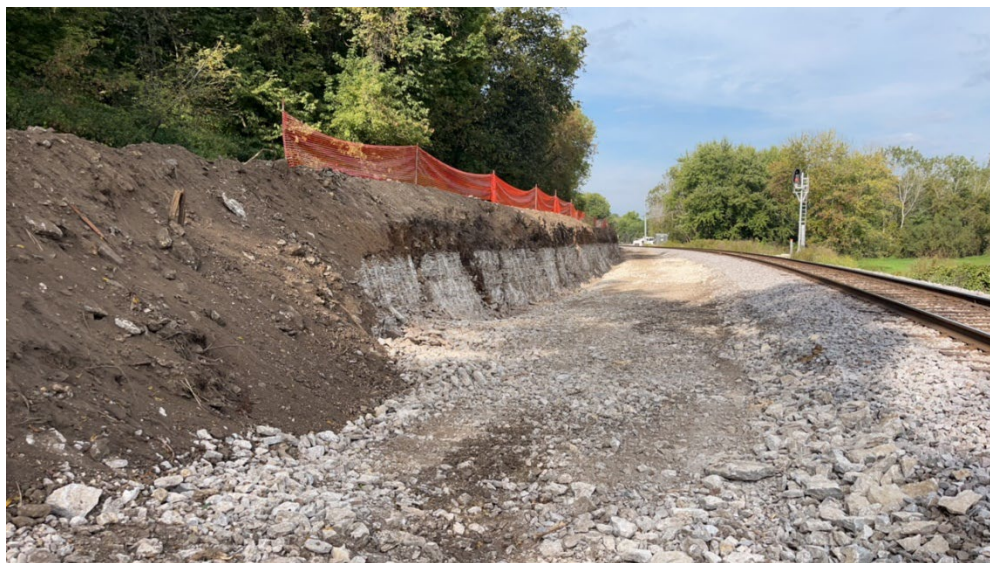
**Figure 17. 360<sup>th</sup> St entrance to ROW topsoil and overburden removal complete, westernmost area of project area near railroad crossing; facing Northwest. (M. Richison 09/18/24)**

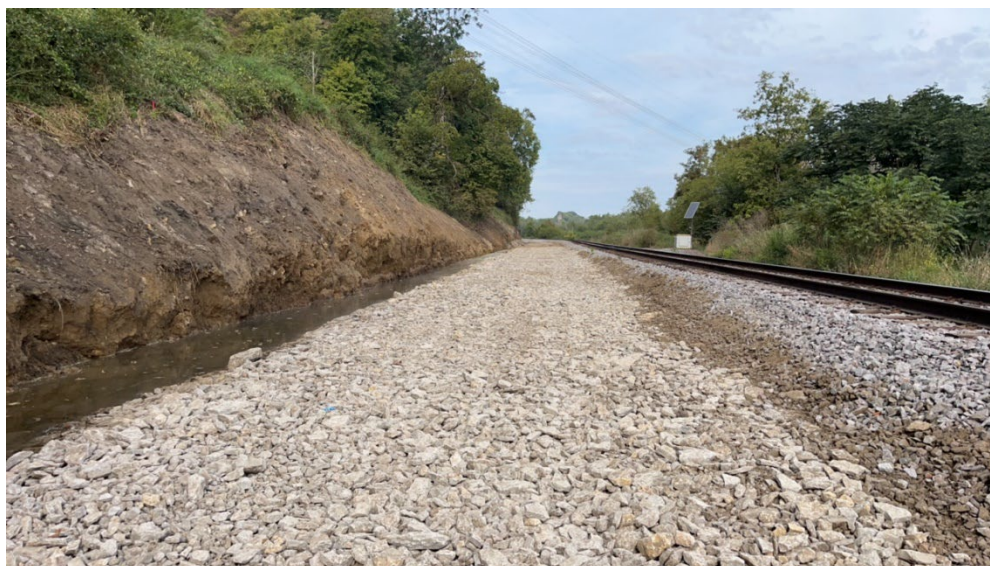
**Figure 18. Western portion of project area, new disturbance complete; facing West. (M. Richison 09/18/24)**

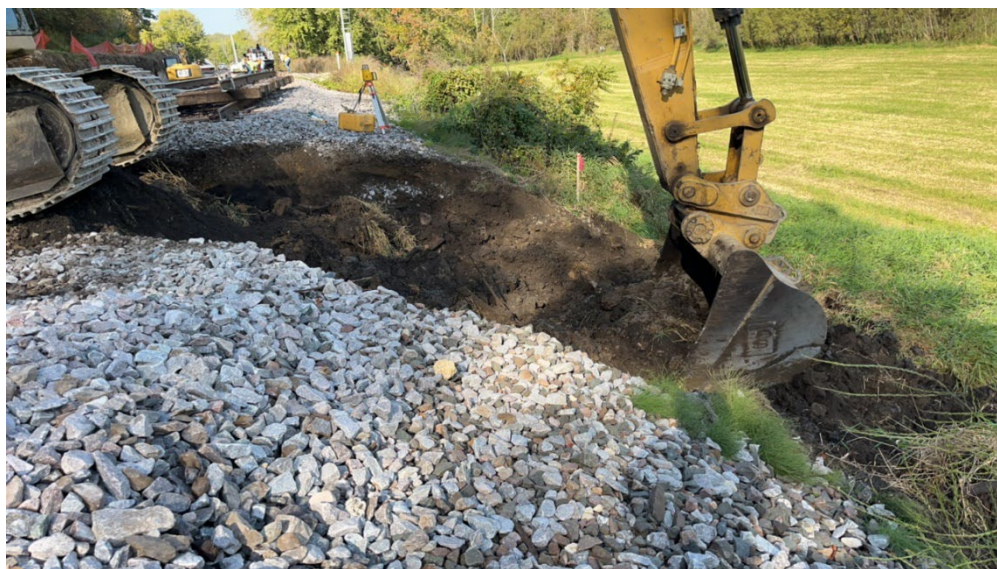
**Figure 19. Culvert installation under existing railroad, near western extreme of project area and railroad crossing; facing Northwest. (M. Richison 10/09/24)**

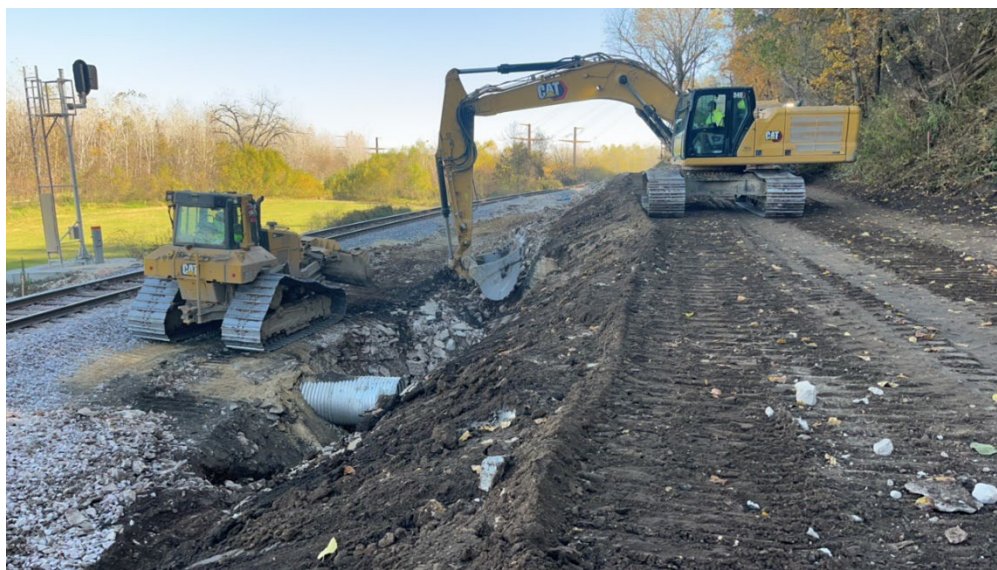
**Figure 20. Culvert area cleanup after installation, near westernmost extreme of project area standing on 360<sup>th</sup> St; facing east. (M. Richison 10/24/24)**

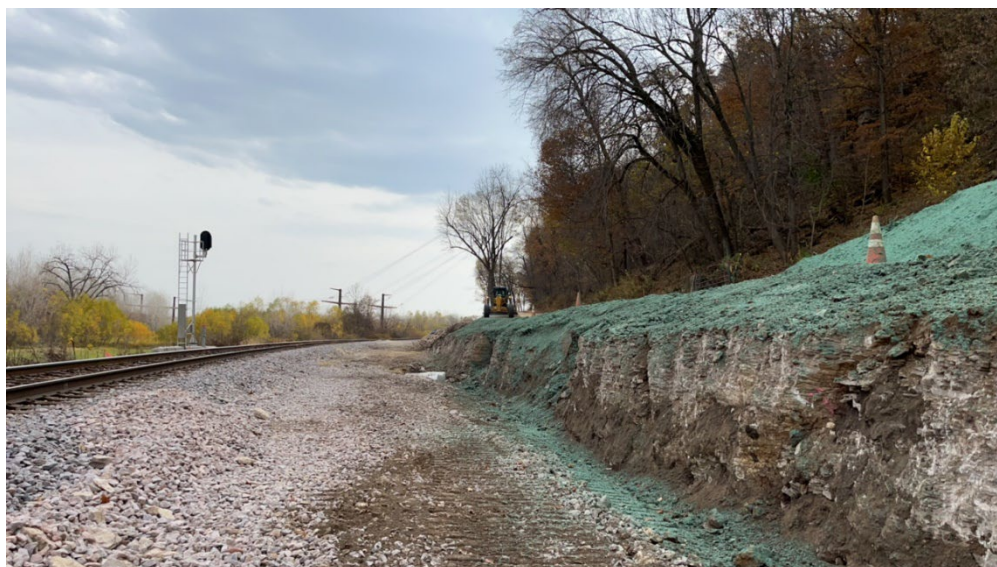
**Figure 21. Western extreme of project area, new disturbance complete; facing East. (M. Richison 10/30/24)**

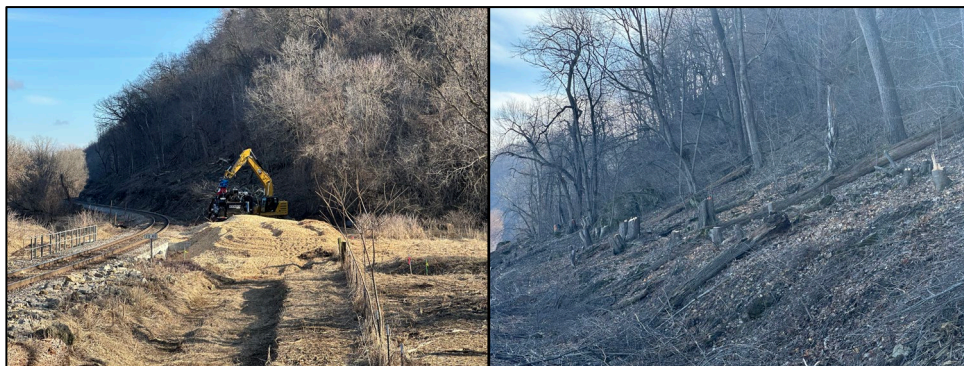
Tree clearing at Turkey River was started on 12/5/23 and completed before 3/31/24. No eagles nests or other active bird nests were identified on the project site during tree clearing or construction, and no more trees were cleared than necessary for construction.

The photos below show the ROW during tree clearing.
