**NET LIQUIDATION VALUATION  
OF THE  
FISHERS, IN-OWNED TRACK ASSETS**

Prepared for:  
**THE CITY OF FISHERS, IN**

## Track Inspection Report & Rehabilitation Plan

**Hoosier Heritage Port Authority Railroad  
Track Inspection Report & Rehabilitation Plan**

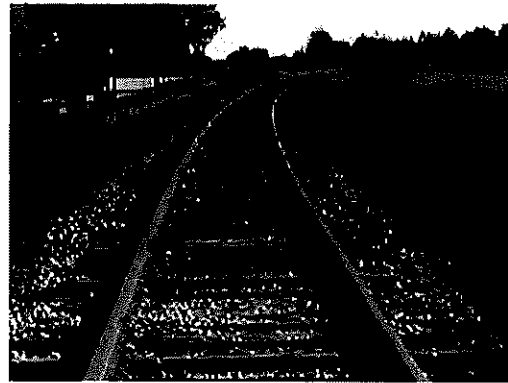
One location on the north end had a very hard to kill plant on the shoulders of the track which the Consultant is familiar with. It is an ancient plant growth called "Equisetum" or "horsetail" and is typically not affected by typical weed spraying. It is prudent to mention this type of plant to the weed spraying contractor in advance. Many national track weed spraying contractors are familiar with this particular vegetation.

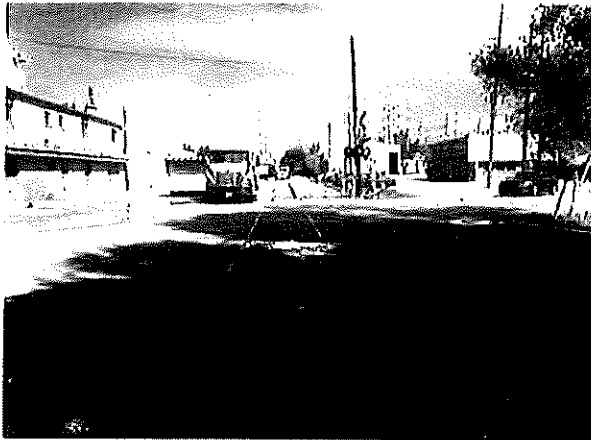
Regarding overall drainage, it was evident that the railroad was very well engineered and constructed originally and maintained throughout the course of time. Rarely does a track inspection over 37 miles of track exhibit such a high and dry right-of-way with so few drainage problem locations. There were only a few "standing" water locations identified where the drainage was infiltrating the track structure along the entire railroad. Those included 56<sup>th</sup> Street where the hy-rail truck had to be taken off the track and set back on after skipping between Kessler Boulevard and 56<sup>th</sup> Street due to the track equipment occupying the track. The other location was between the embedded street running track at Logan Street in Noblesville and the two bridges north.

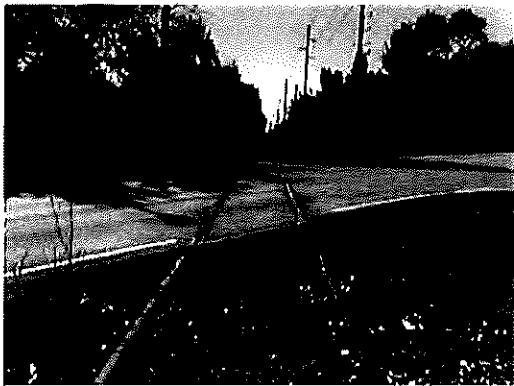
The crossings that have poor drainage conditions often create surface problems on the approaches to the crossings. Though there are a few crossings that have this condition it presently is not a problem due to the infrequency and slow speed of the rail traffic. The problems will become more prevalent on the subject crossings when the track is upgraded to Class Two level of speed and service. The impact of the higher speed on the track below magnifies track surface irregularities and the track becomes generally harder to maintain. As discussed above, the overall line has been well engineered and constructed with attention to drainage so therefore the Plan will need to concentrate on correcting these drainage issues using existing facilities and perhaps installing pipes and inlets during the rehabilitation effort.

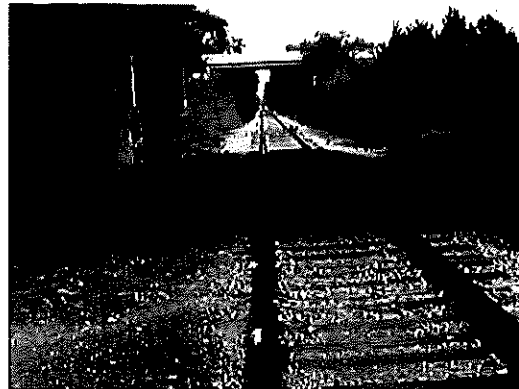
Typical of many railroads, brand new highway overpasses that cross over railroads don't design in adequate drainage for the railroad underneath and will ruin the track's ballast section by fouling it with dirt and fines during and after the construction of the bridge. The track at the Overhead Bridge where Route 52 intersects with I-69 will need to be cribbed or undercut to remove and replace the fouled ballast. Though that is not a problem now the higher speed will cause deleterious impact on the track surface.

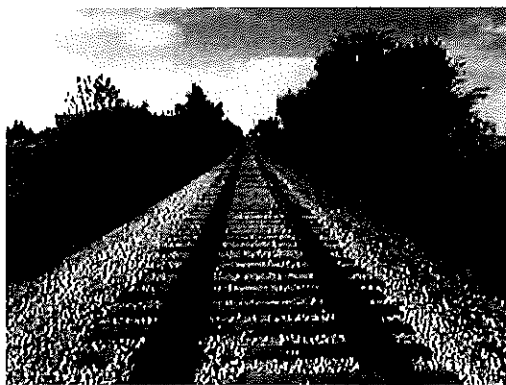
The general track surface and alignment of the Main track can best be described as good. The surfacing work that will be required to bring the specific sections of railroad to Class Two speed and service will be surprisingly less than what the Consultant had originally, (without seeing the Railroad) anticipated.

An important consideration with the surfacing is the frequency of defective ties within any track that is raised and lined. If the track is only "safety tied", that is spot tied every 3 or 4 ties to make it safe for movements on say storage tracks, then the defective or nearly defective ties do not raise and consequently you have less support than if you left the track at the existing elevation. The tie replacement program will take this into consideration.

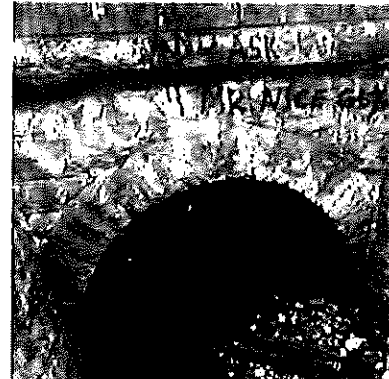
The six foot stone arch bridge at 18.30 had some minor grout loss at the west side wing wall which was undermining the southeast approach wall. Some shoring and ballast should be installed there and on the closed deck.

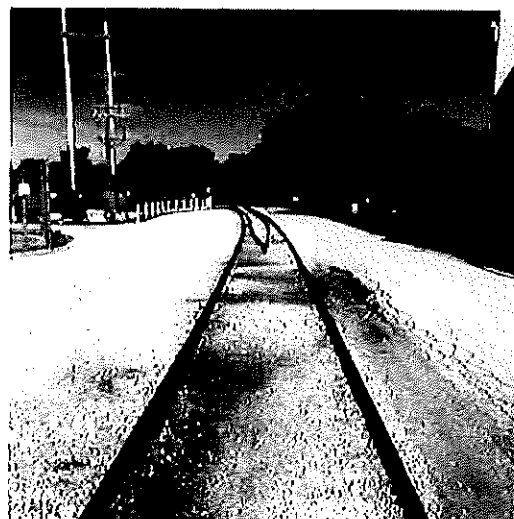
The inner track guard rail or "rails between the rails" that come to a point and stretch out as much as 30 feet from the headwall of both sides of a bridge are installed to deflect a derailed car wheel flanges back to a position that will keep the car on the bridge. Most railroads have taken them off the approaches because standard tie insertion equipment cannot install a tie under the inner set of rails. Production tie gangs will skip them all together with the intention that a "hand" crew will come back and install them later. That very infrequently happens so typically there are numerous and dangerously few effective cross-ties at one of the most critical areas on every railroad, bridge approaches.

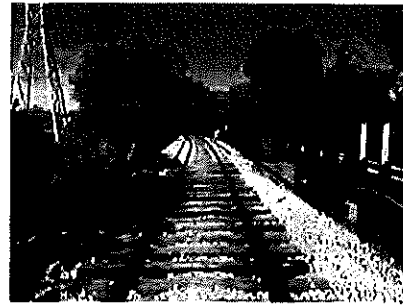
Bridges 20.71 and 20.80 both had good bridge deck timber and well distributed effective ties on the approaches under the "nose" of the inner track guard rail. Bridge 22.62 in Noblesville requires additional ties on the south end approach within the nose area of the inner track guard rail. Gauge at this location measured 57-5/8". All the ties between Bridge 22.62 and 22.69 have been recently replaced and the rail on the high side of the curve through Bridge 20.80 was replaced.

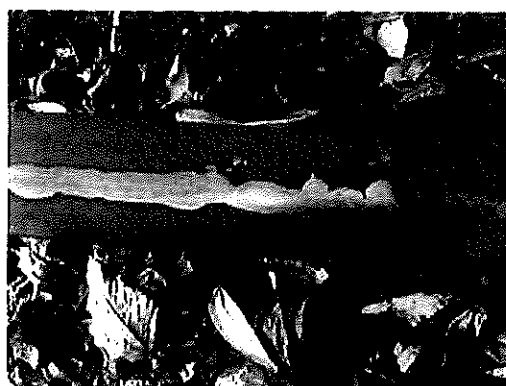
four feet on each rail head. The intermittent pattern started at the turnout at Fall Creek Milepost 6.1 and extended to roughly 900 feet north of 39<sup>th</sup> Street.

On further investigation, the material is stainless steel and is welded into an electric arc burned groove in the center of the rail head that maintains the electric shunt in rusty rail conditions so the circuit is not lost when trains are approaching grade crossings that are protected with electric warning devices. There is a railroad in Minerva, Ohio that performs the same procedure to maintain the circuit and it is conjectured that it was developed and implemented by the same owner.

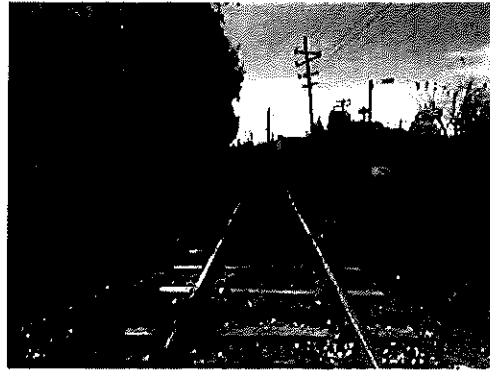
**South of 56<sup>th</sup> Street Turnout – O/S, Frog is poor, reverse move back to back measurement is O/S, Frog needs replaced.**

A cracked frog point is sometimes “weld-able” if it does not migrate through the entire point and definitely into the casting. It has been the prudent action to simply replace the frog then to attempt to cut out the fracture and build the point from scratch. Even the best of frog welders cannot always make a weld of this magnitude and have it last for any length of time. The fact that the track will be raised to Class Two level of service negates the option of welding. The frog must be replaced.

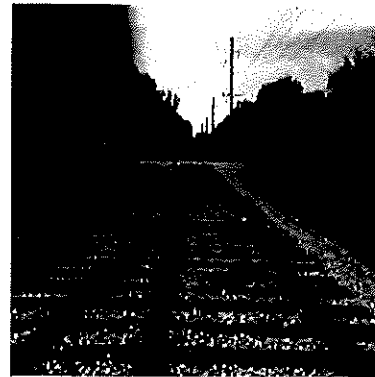
South of Milepost 16

**South of Milepost 16 (South Run-around Turnout – Fishers)** – Switch rods are close to switch timber, mildly chipped reverse left hand point. Switch timber are good but measurement for Face and Check gauge need correction on reverse move.

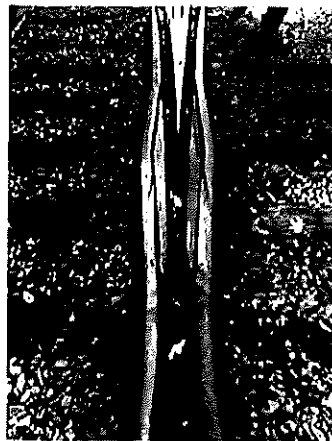
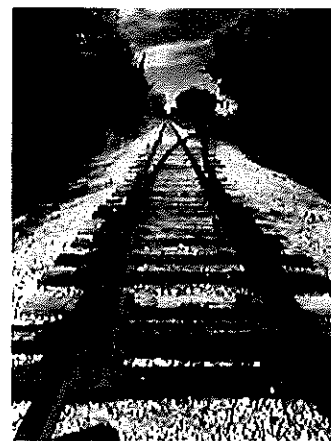
South Wye Turnout

**South Wye Turnout** – Frog bolts are loose.

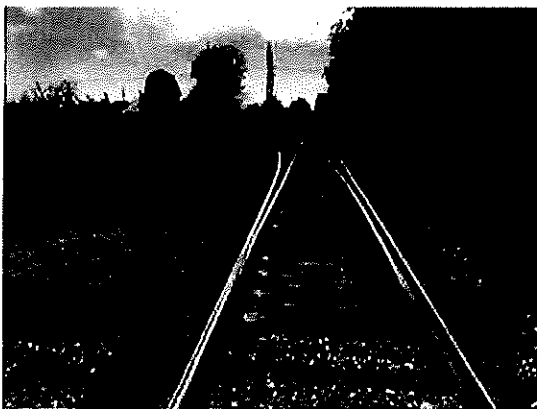
North Wye Turnout

**North Wye Turnout** – Risers on frog need welded.

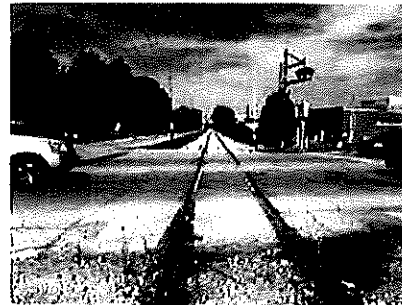
MP 6.2 - 46<sup>th</sup> Street

**MP 6.2 - 46<sup>th</sup> Street** Crossing like many more below do not have a positive flangeway. Track is relatively solid.

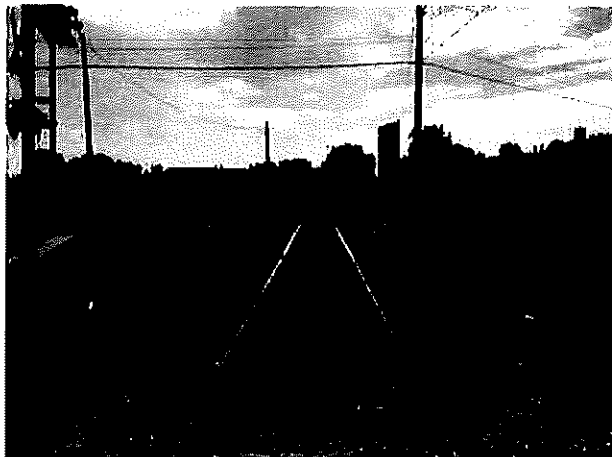
MP 6.7 - 52<sup>nd</sup> Street

**MP 6.7 - 52<sup>nd</sup> Street** No positive flangeway grade crossing.

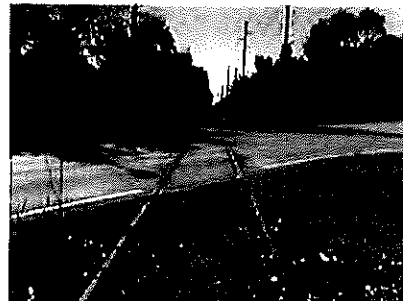
MP 10.3 – 71<sup>st</sup> Street

**MP 10.3 – 71<sup>st</sup> Street** Asphalt, no positive flangeway. Track solid.

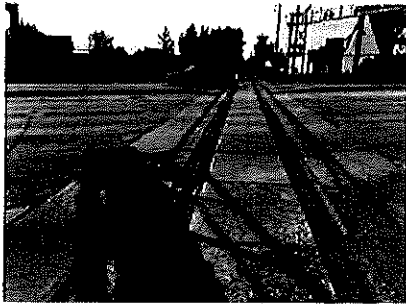
MP 12.3 - 82<sup>nd</sup> Street

**MP 12.3 - 82<sup>nd</sup> Street** Tub crossing mild misalignment in crossing at median. Broken up asphalt in flanges. Track appears solid.

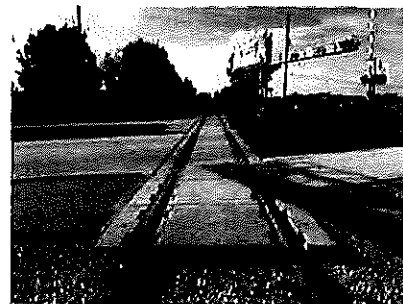
MP 13.7 - 96<sup>th</sup> Street

**MP 13.7 - 96<sup>th</sup> Street** Concrete tub crossing, solid track.

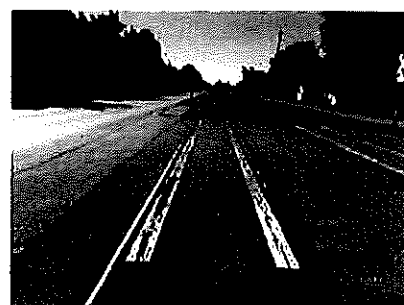
MP 21.3 - Chestnut

**MP 21.3 - Chestnut** Timber flangeway, some failing but track structure appears solid.

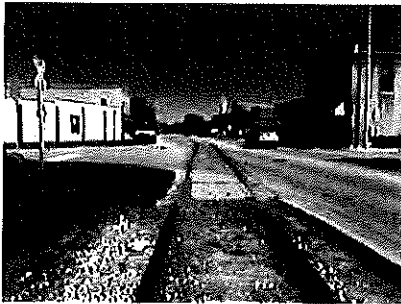
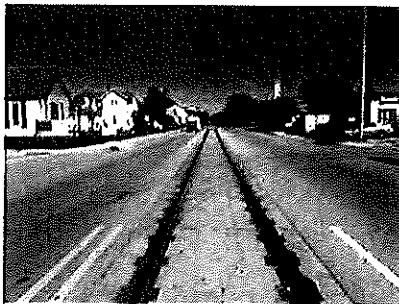
MP 21.8 – Division Street through Logan Street

**MP 21.8 – Division Street through Logan Street** Embedded street running track in concrete tubs with continuous welded rail. Sturdy track.

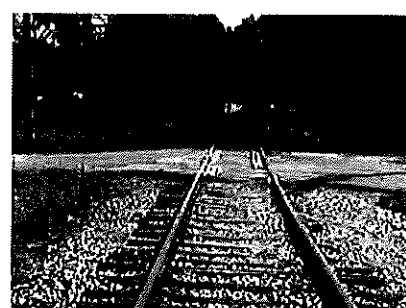
MP 28.9 – Park Street

**MP 28.9 – Park Street** Broken up timber crossing. Scheduled to be replaced in spring.

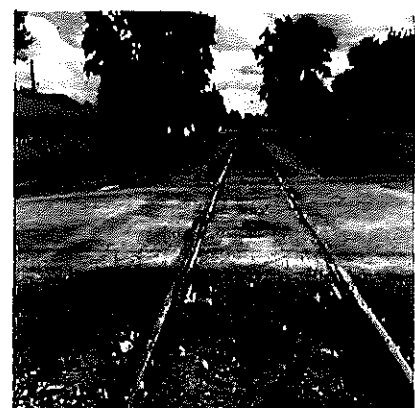
MP 34.6 – County Line Road

**MP 34.6 – County Line Road** Flangeways must be provided for train movements.

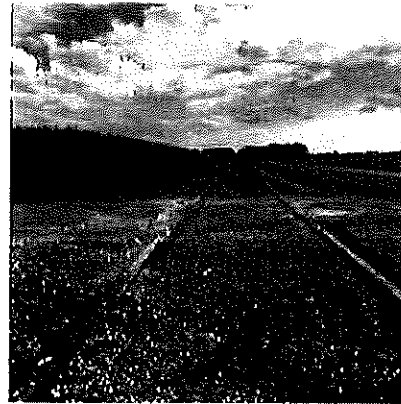
MP 36.1 – County Route 450

**MP 36.1 – County Route 450** Gauge is 58” within crossing and has been tar and chipped filling in the flangeways. Crossing track and surface must be fully replaced.
