Environmental Site  
Investigations, Management  
& Design

Re: Comments on PRB Expansion DEIS  
Presented to the Surface Transportation Board  
Sections: 4.4.5.2 Geologic Hazards, 4.4.5.3 Soil Impacts, 4.4.12 Safety

#### **4.4.5.2 Geologic Hazards**

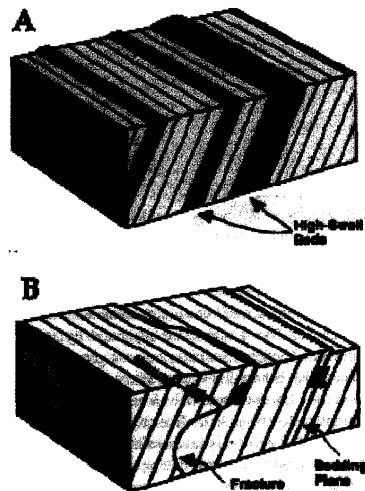
Figure 2: Block diagrams showing different types of heave features associated with heaving bedrock (modified from Noe and Dodson, 1995).

(A) Near-symmetrical heave features formed by differential swelling and/or rebound of individual bedrock layers, each having a different swell potential. This type of heaving results in straight-crested, longitudinal uplift of the ground surface, oriented parallel to bedding strike.

(B) Strongly asymmetrical heave features formed by thrust-like, shear-slip movement along bedding planes or fracture surfaces. The bedding-plane features are straight crested and are oriented parallel to bedding strike, whereas the fracture-plane features have curvilinear crests and may not necessarily be oriented parallel to bedding strike.

As seen in the heaving bedrock illustrated from Colorado in the above figure, the uplift is not uniform in areas of tilted strata. This situation exists in the Cheyenne River Valley where the Pierre Shale is tilted away from the Buffalo Gap Monocline south of Rapid City. In areas like the Cheyenne River Valley where the Pierre Shale Formation is tilted, heave features are usually dramatic and pose severe engineering limitations to any construction. The following figure illustrates the problem.

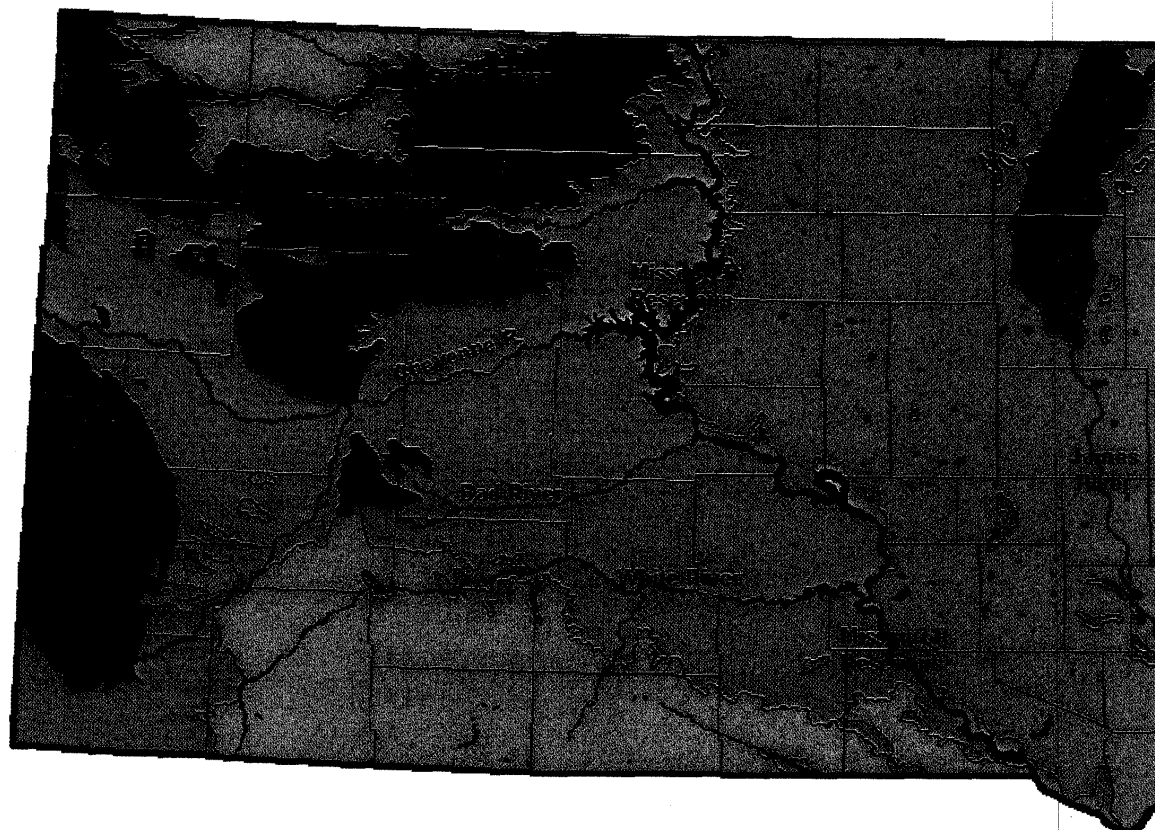
Figure 2: The above figure depicts the first encountered bedrock throughout the state of South Dakota. The area labeled as Upper Cretaceous (shale, chalk) generally refers to the Pierre shale formation. (South Dakota Geological Survey, 2001)

Figure 3: The above map and table shows all rail accidents, excluding highway rail accidents that have occurred on DM&E railroad in South Dakota over the past 15 years. Using the bedrock geology map (Figure 2) you can see that the majority of railroad accidents in the past 15 years have occurred on rail line that is underlain by the Pierre shale formation. Once the rail line crosses the Missouri River and is no longer directly underlain by the Pierre shale the rail accidents decrease. (Federal Railroad Administration, Office of Safety Analysis, 2001)

Figure 4: The above map and table shows all rail accidents, excluding highway rail accidents that have occurred on all railroads in South Dakota over the past 15 years. Using the bedrock geology map (figure 2) you can see that the majority of railroad accidents in the past 15 years have occurred on rail line that is underlain by the Pierre Shale formation. Once the rail line crosses the Missouri River and is no longer directly underlain by the Pierre Shale the rail accidents decrease. (Federal Railroad Administration, Office of Safety Analysis, 2001)

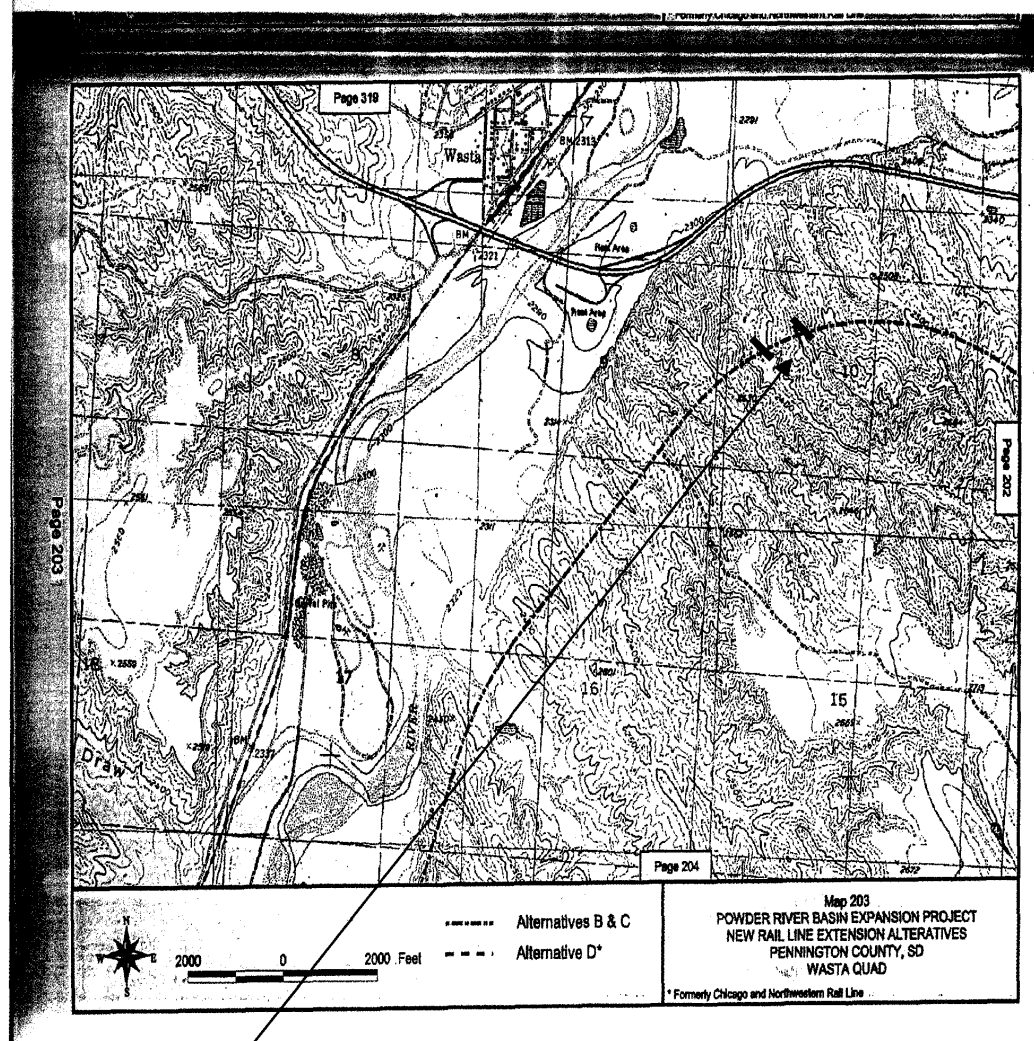
Figure 5: Within this 1000-foot section of proposed rail line in section 10 we find a maximum ground level elevation of 2500' and a minimum ground level elevation of 2360'. With a relief of 140' over 1000' a valley or ravine with a 14% slope must be cut and filled to construct the 1% maximum grade. The Pierre Shale is not suitable material for the fill section and must be over-excavated and re-filled in the cut section making Alternatives B & C unfeasible.

Construction of either Alternative B or C in the Cheyenne River valley will require major grading including massive cut and fill sections in the geologically unstable Pierre Shale. As stated in the DEIS, section 4.4.5.2, Alternative B (Proposed Action), "The potential for slumps and landslides would be high where this alternative would cross steep slopes or where cutting or loading of slopes or unusually high precipitation events may cause landslides. In South Dakota, approximately 40.8 miles of the Pierre shale formation would be crossed." In order to maintain the proposed engineering constraints of 1-degree maximum curvature and 1 percent maximum grade, cutting and loading will need to be done extensively along the already unstable undisturbed banks of the Cheyenne River valley. Figure 5 illustrates the difficult and imprudent option presented in alternative B and C.
