## BEFORE THE SURFACE TRANSPORTATION BOARD

North Coast Railroad Authority – )  
Abandonment Exemption – ) AB 1305X  
In Mendocino, Trinity and Humboldt Counties, CA )

Great Redwood Trail Agency's  
Certification of Filing and Service  
of Information Required Pursuant to 49 C.F.R. 1152.27(a)

# Railroad Rehabilitation Assessment Willits MP 139.5 to Longvale MP 152.5

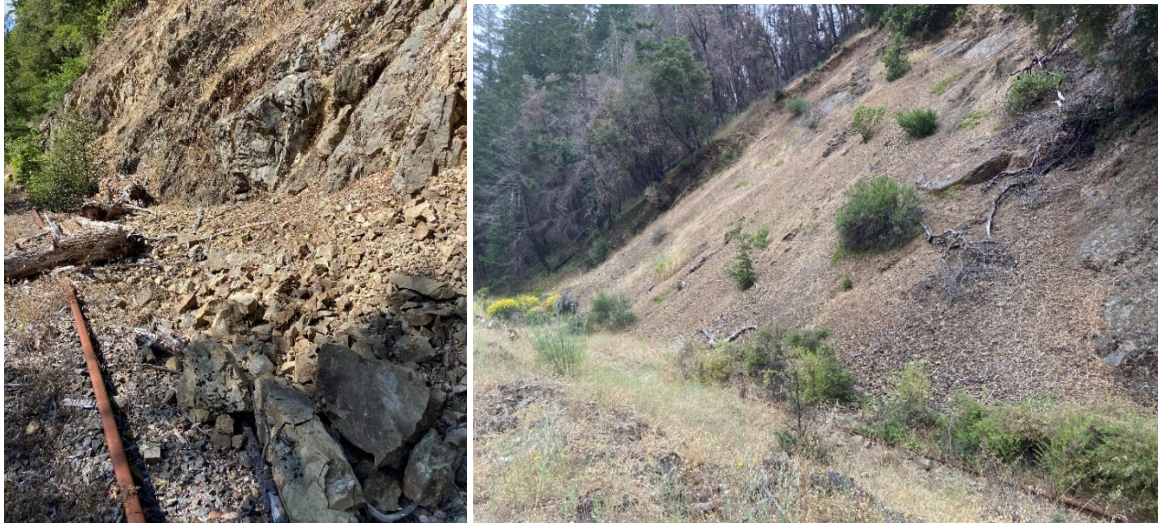
*Photo 1 Typical slide example*

**Ditching at Slides:** There are several areas that require ditching due to rock and debris slides. The rockslides consist of fracture rock, mixed soil, and woody debris resulting in talus slopes. It is evident at several of these slide areas that they have required substantial clearing over time based on large stockpiles of material on the opposite side of the track from ditching. In areas of recurring larger rock falls it is recommended that rock slopes be scaled and catchment walls constructed with K-Rail Barriers.

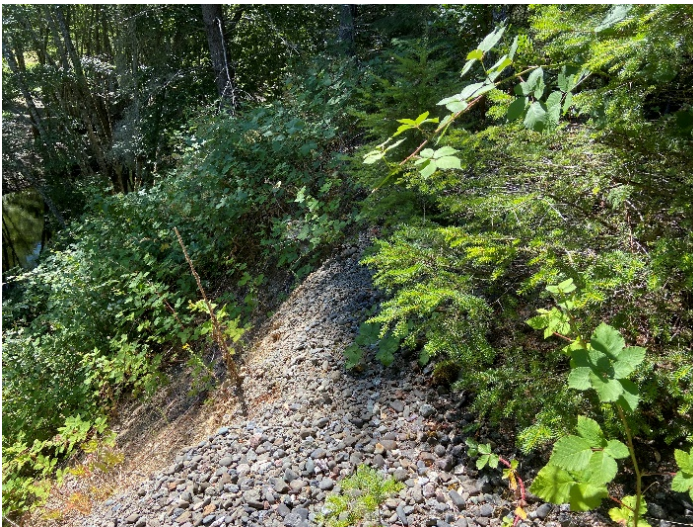
*Photo 3 MP 151.6 steep slope at Outlet Creek.*

**Shoulder Walls:** As a result of steep embankment slopes and bank erosion along bends of Outlet Creek, four locations require shoulder retaining walls. Shannon & Wilson geotechnical engineers recommend cast-in-place concrete or shotcrete walls supported on vertical micropiles installed from the roadbed as the most economical solution. The four locations are: MPs 148.9, MP 151.0, MP 151.6, and MP 151.8. At MP 151.6 a field visit measured the distance from face-of-rail to top-of-embankment down slope of 4.0 feet. See Photo 3 and Photo 4 showing the steep railroad embankment on the right side of the track and at the same location the left side of the track with poor drainage. At MP's 148.9 and 152.6 Photos 5 and 6 show bare earth LiDAR views of the erosion of Outlet Creek which is very susceptible to frequent high flows in the rainy season.

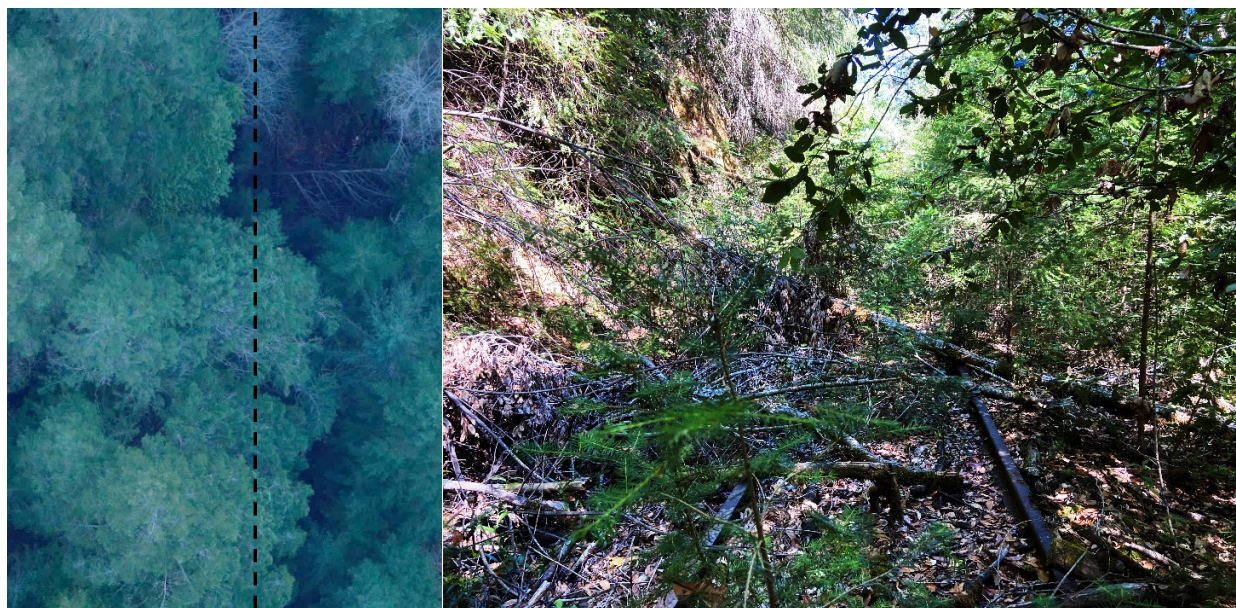
*Photo 7 Example of Heavy Vegetation  
Canopy over Rail Right-of-way MP  
150.6 (dashed line is centerline of  
track)*

Heavy = Trees up to 6" to 8" diameter; not walkable; track 20% visible

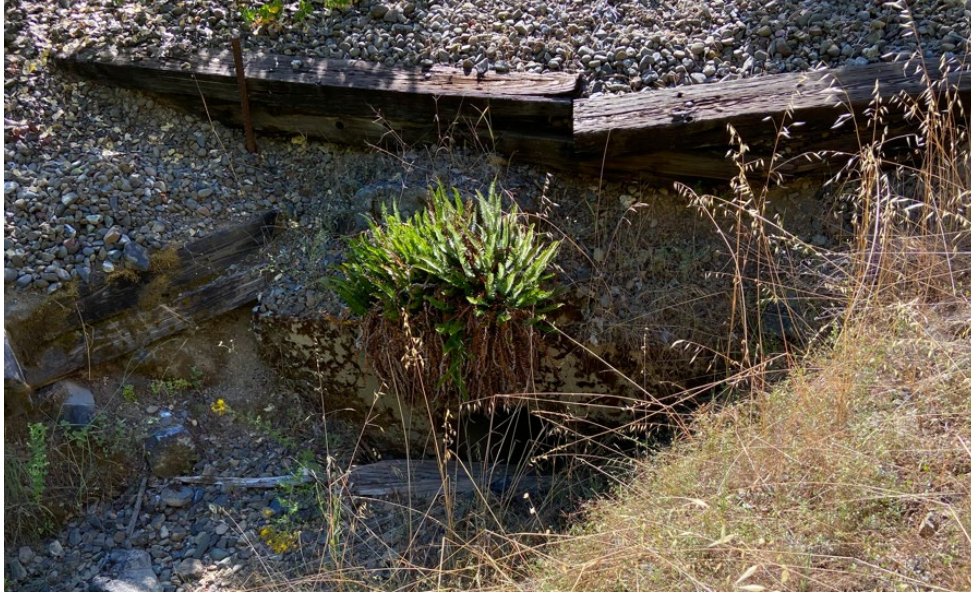
*Photo 9 Example of ineffective headwall*

- All culverts will need to be located and cleared of obstructions
- Small timber culverts require replacement
- 50% of the pipe culverts require headwall and wing wall repairs/replacements to address erosion
- The final program will require a detailed inspection of all culverts after removal of vegetation
- All culvert sizes need to be reviewed for capacity based on watershed hydraulics

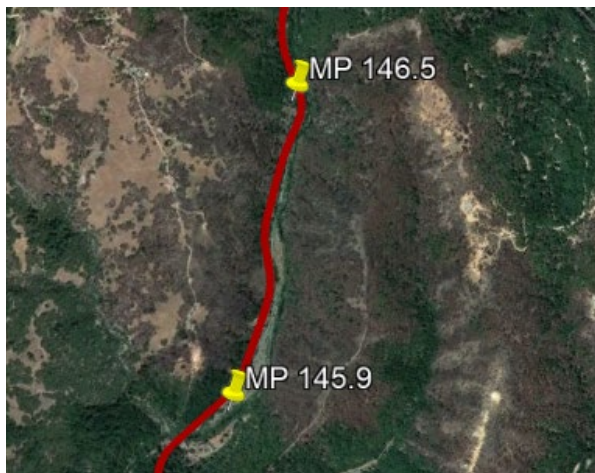
*Photo 11 Area of fire damage*

From MP 145.9 to 146.5 the track was subjected to a large forest fire. The fire destroyed all ties for this 0.6 miles of track. In this area the most economical rehabilitation is a complete replacement of the track ties and ballast. Field observations indicated that much of the ballast does not meet railroad ballast specifications. The rail was visually inspected, and it appears that the heat of the fire did not impact the rail and it can be relayed. The rebuild of this segment assumes removal of the rail to be set aside and relayed, replacement of 100% of the ballast (existing non-compliant ballast stockpiled for other use) and installation of all new ties. The rail would be relayed and the ties would be surfaced and regulated. See photos below of fire damaged area, tie damage and substandard ballast.

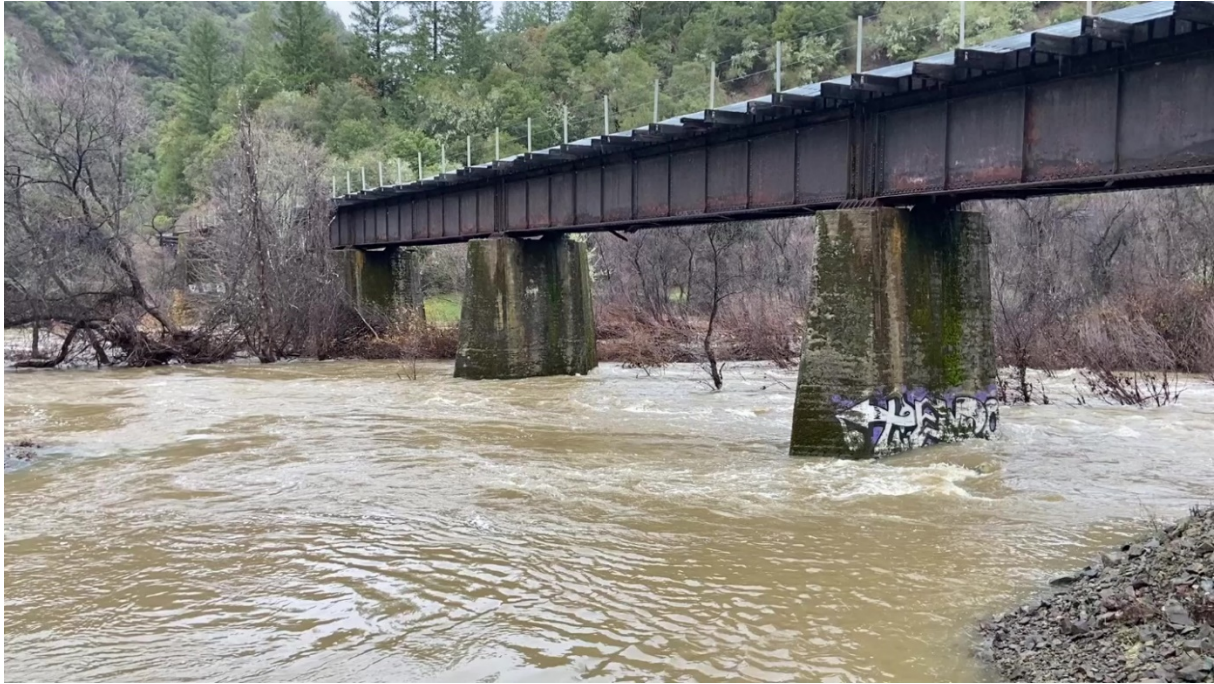
*Photo 15 Bridge 151.99 Outlet Creek heavy flow*

The eight Deck Plate Girder bridges have multiple spans with concrete piers and abutments all spanning Outlet Creek. These crossings of Outlet Creek are frequently subjected to very high flows resulting in scour around concrete piers. Exacerbating the impact, many of the piers are skewed to the high flows. During the December 2021 inspection, Outlet Creek was overflowing its banks. See photos below of Bridge at MP 151.99.

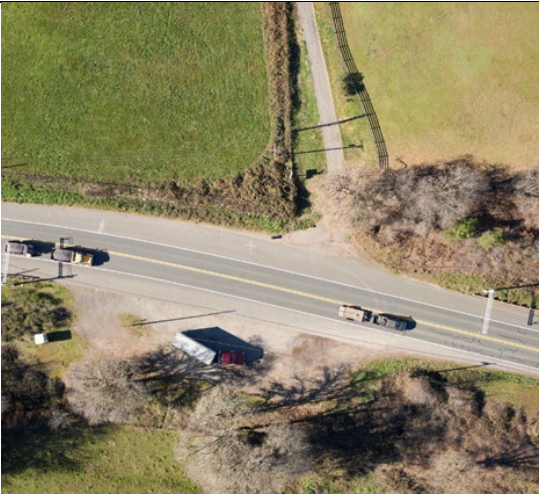
| Crossings | Mile Post | Recommendation | Comments | Photo |
|---|---|---|---|---|
| Highway 101 | MP 141.2 | Install 200-foot curved track crossing with concrete panels, Install active constant warning devises including gates and cantilevers, approach roadway signs and address driveway entrance that lays within the crossing. | Tree removals along highway will be required to improve train crew line of site. Crossing skewed 60 degrees. | |

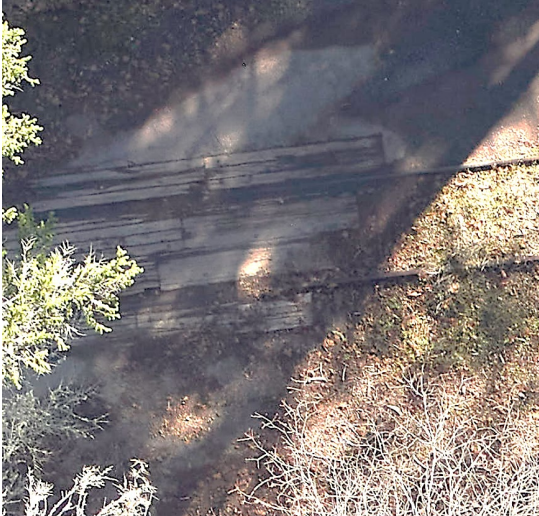
| Crossings | Mile Post | Recommendation | Comments | Photo |
|---|---|---|---|---|
| Reynolds Highway | MP 143.91 | Reconstruct existing very poor 24-foot timber crossing with a concrete panel crossing, add appropriate approach warning signs. | Tree Trimming required S.W. & N.E. Quadrants. Crossing skewed 30 degrees. | |

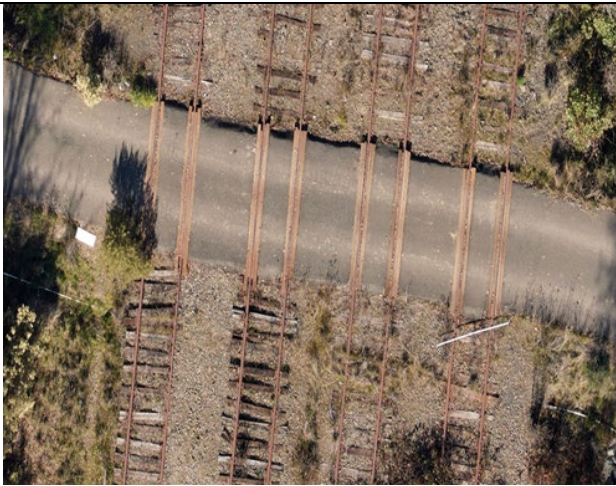
| Crossings | Mile Post | Recommendation | Comments | Photo |
|---|---|---|---|---|
| Located in Willits Yard | MP 140.00 | Crossing in good condition. Constructed as part of Highway 101 Bypass. Crossing signs required | Tree removal on west approach to railroad may require additional tree removal for line of sight. | |

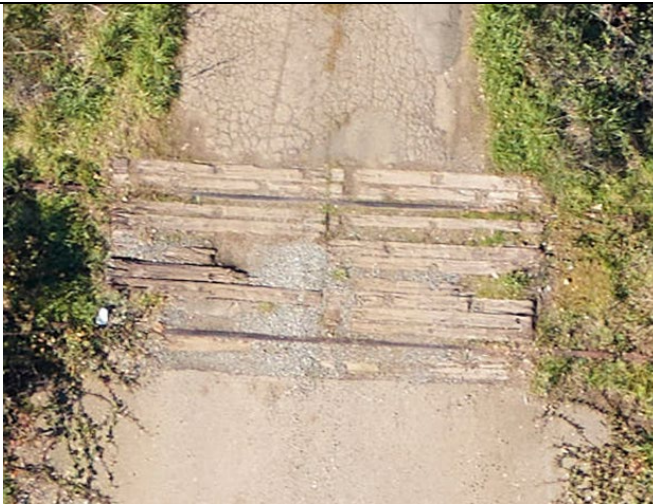
| Crossings | Mile Post | Recommendation | Comments | Photo |
|---|---|---|---|---|
| Private Resident | MP 141.40 | Reconstruct existing very poor 24-foot timber crossing with a concrete panel crossing, add appropriate approach warning signs. | One residence | |

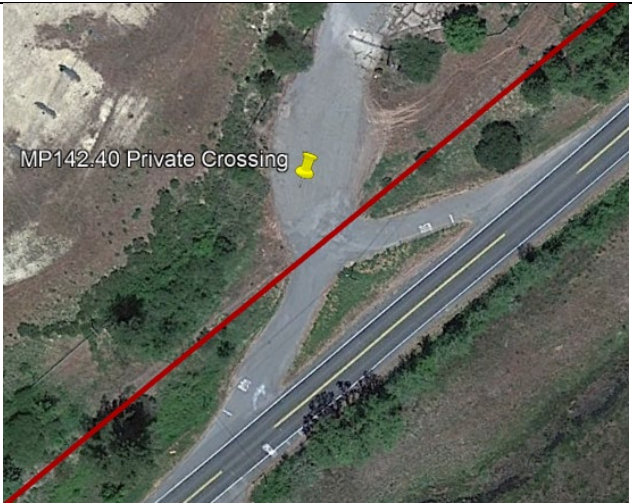
| Crossings | Mile Post | Recommendation | Comments | Photo |
|---|---|---|---|---|
| Mendocino Forest Products Crossing | MP 142.03 | Heavy truck usage, earthwork activities. Crossing parallel to 101 with wide angle egress and entrance roads to crossing from 101. Signing and reconstruction of paved over crossing required | This will be a costly repair. | |

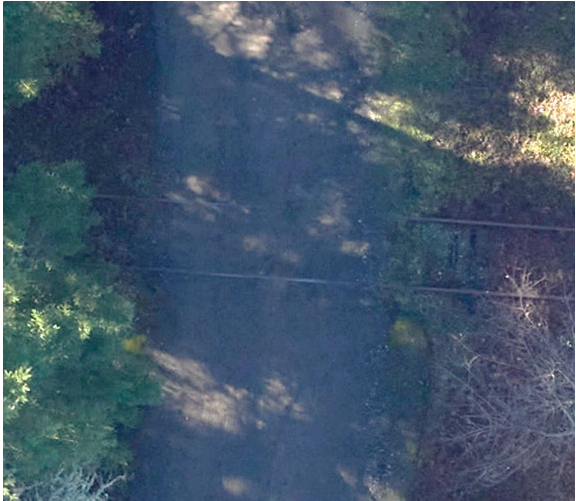
| Crossings | Mile Post | Recommendation | Comments | Photo |
|---|---|---|---|---|
| Serves Several private residences | MP 142.68 | Poor condition Rail exposed | | |

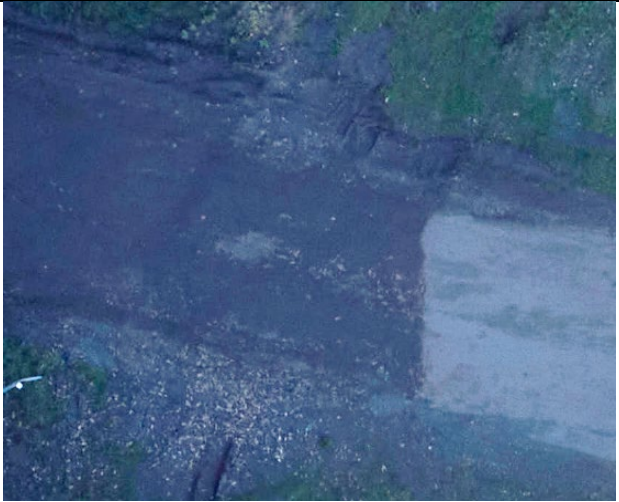
| Crossings | Mile Post | Recommendation | Comments | Photo |
|---|---|---|---|---|
| Private Residence may include addition homes | MP 142.77 | Crossing in poor condition. Gravel track buried | | |

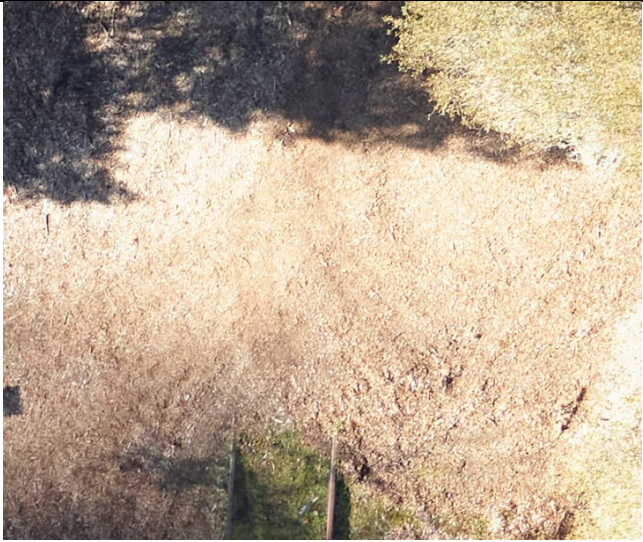
| Crossings | Mile Post | Recommendation | Comments | Photo |
|---|---|---|---|---|
| Serving two residences | MP 145.13 | Crossing in poor condition. Gravel track buried | . | |

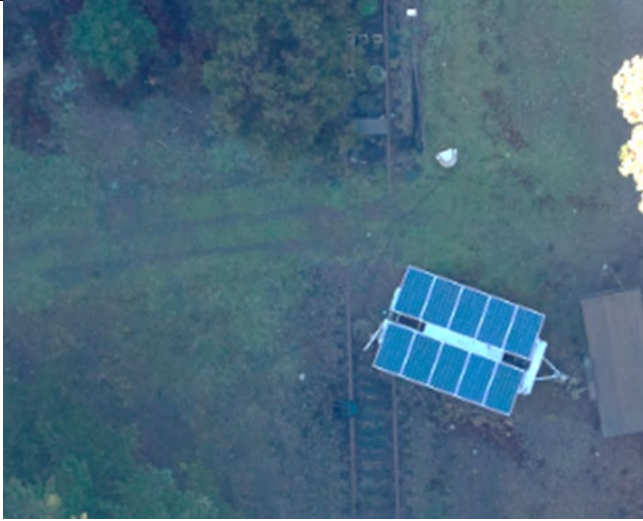
| Crossings | Mile Post | Recommendation | Comments | Photo |
|---|---|---|---|---|
| Gravel over track, Appears to be serving two residences | MP 145.17 | Crossing in poor condition. Gravel track buried | . | |

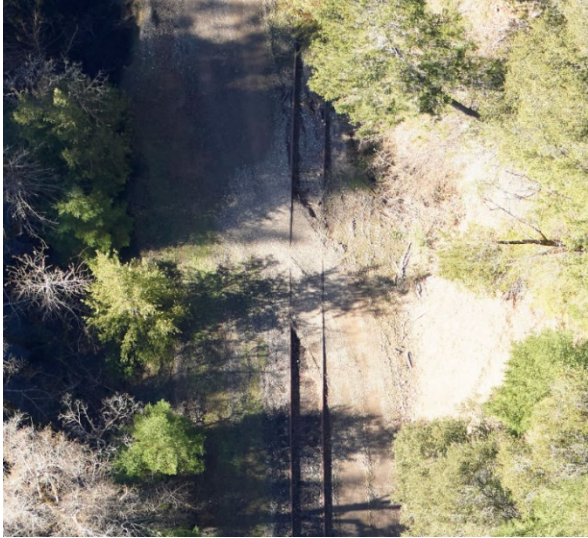
| Crossings | Mile Post | Recommendation | Comments | Photo |
|---|---|---|---|---|
| Appears to be serving two residences | MP 145.34 | Gravel over track, very skewed. crossing in poor condition | . | |

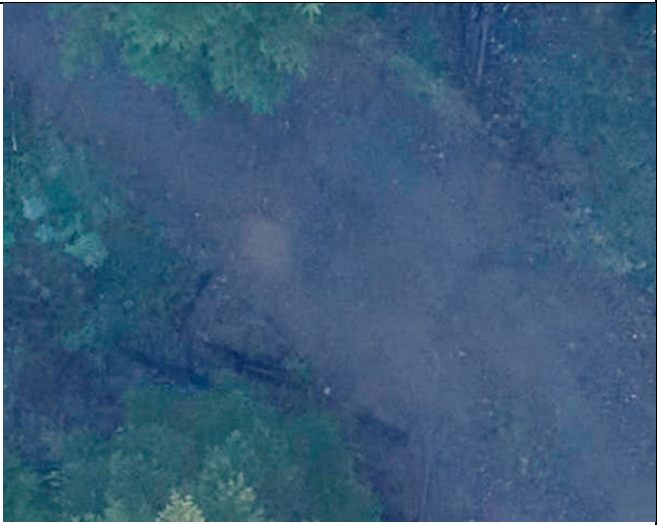
| Crossings | Mile Post | Recommendation | Comments | Photo |
|---|---|---|---|---|
| One Resident | MP 145.60 | Crossing in poor condition. Gravel track buried | Timber crossing planks in very poor condition | |

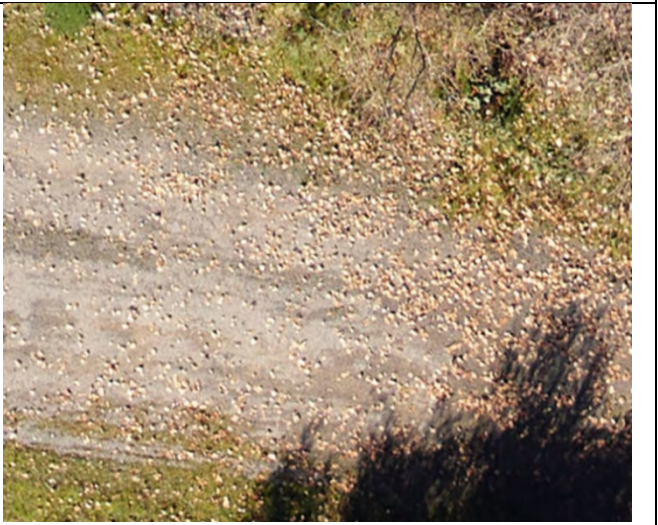
| Crossings | Mile Post | Recommendation | Comments | Photo |
|---|---|---|---|---|
| Serving one parcel | MP 148.34 | Crossing in poor condition. Gravel track buried. | | |

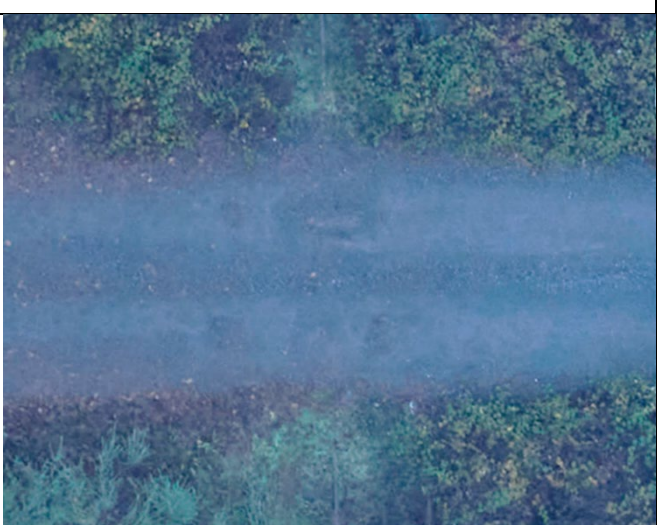
| Crossings | Mile Post | Recommendation | Comments | Photo |
|---|---|---|---|---|
| Serving one residence | MP 148.41 | Crossing in poor condition. Gravel track buried | | |

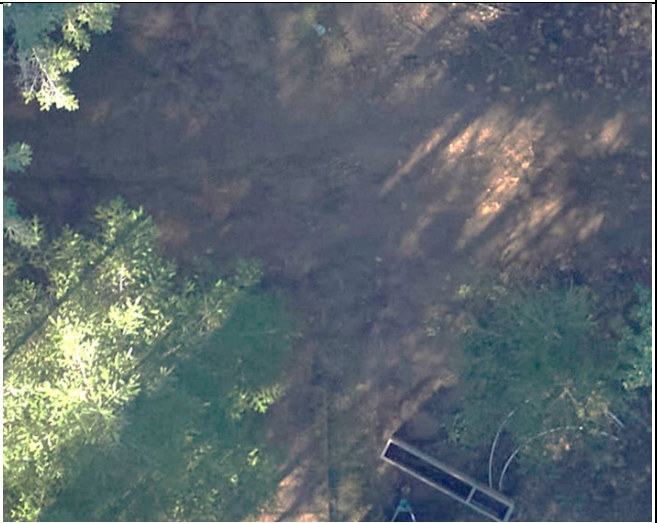
| Crossings | Mile Post | Recommendation | Comments | Photo |
|---|---|---|---|---|
| Serving one parcel | MP 149.40 | Crossing in poor condition. Gravel track buried | | |

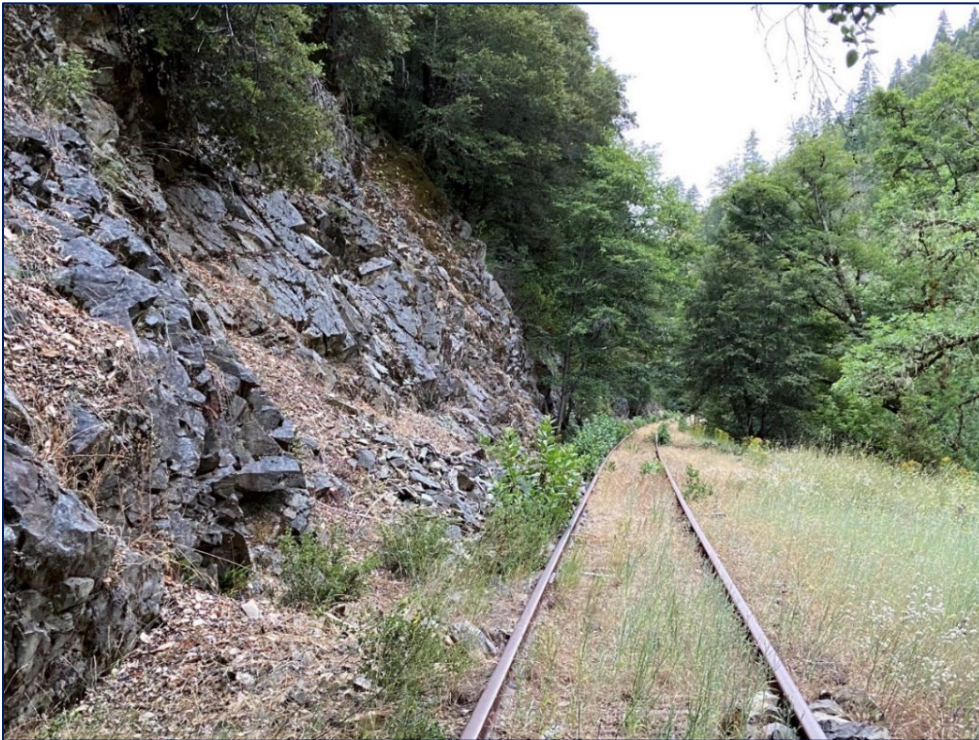
**Exhibit 4-2 – Photo 60 – Blocky sandstone rock slope at approx. MP 147.5**

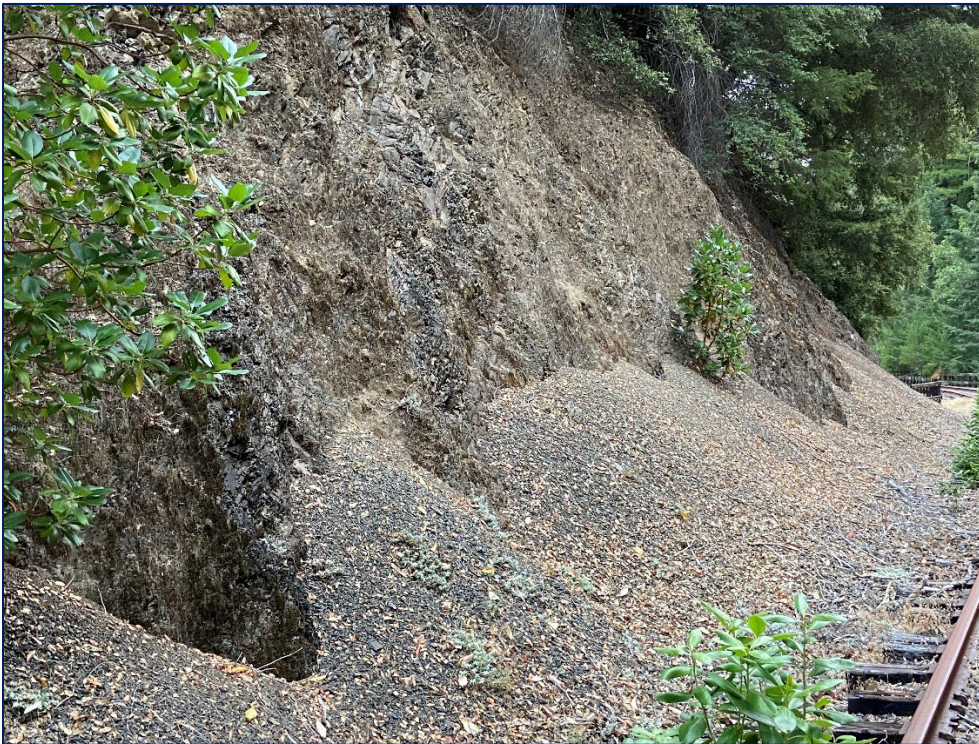
**Exhibit 4-3 – Photo 65 – Fragments of highly fractured siltstone and mudstone raveling from rock slope at approx. MP 147.3**

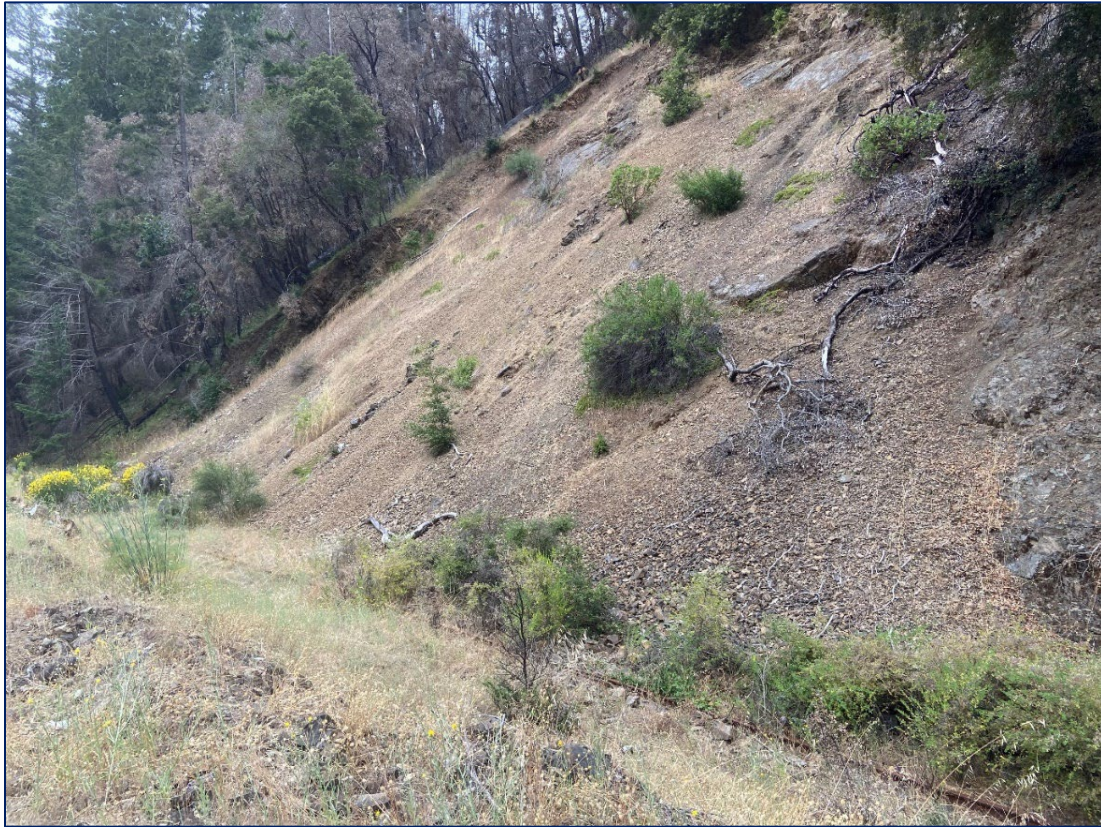
**Exhibit 4-4 - Photo 95 – Highly fractured siltstone and mudstone interbedded with blocky sandstone exposed on slope at approx. MP 146**

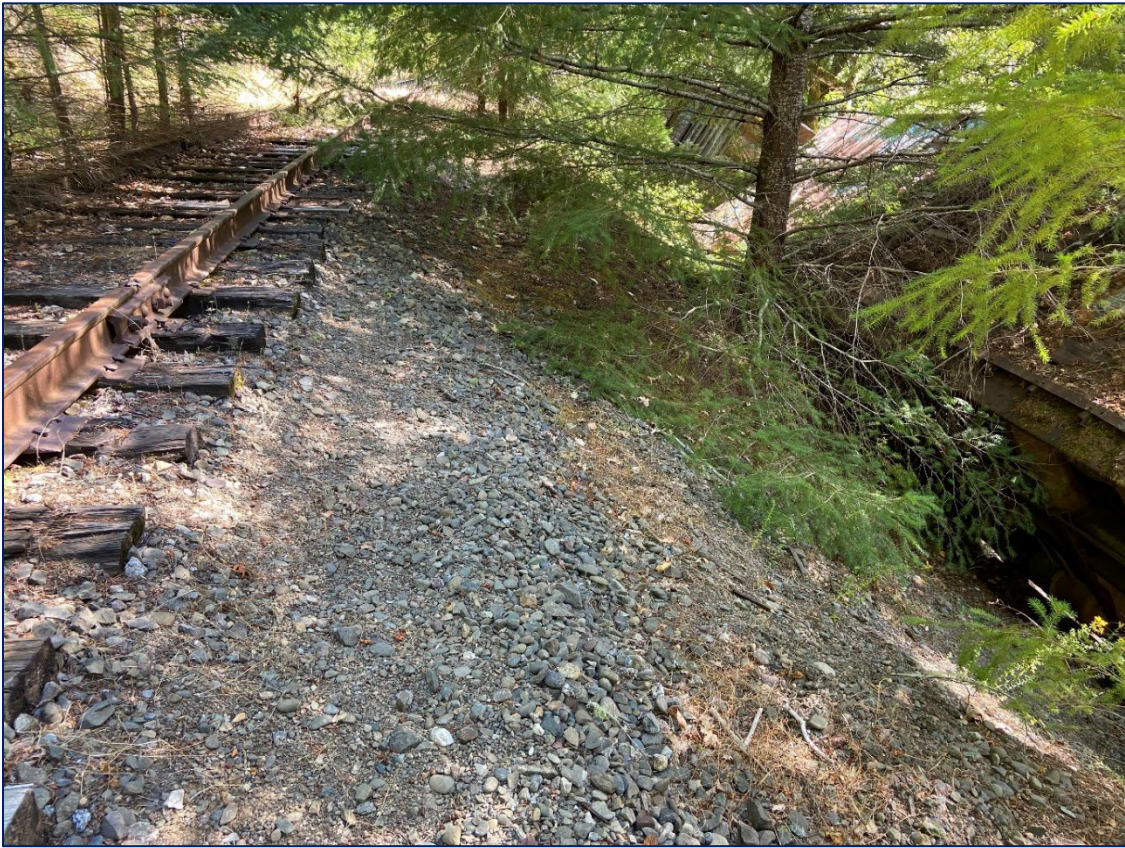
**Exhibit 4-9 - Photo 17 – Narrow shoulder and derailed cars at MP 151.9**
