**OREGON INTERNATIONAL PORT OF COOS BAY  
—FEEDER LINE APPLICATION—  
COOS BAY LINE  
OF THE CENTRAL OREGON & PACIFIC RAILROAD, INC.**

# Coos Bay Rail Link Bridge Condition Assessment

September 26, 2008

DAVID EVANS  
AND ASSOCIATES INC

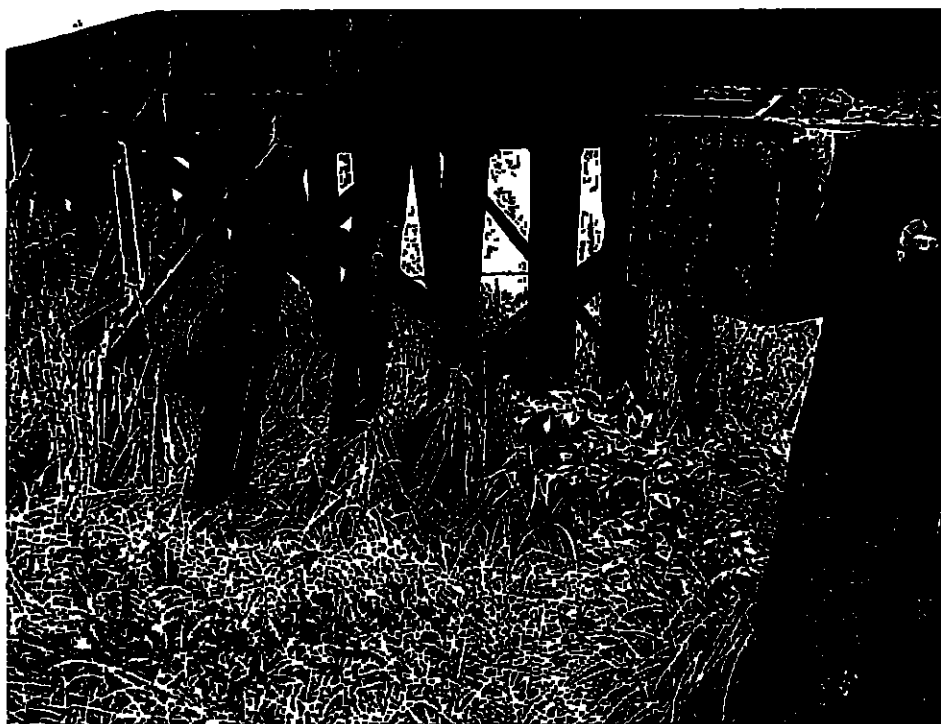
**7. Fire Damage**

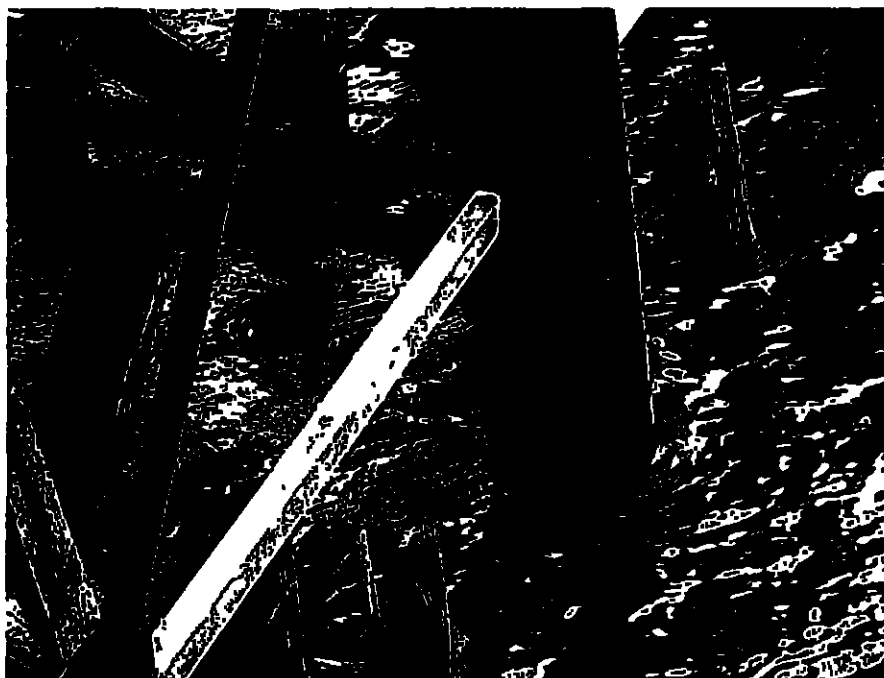
| Item | Poor | Fair | Good | Current Condition | Comments |
|---|---|---|---|---|---|
| 24" Piles | | | X | Good | Rust at and below waterline |

**6. Typical Pipe Pile**

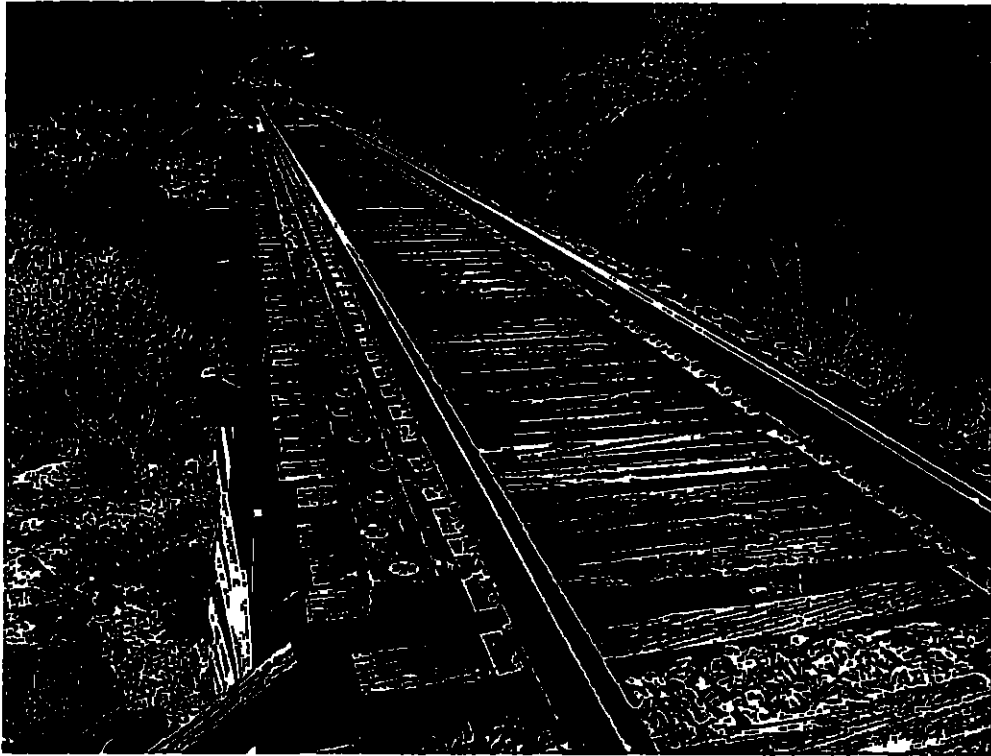
**1. Looking Toward Increasing Milepost**

Notes: Guidance of Fire Damage ~ Apprais: spans 6-9 Partial Replacement  
See photos.  
~ Bts 6-10 damaged ~ Noe replacement
